River Corridor Plan for the White River and Tributaries in Sharon, Vermont

March 15, 2010

Fitzgerald Environmental Associates, LLC.
316 River Road
Colchester, VT 05446

Two Rivers-Ottawquechee Regional Commission
3117 Rose Hill, The King Farm
Woodstock, VT 05091

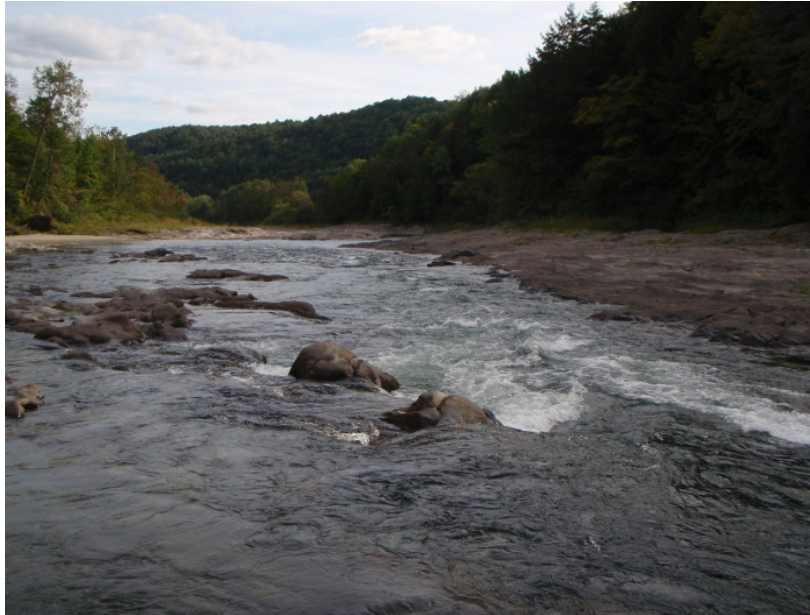
Figure 4.1 Several bedrock grade controls in the upper segment

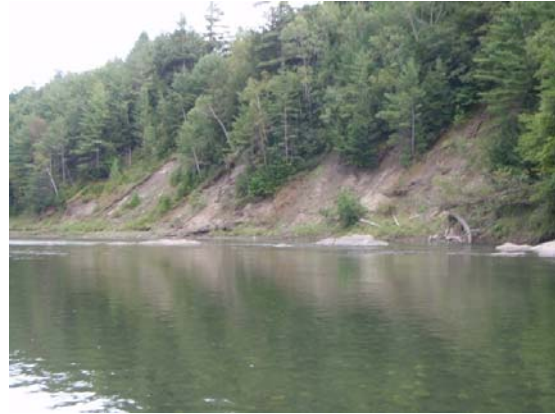
Reach R05 is 1.7 miles in length and begins at the reach break with R04 and extends upstream to the Central Vermont Railroad trestle crossing. R05 has a channel slope of 0.2%. The reach shares many characteristics with downstream segment R04B: it is set in a semi-confined valley; it has several prominent channel-spanning bedrock grade controls (Figure 4.3); it is well buffered to the west with the exception of a terrace in the lower reach where a sand pit is found within 200 feet of the channel. Route 14 and some residential development are found within the eastern corridor for the entire reach. According to the FEMA flood hazard mapping, the 100-year flood zone does not extend across Route 14 to the east, and overlaps with only a few residential properties along the east bank. However, aerial photos taken following the 1927 flood indicate that very large and infrequent flood events are capable causing flood and erosion damage within the valley limits to the east of Route 14. Several large bank failures on the west bank (approx. 100ft high x 600ft long; Figure 4.4) were noted during the field surveys. A town-owned gravel/sand pit is found along west bank within 200 feet of this failing slope, and could pose a significant erosion hazard in the future if the slope failure advances to the west.

Figure 4.4 Large mass failures along the west bank

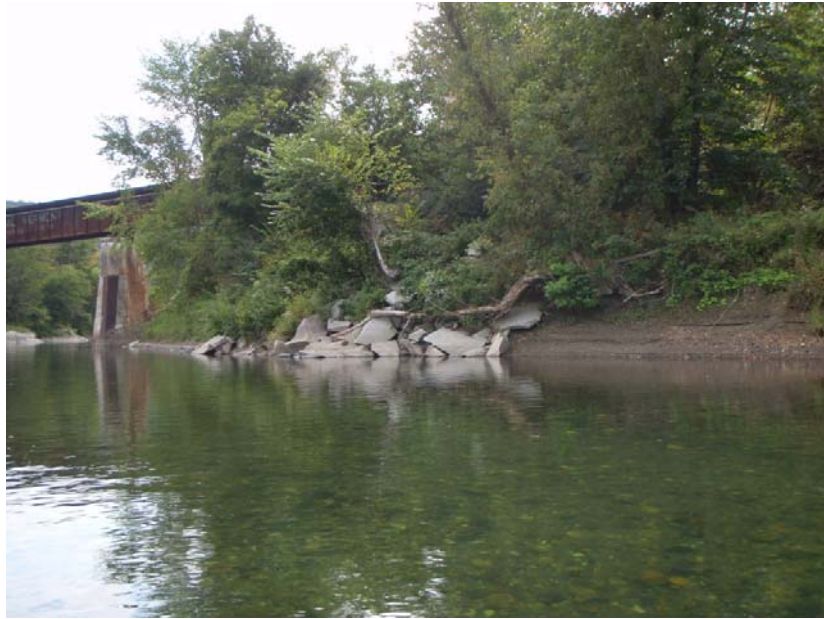
This reach has some notable erosion features on both banks and two very prominent mid-channel bars. The current geomorphic state is still adjusting to historic incision following the 1927 flood and the failure of the Sharon Dam. Any sediment that aggraded behind the dam, prior to its failure, was transported out of the system and downstream. Now, the channel is re-aggrading sediment and some moderate bank erosion and widening is occurring. Bar enlargement and bank erosion is most severe in the lower reach near the railroad trestle (Figure 4.8). The substrate was predominately cobble (58%), with a median substrate size of 210 mm.

Figure 4.8 Bank erosion and failing rip-rap upstream of the railroad trestle

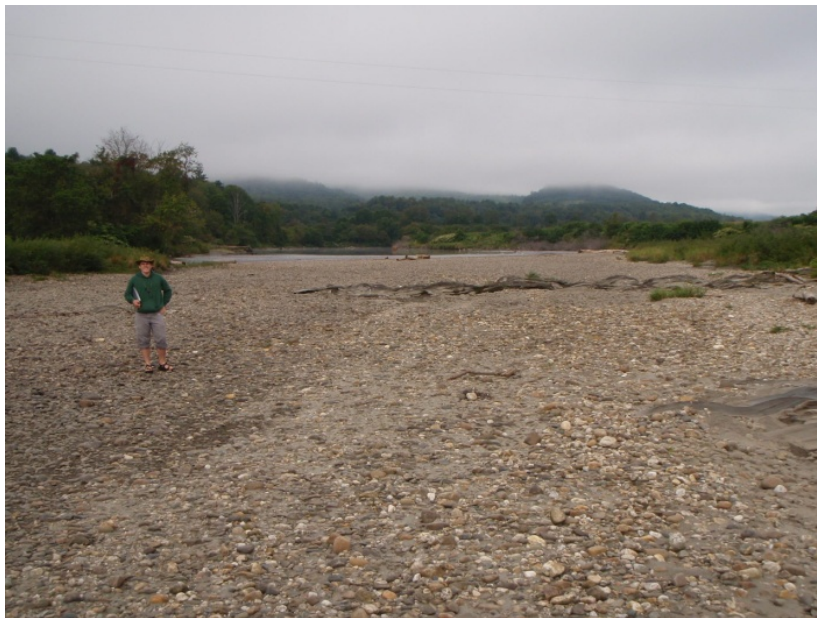
Figure 4.11 Mid-channel deposition in the upper reach

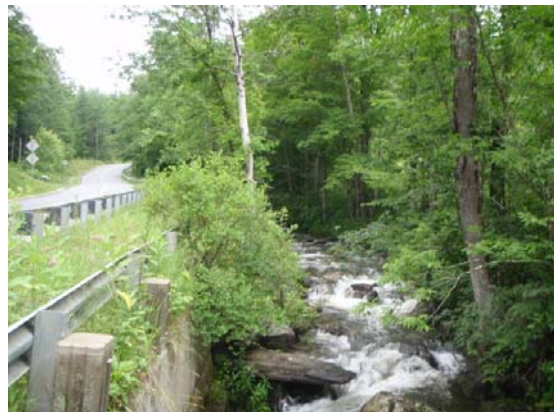
Reach R6.S3.01 begins at the confluence with the main stem of the White River and it extends upstream 1.5 miles at an average slope of 6.7%. This reach is a B-type by reference with a subclass slope designation a. The valley is semi-confined with human-caused change in the valley width. The width-to-depth ratio and entrenchment ratio are both indicative of the stream type (WDR = 11.7; ER = 1.9). No incision was observed on this reach (IR = 1.0; Figure 4.12). Slope changes are common within this reach because of bedrock grade controls. This makes it possible for several different types of bedforms to be present: cascade, step-pool, and plane bed features were all observed, but step-pool features were dominant. The substrate was predominately cobble (37%) and boulder (38%) in R6.S3.01, with a median substrate size of 210 mm (cobble). The frequency of grade controls is higher in the lower reach, and the channel is vertically stable. Much of the reach is heavily encroached upon by Route 132, which limits the buffer width on the right side and impacts the valley width (Figure 4.13). In the upper reach the armoring and encroachment of the channel has caused some large mass failures to form. These features are contributing significant sediment to the upper reach and if slope failures persists problems with the roadway and channel flooding could result.

Figure 4.13 Channel encroachment by Rt. 132 and armoring

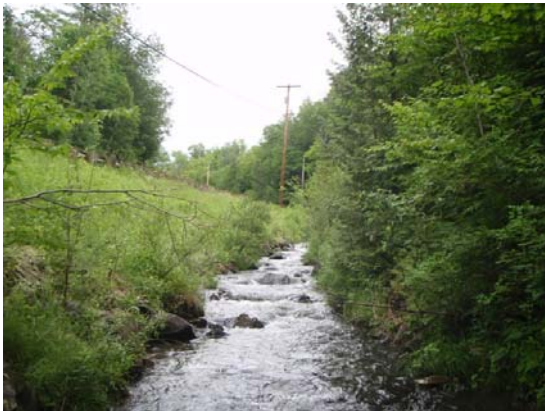
Figure 4.16 Route 132 fill changing the right valley wall

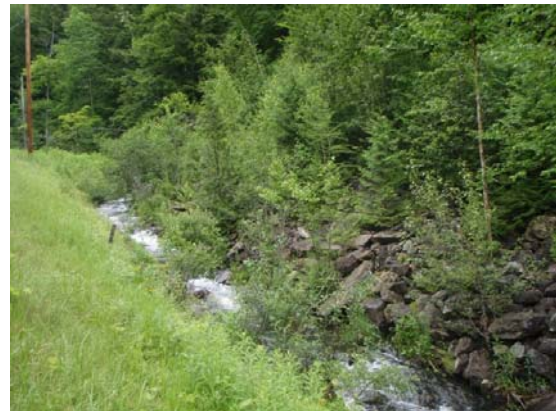
R6.S3.02-B begins at the segment break at the next Route 132 crossing and extends upstream 0.4 miles at an average slope of 2.8%. The valley is semi-confined with extensive human-caused change in the valley width. This segment exhibits B-type morphology with plane bedform. The width-to-depth and entrenchment ratios of the channel are 7.1 and 1.9, respectively. Reference conditions for this segment are likely similar to the downstream reach: C4-type, with riffle-pool bedform and narrow confinement. Incision was observed on this segment (IR = 2.0). The right floodplain of this segment is largely fill; placed there to provide an adequate base for Route 132 (Figure 4.16). The substrate was predominately cobble (48%) and Boulder (29%), with a median substrate size of 170 mm (Cobble). Much of the coarser substrate observed in the pebble count could be sourced from the extensive rip-rap was placed on both the left and right banks to prevent erosion (Figure 4.17).

Figure 4.17 Extensive rip-rapping on the left bank

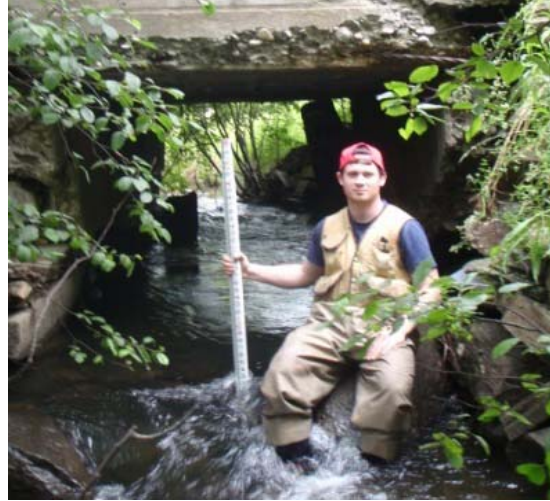
was noted. The substrate was predominately sand (44%) and gravel (55%), with a median substrate size of 5 mm (Gravel). Bedform is predominately plane bed; however some nice dune-ripple features were observed where the channel was within an area densely covered with WAD species (Figure 4.18). A historic farm crossing remains in the lower segment. This structure is deteriorating and it acts as a constriction to the bankfull and floodprone flows, but a pool feature has scoured out underneath it (Figure 4.19).

Figure 4.19 Old farm-trail bridge that is deteriorating

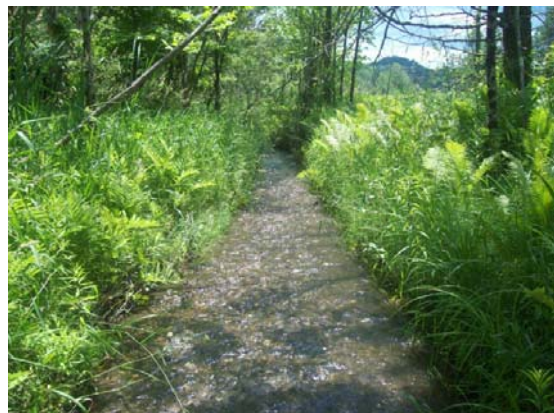
Figure 4.22 Straightening and plane bedform in upper segment

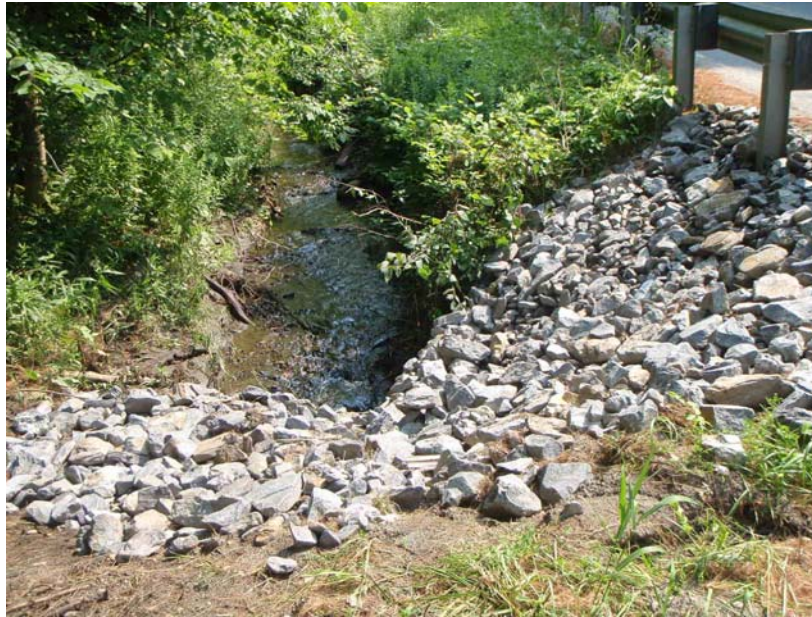
Figure 4.24 Armoring upstream of an undersized culvert (Rt. 132)

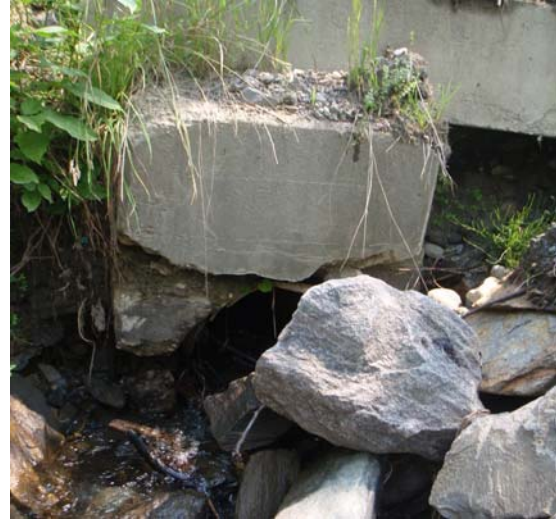
R6.S3.04-B is the final assessed segment of Quation Brook. This segment begins just downstream of the second-to-last crossing of Route 132 and extends up into the wetland area north of Cross Road. In total, the segment is 0.6 miles in length and has an average slope of approximately 2.8%. The valley setting of R6.S3.04-B is very broad, with no significant human-caused change to the valley width. The channel is E-type by reference, with a subclass slope of b. The width-to-depth (WDR = 10.4) and entrenchment (ER = 6.8) ratios reflect the E-type morphology observed in this segment (Figure 4.25). The bedform is riffle-pool and substrate is predominately gravel (58%) with a median substrate size of 50 mm (Gravel). The culvert at the Cross Road crossing is problematic (Figure 4.26). The culvert is undersized and partially collapsing, the upstream end of the structure is deteriorated and the road is eroding down into the channel. This structure has a high priority for replacement because of structural reasons and fish passage issues.

Figure 4.26 Deteriorated outlet of the Cross Road culvert

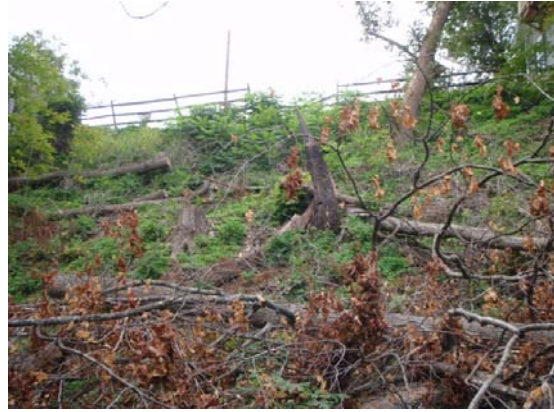
Figure 4.28 Trees felled from valley wall adjacent to the channel

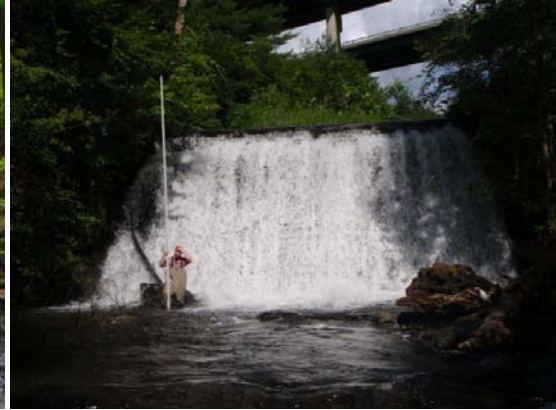
Figure 4.30 Large dam upstream of the segment break

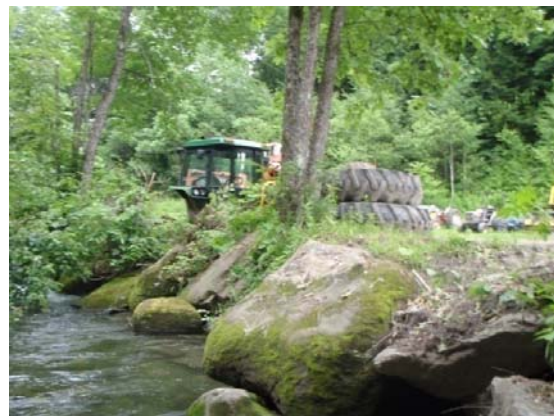
Figure 4.36 Low buffer width, rip-rap and corridor development

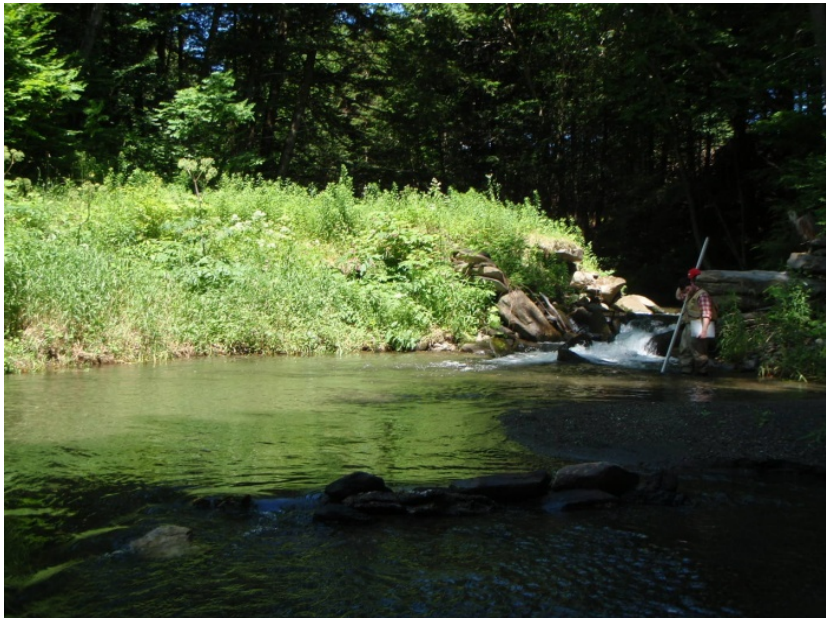
Figure 4.38 Historic mill structure that is influencing the sediment dynamics of the upper segment

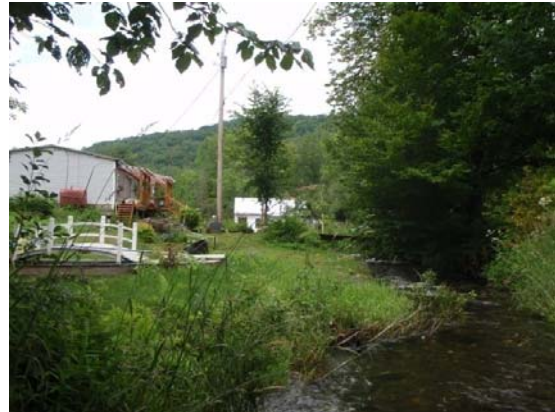
Figure 4.42. Low buffer width with development in the corridor

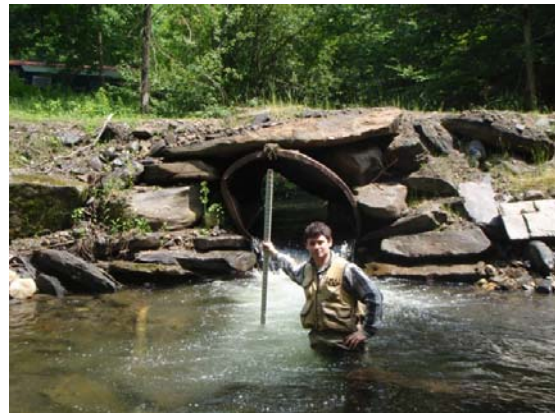
Figure 4.44 Squashed driveway crossing and dredging site

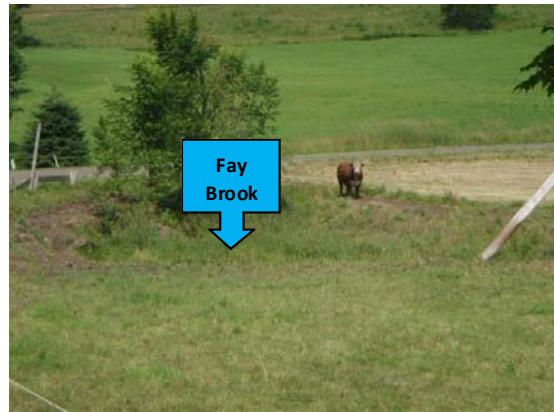
Figure 4.46 Large bull that grazes in and around the channel

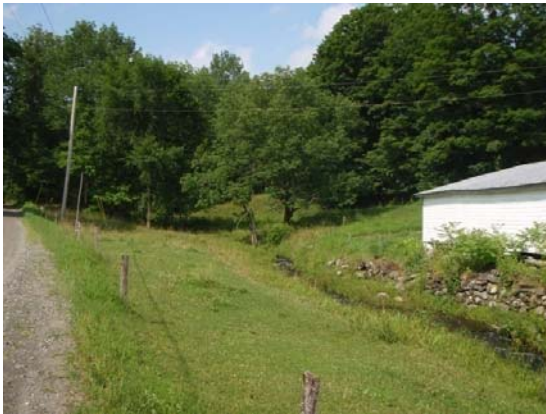
Figure 4.47 Encroached/straightened area in lower segment

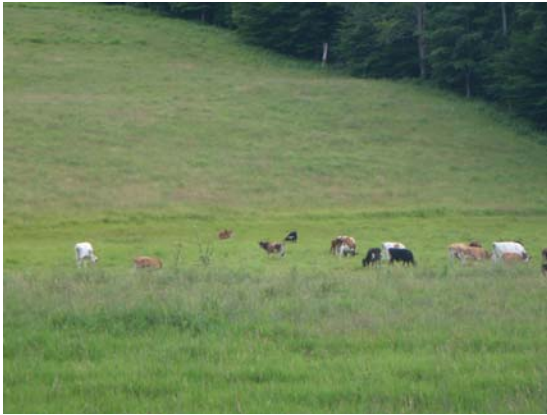
Figure 4.49 Cattle grazing in and around the channel

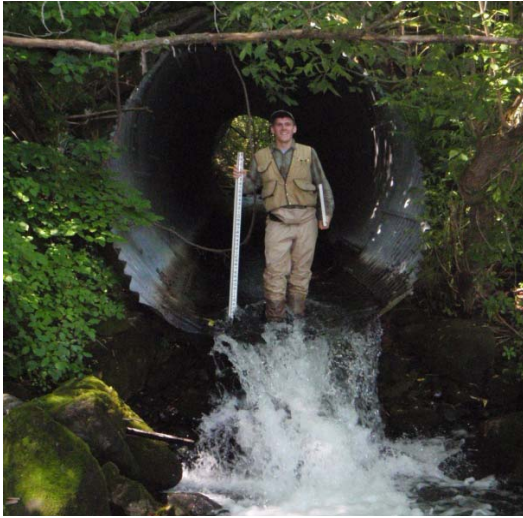
Figure 4.53 A perched culvert at the Route 14 crossing

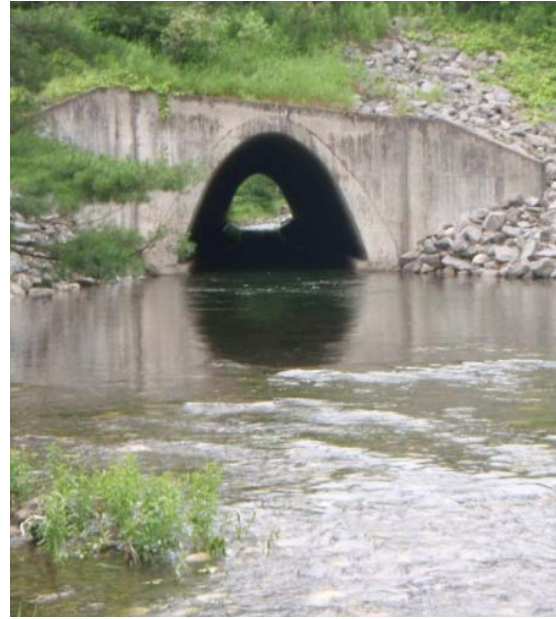
Figure 4.61 Misaligned I-89 culvert with large plunge pool

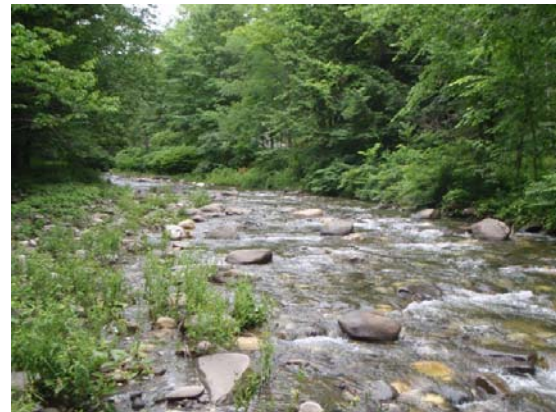
Figure 4.63 Widened channel in lower segment
