SECOND BRANCH WHITE RIVER WATERSHED

STREAM GEOMORPHIC ASSESSMENT and RIVER CORRIDOR PLAN

March 19, 2021

Prepared by:
Daniel Ruddell, Christian Pelletier,
Greg Russ and Mary Russ,
White River Partnership

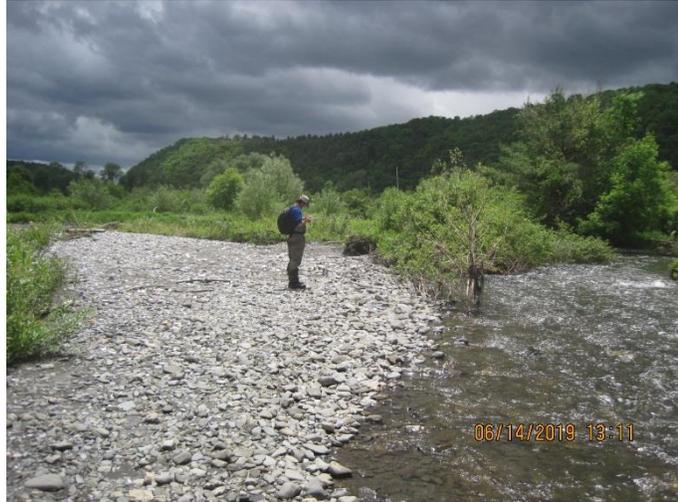
Figure 16. Sediment plug from Snow's Brook led to rapid neck cut-off through former dam-impounded fine sediments in segment M11-B.

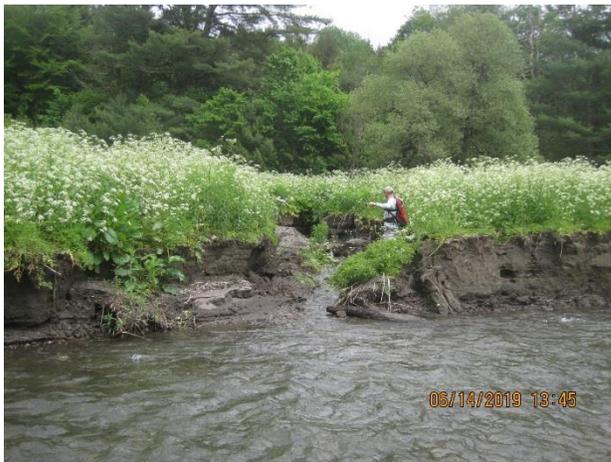
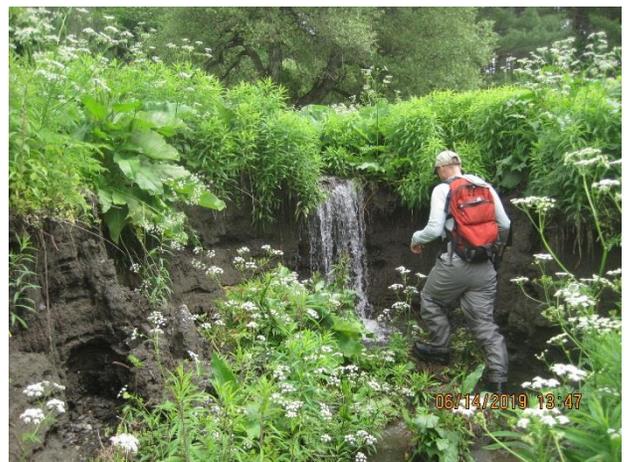
Figure 17. Eroded fine sediments from former dam impoundment in segment M11-B near Ferris Rd. were traced back to this headcut, possibly due to diversion of a small tributary (needs further investigation).

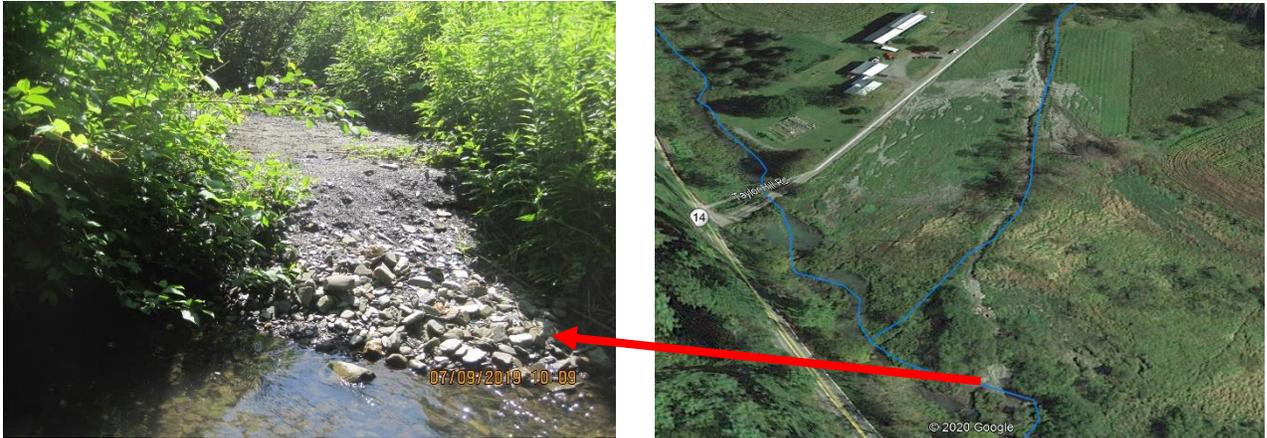
Figure 18. Coarse sediments entering the Second Branch in M16-B appeared to be related to repeat flood discharges along Taylor Hill Rd., deposited in an alluvial fan at the base of the stream off the steep valley sidewall.

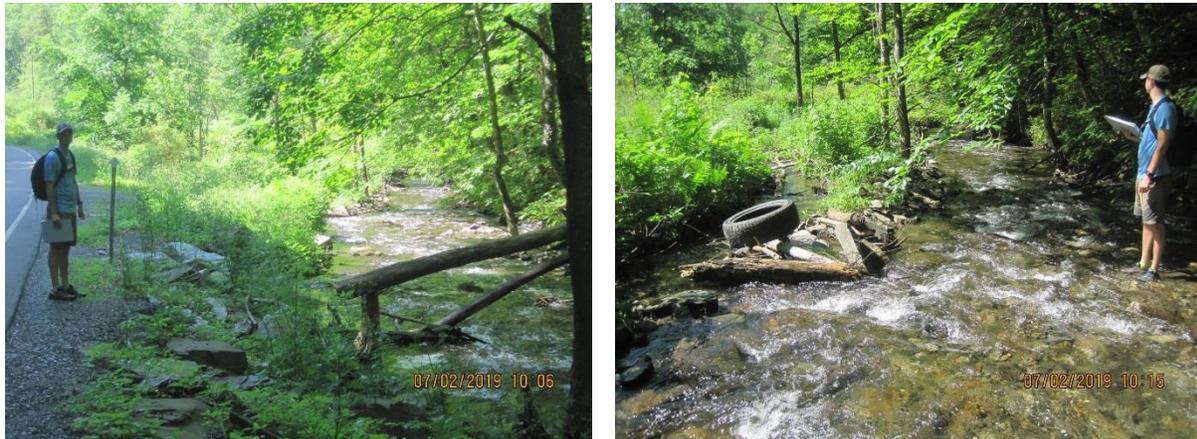
Figure 21. Windrowed sediments below a steep ledge drop (jammed against the side of Rte. 14 in the Brookfield-Williamstown Gulf) funnel the stream toward the valley wall and away from a multithread beaver area. April 2019 flooding appeared to have broken part of the berm, allowing high flows at least to once again access the wetland.

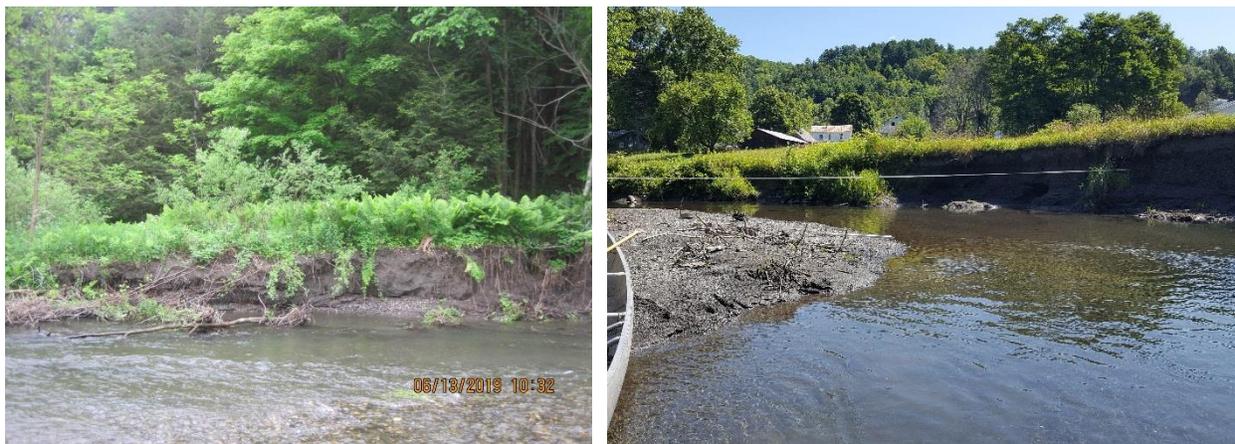
Figure 24. Highly erodible banks comprised of alluvial and glaciolacustrine soils upstream of the former Creamery dam in North Randolph (left) and downstream of the Gulf Road dam in East Randolph (right).

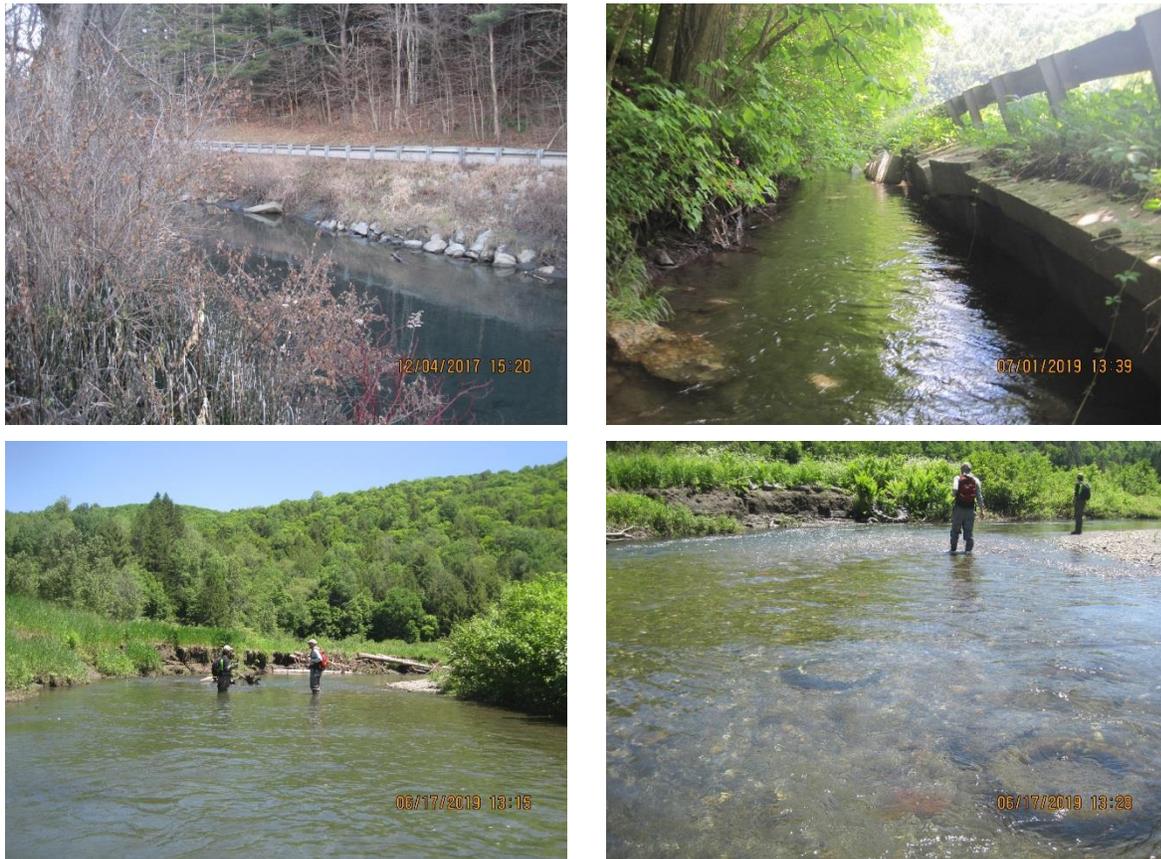
Figure 25. Failing bank toe stabilization, concrete culvert headers, and granite slabs along Rte. 14 in M04 and M17 (top) and failed brush and tire revetments in M10 (bottom) indicate the installation and maintenance challenges of bank armoring in the soils along the Second Branch.

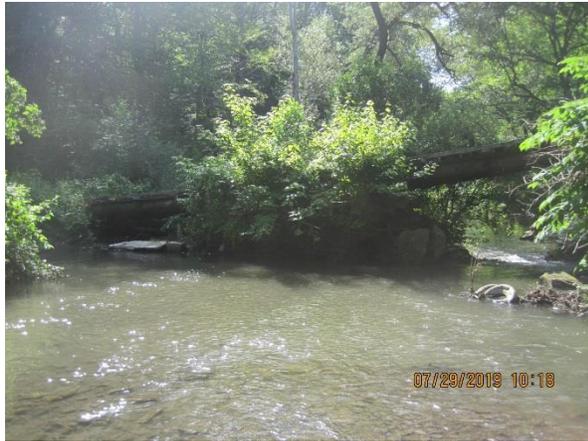
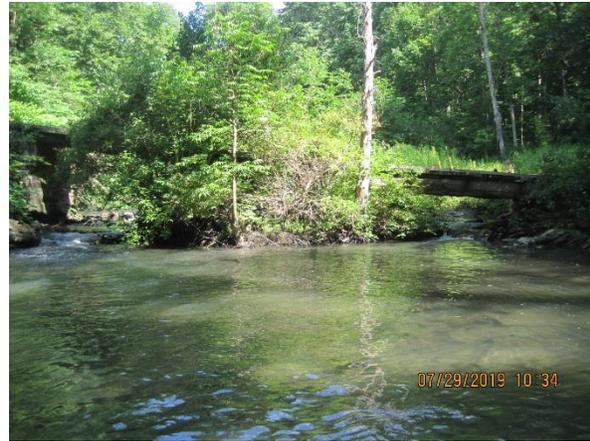
Figure 31. Ledge and old dam remains in North Randolph segment M11-C (left looking DS, right looking US), now carrying a log and plank footbridge, limit bed incision that could undercut and trigger mass failures on the cohesive but still erodible silts along the valley sidewalls.

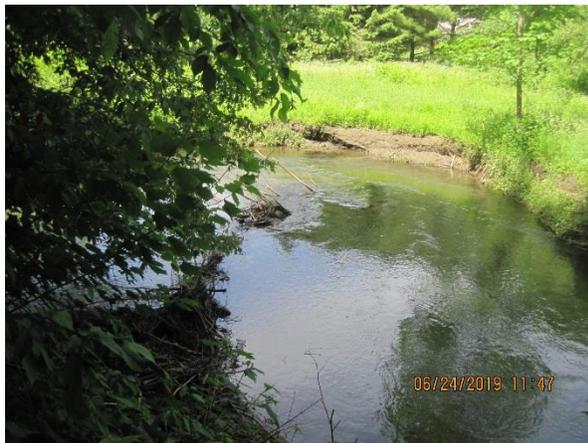
In M14 banks are cohesive and grade controls are lacking, leaving the bed often more erodible than the banks. Floodplain access was diminished during 2019 fieldwork (incision ratio 1.5) so that only higher level floods will achieve overbank sediment deposition, and stream power is enhanced due to containment in the channel in moderate level floods. As in M11-C, banks are cohesive due to silt content, but ultimately are erodible under sufficient stream power or undercutting, tending to slough (Fig. 32).

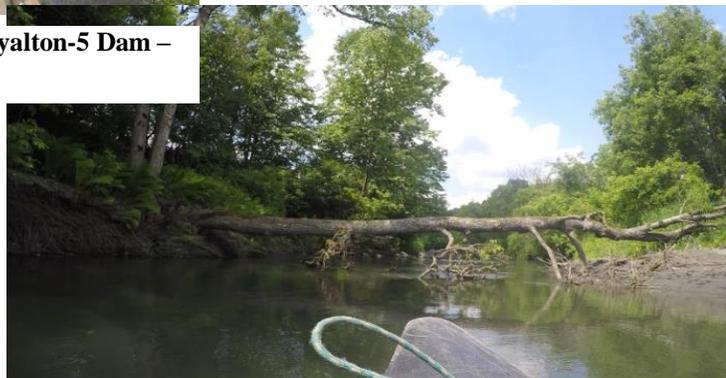
Figure 41. Eroded left bank resulting in downed tree; over 150 pieces of large woody debris found in reach M03

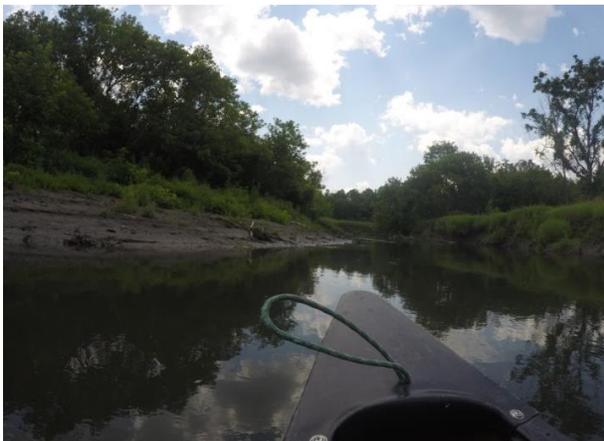
Figure 43. Renovated stream ford found at top of reach M03 close to M04 reach break

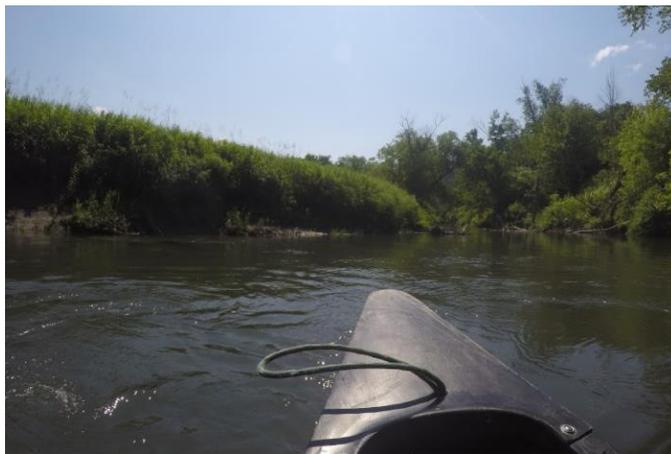
Figure 45. Lower portion of M04 has actively eroding banks, notably worse in areas with no buffer. Buffered valley wall at right bank increases erosive pressure on agricultural fields.

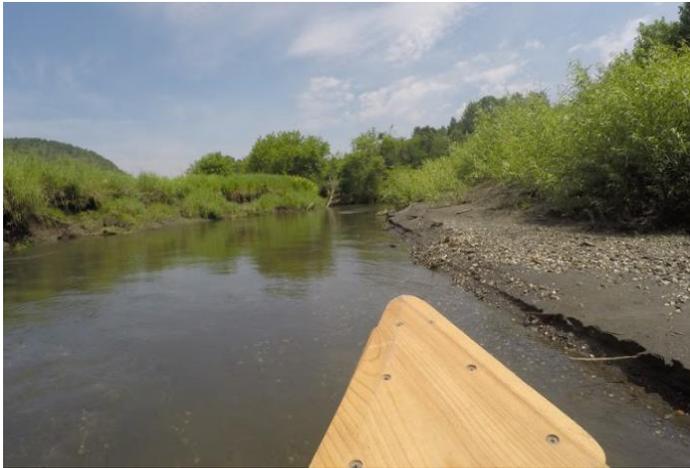
Figure 52. Erosion (some active, some healed) lines the left bank of M06, fine sediments have increased the intensity of erosion and lead to multiple neck cut offs

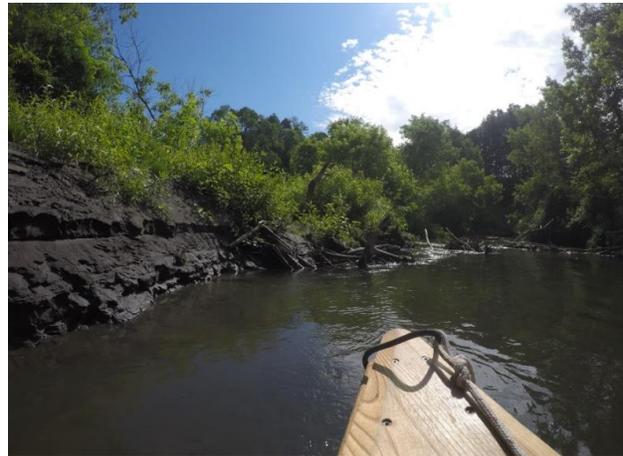
Figure 53. Severe erosion on left bank in M06, over 4 feet in height

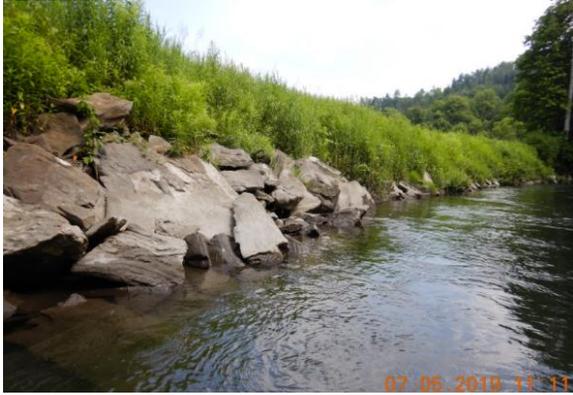
Figure 56. Riprap revetments along the left bank and adjacent agricultural fields in M07

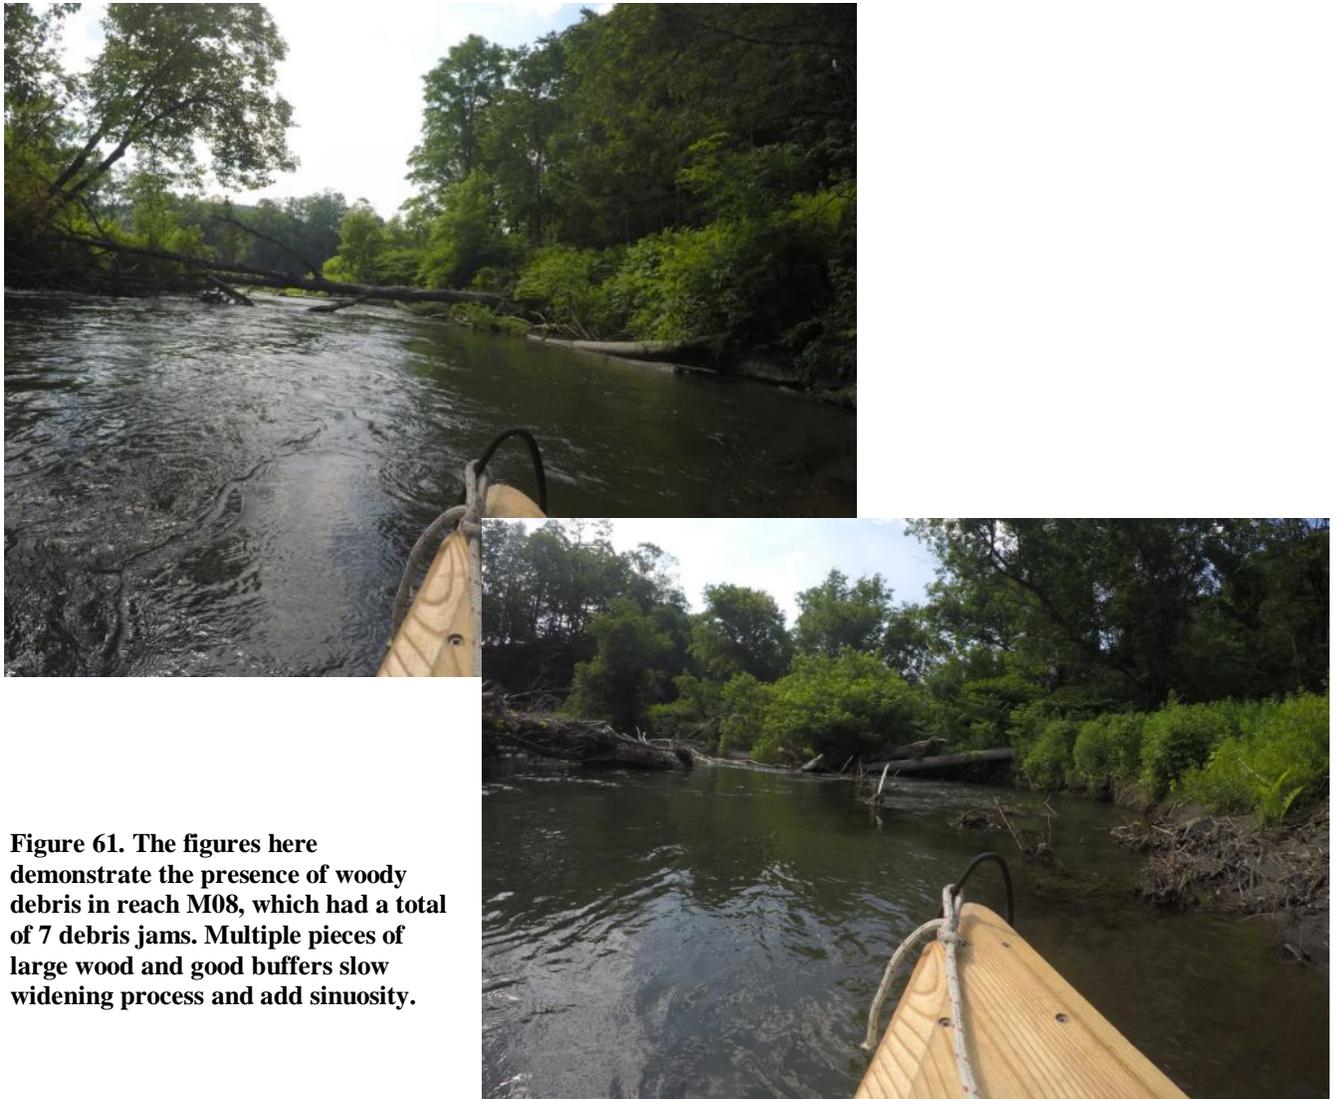
Figure 61. The figures here demonstrate the presence of woody debris in reach M08, which had a total of 7 debris jams. Multiple pieces of large wood and good buffers slow widening process and add sinuosity.

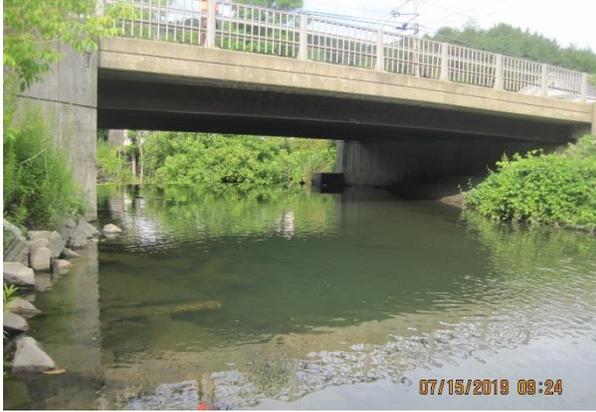
Figure 64. The Gulf Road dam impounds a pool deep enough to maintain a dry hydrant for the East Randolph Fire Department (intake pipe at lower left of photo)

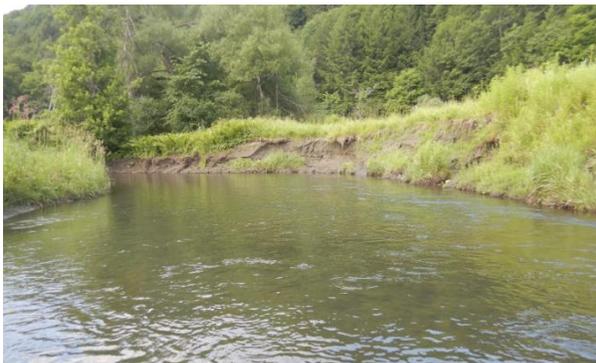
Figure 65. Upstream of the Gulf Road Dam, the river is flat and heavily sedimented. VT-14 encroaches intermittently on river right while a steep valley wall sits off river left.

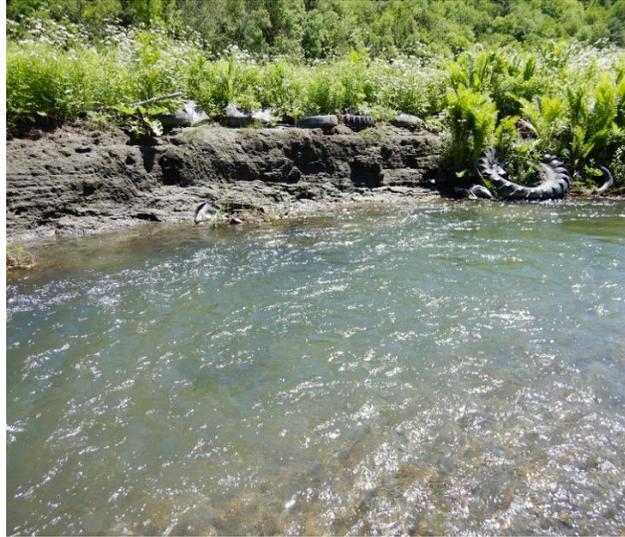
Figure 68. Tire dump in M10, tires used for revetments are now in river bed or slumped along the banks

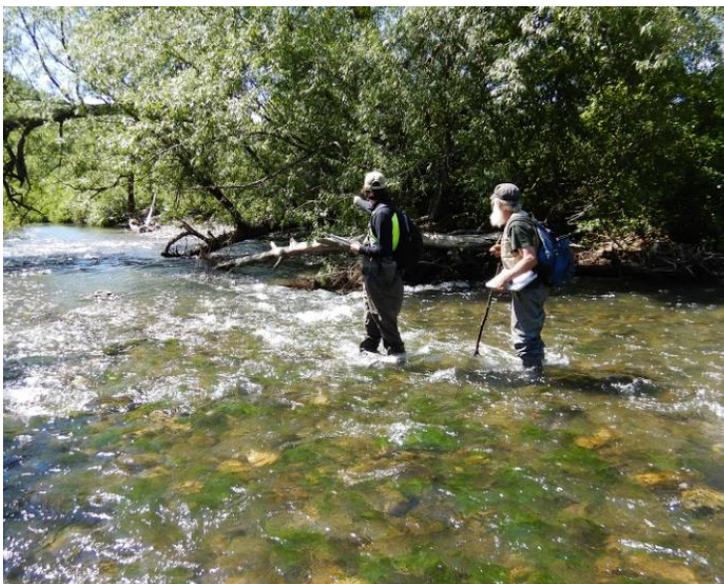
Figure 69. Larger bed material (gravel and cobble), likely originating from tributaries and discharged to the mainstem in flash floods, differentiate M10 from many of the sandy/fine sediments found along much of the Second Branch

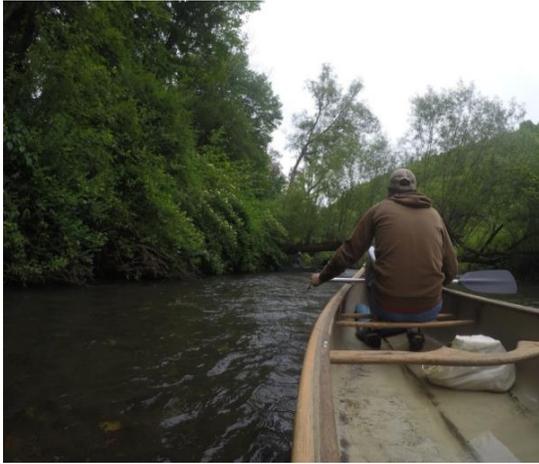
Figure 71. The lower portion of M11-A is confined between the steep valley wall on river right, which still has remains of a historic dam and infrastructure, and the VT-14 road embankment on river left

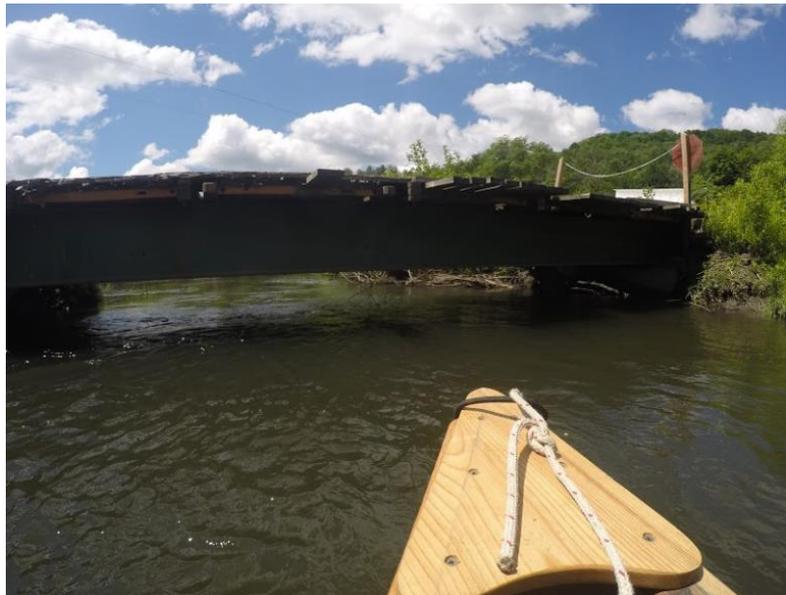
Figure 76. Example of a private bridge in M12 with low clearance; these bridges and their abutments significantly straighten the reach and restrict access to floodplain

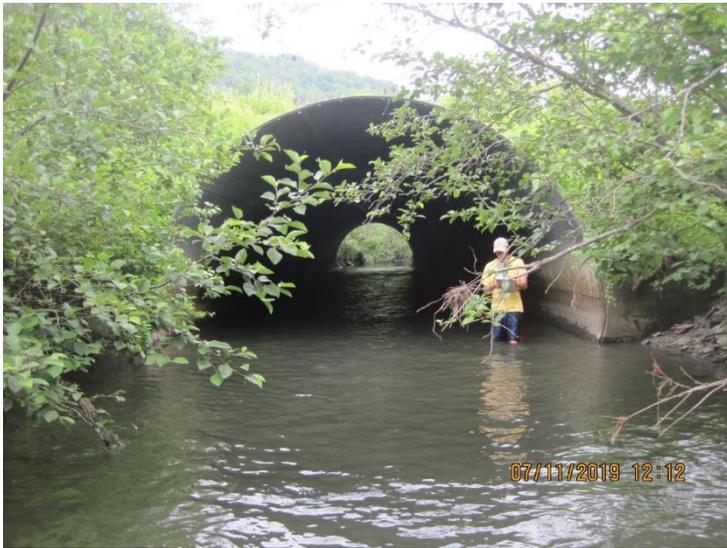
section shows effects of straightening by the culvert, historic farming practices, and a recently installed private bridge; this area was thus not segmented during assessment.

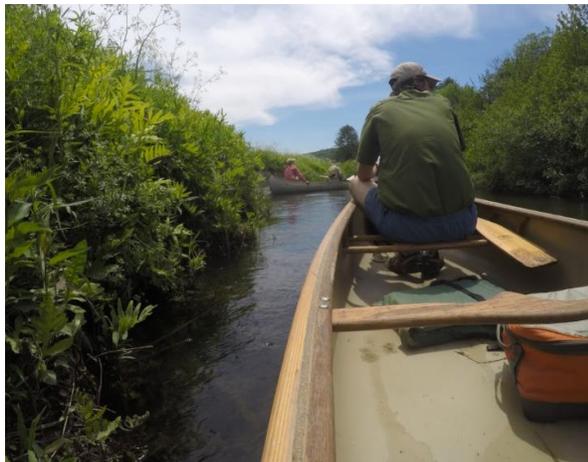
Figure 83. Steep banks make M14 feel entrenched as it meanders through agricultural fields to left and valley wall on river right

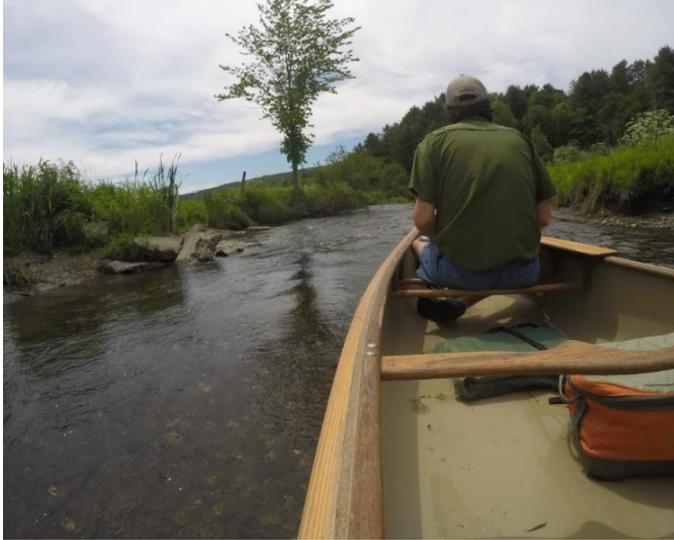
Figure 84. Small sections of reach M14 have increased access to floodplain on river left, but overall the reach is moderately incised

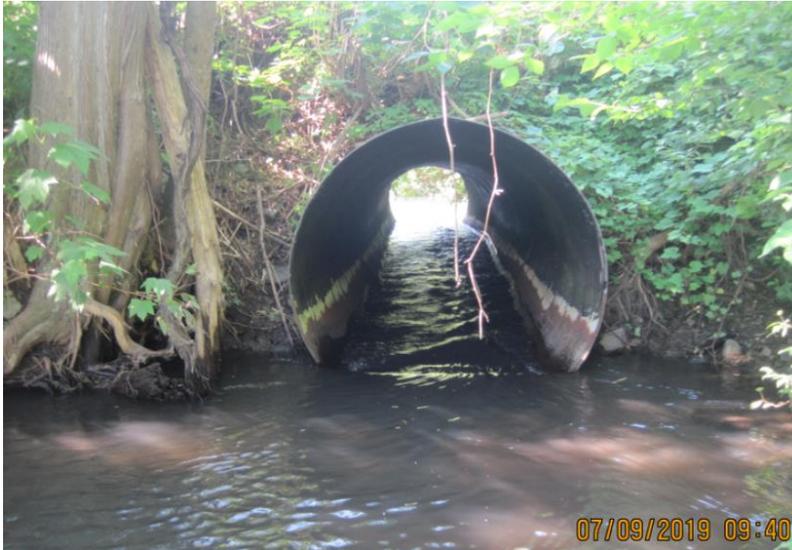
Figure 90. The severely undersized Taylor Hill Road Culvert (looking downstream)

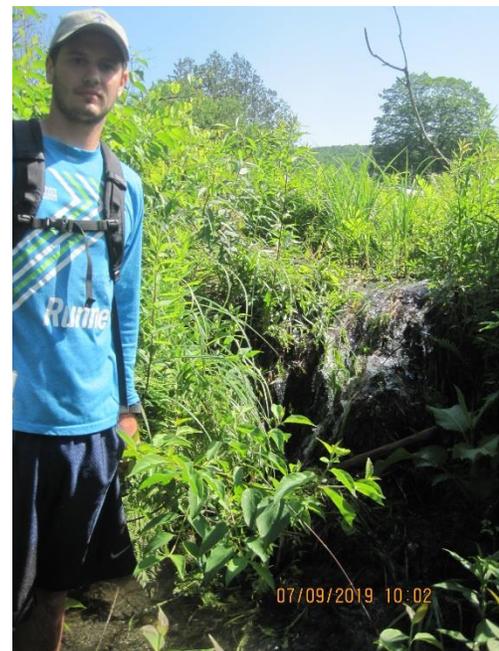
Figure 91. Headcut through alluvial fan deposits below Taylor Hill Rd, off the left bank of M16-A, likely related to April 2019 flooding

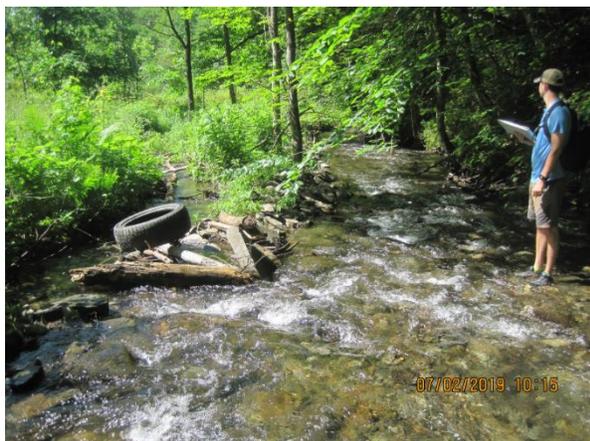
Figure 95. This small berm was identified for removal; the berm pins the river against the right valley wall.
