Upper & Middle White River Watershed Corridor Plan

Barnard, Hancock, Pittsfield, Rochester, and
Stockbridge, Vermont
July 15, 2015

Prepared by:
Bear Creek Environmental, LLC
149 State Street, Suite 3
Montpelier, Vermont 05602

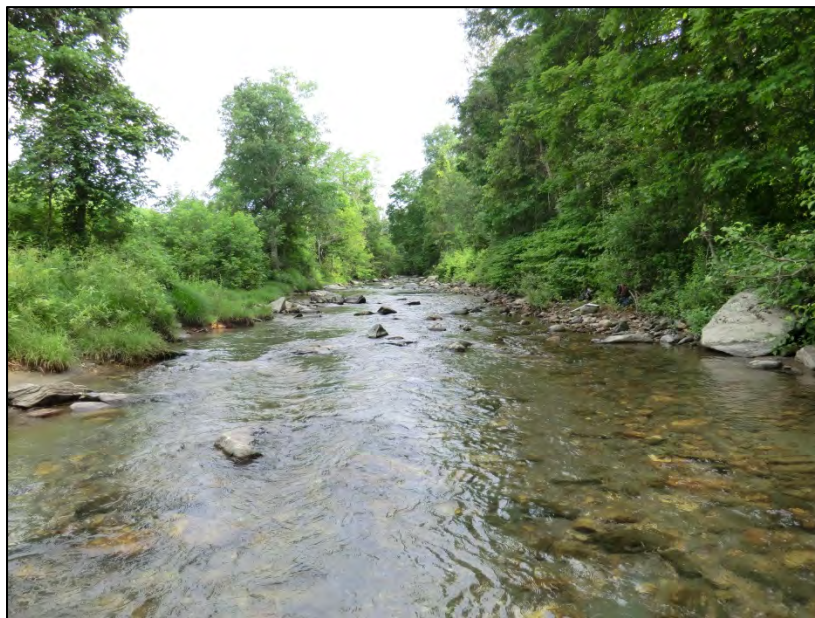
Figure 5.5. Stream channel has been extensively straightened in T3.02-A and lacks a diversity of bed features.

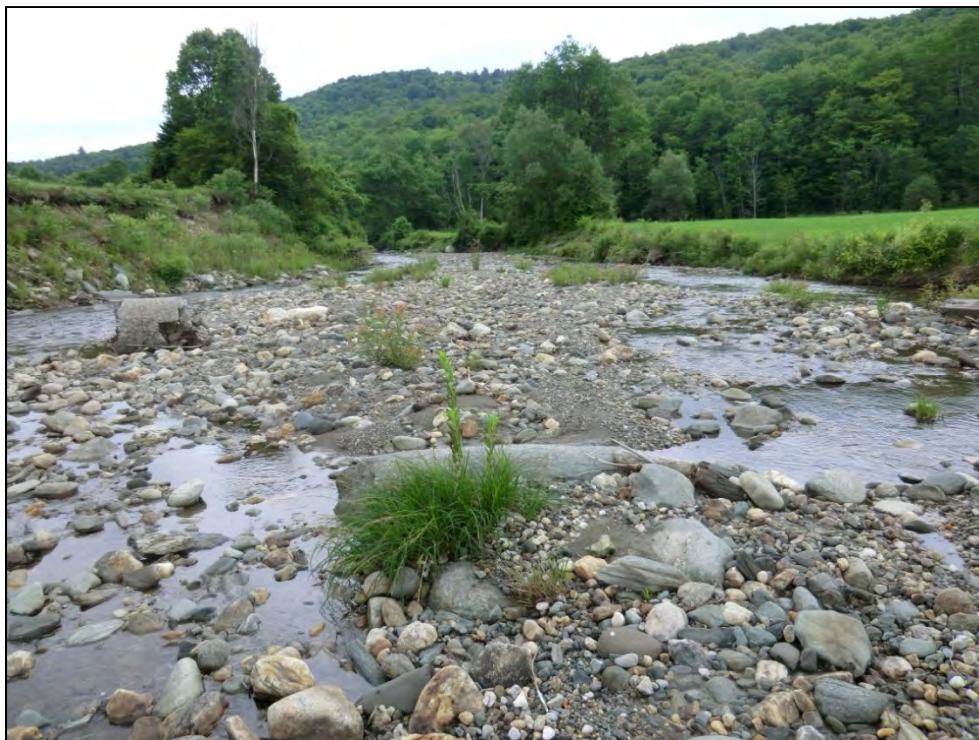
Figure 5.6. T3.02-B is very aggradational and has majorly widened.

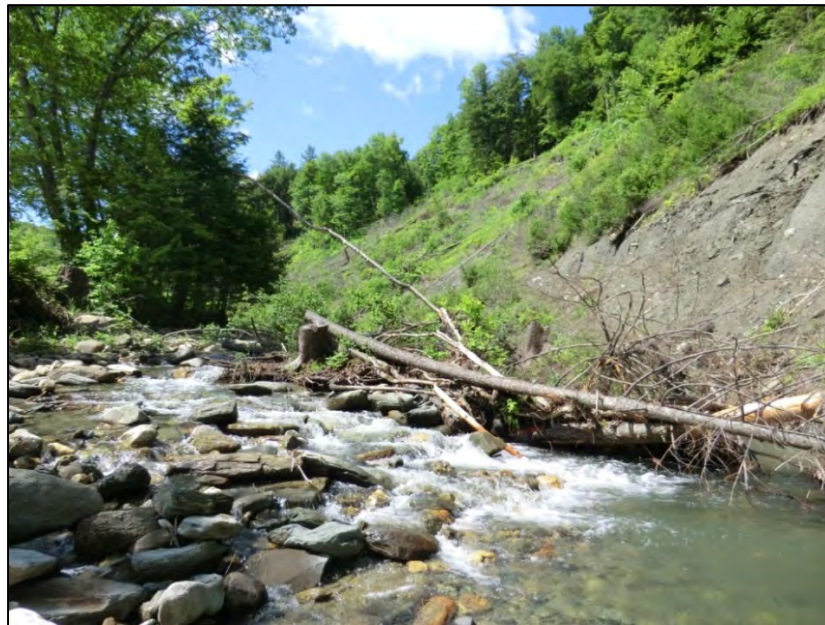
Figure 5.8. One of two active headcuts present in T3.03-A.

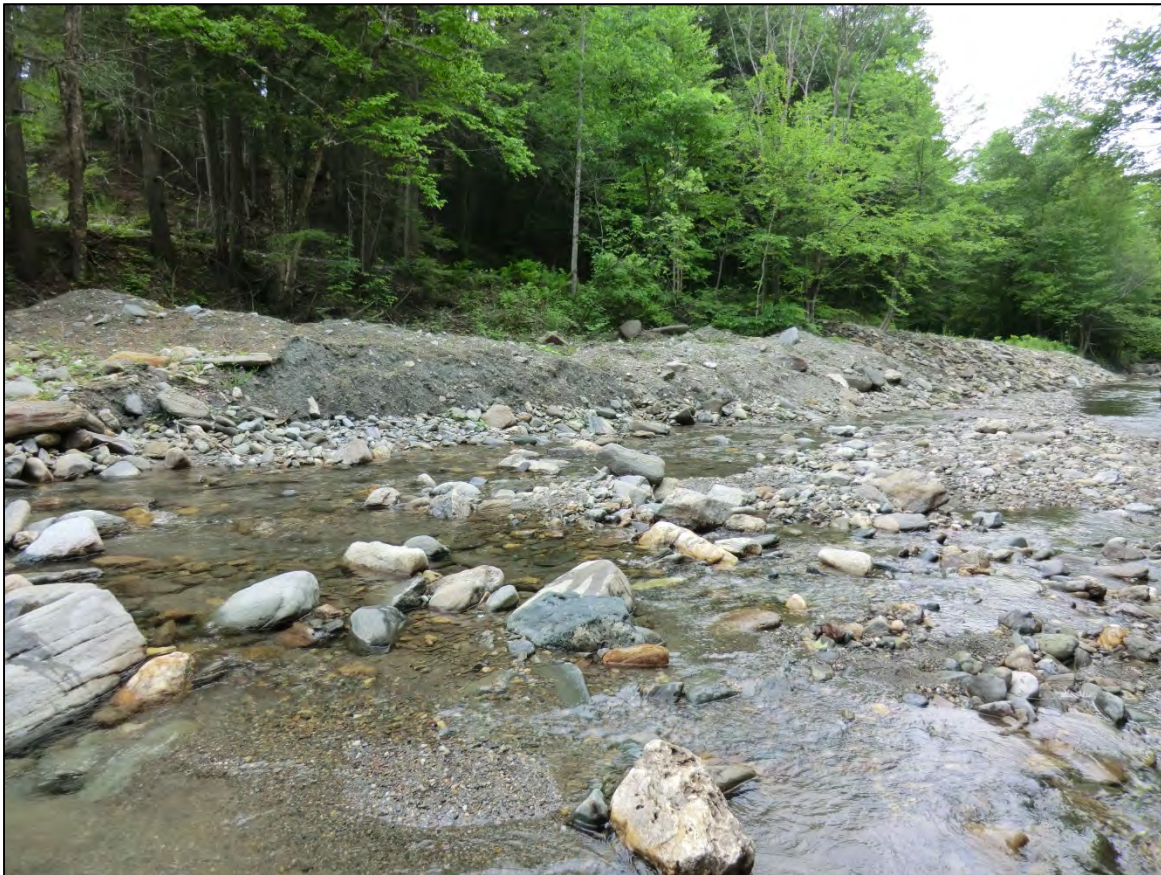
Figure 5.9. Chateauguay Road washed out during TSI in T3.03-B and post-flood work involved windrowing.

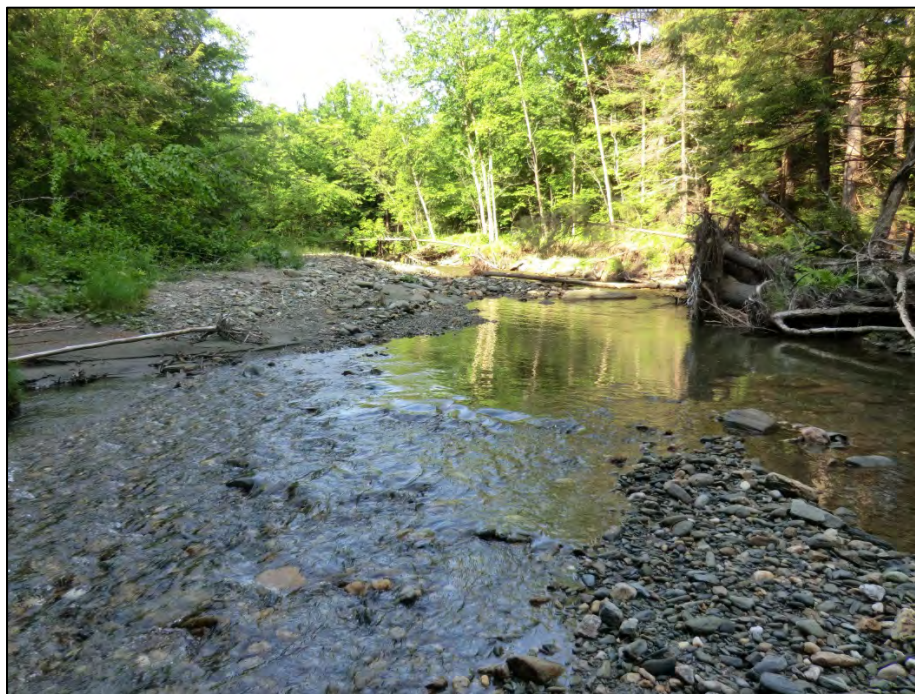
Figure 5.10. Major aggradation is occurring in T3.04-A.

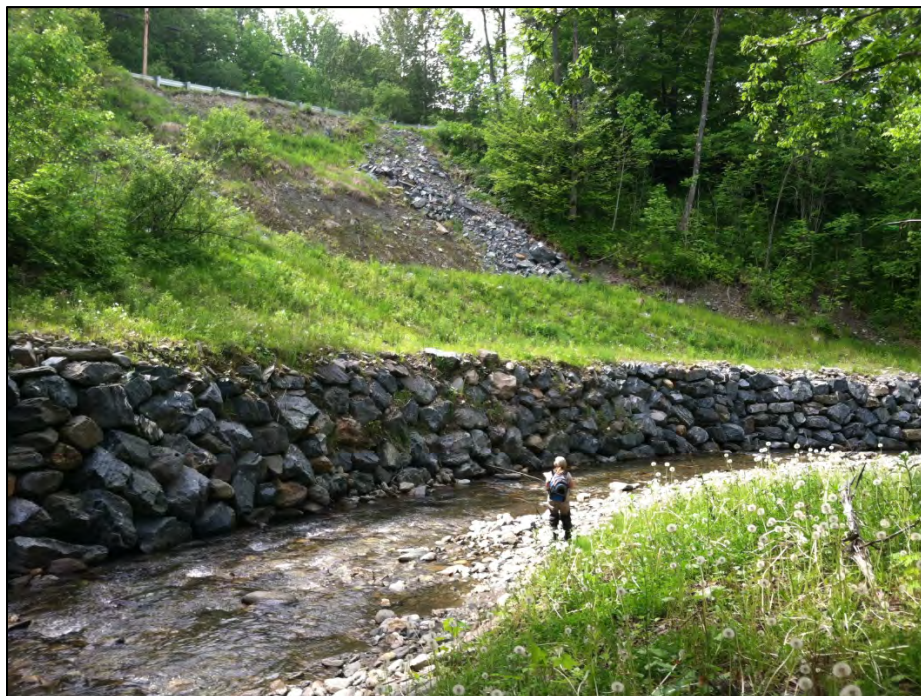
Figure 5.11. Bank instability is common in T3.04-B, as is bank armoring.

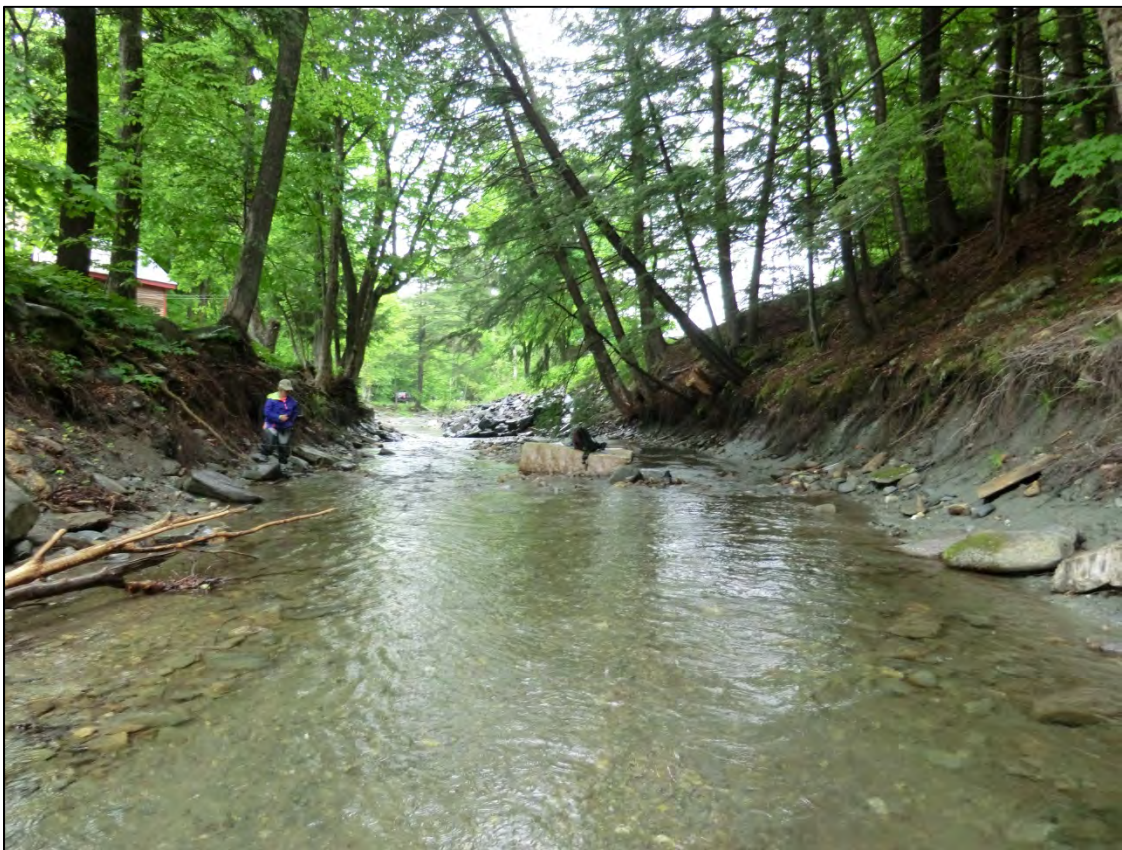
Figure 5.12. Extreme channel incision has occurred and continues to occur in T3.04-C.

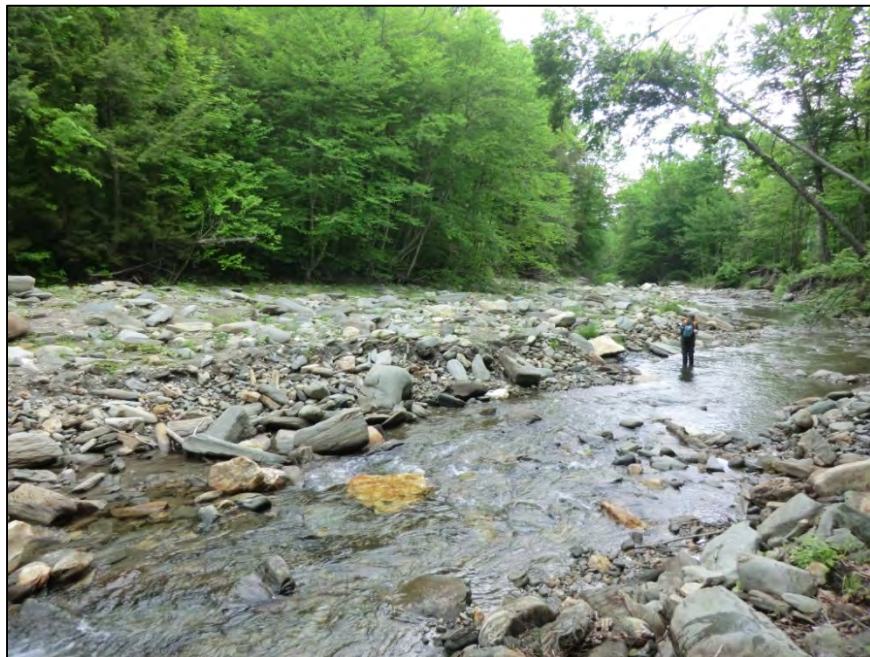
Figure 5.13. Many areas of T3.05-A are very wide and aggradational, building a juvenile floodplain.

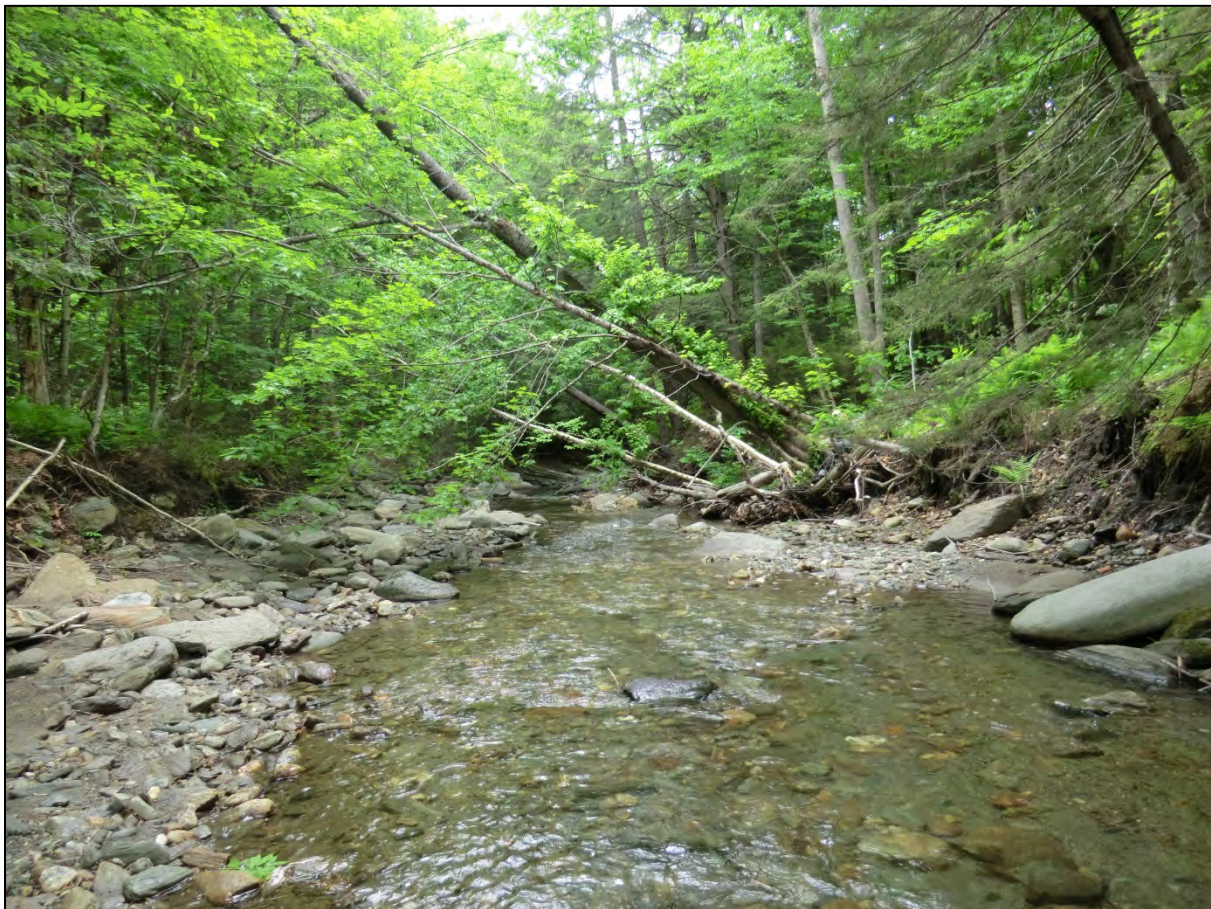
Figure 5.14. T3.05-B has well forested buffers but abundant bank erosion.

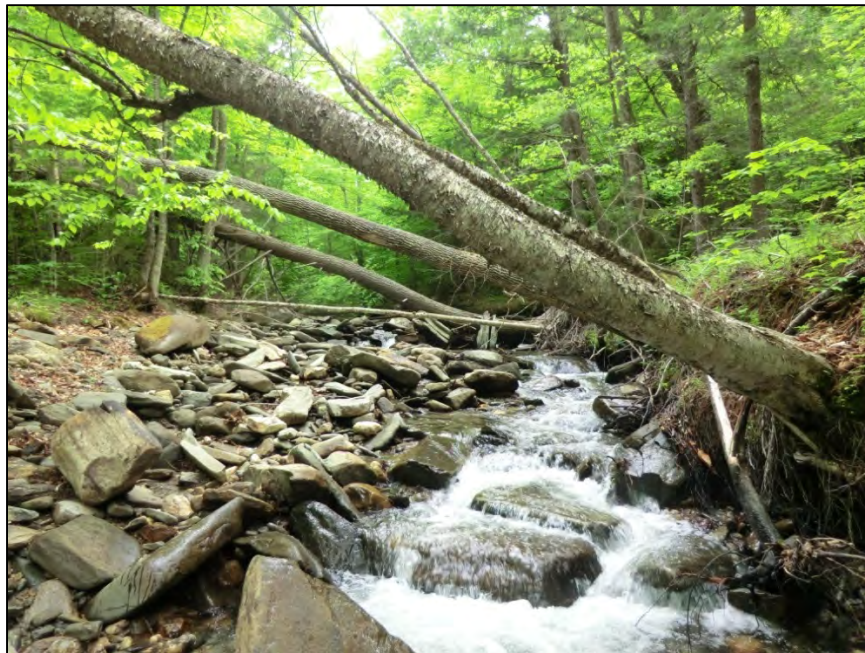
Figure 5.16. One of four headcuts in T3.05-D contributing to channel incision and instability.

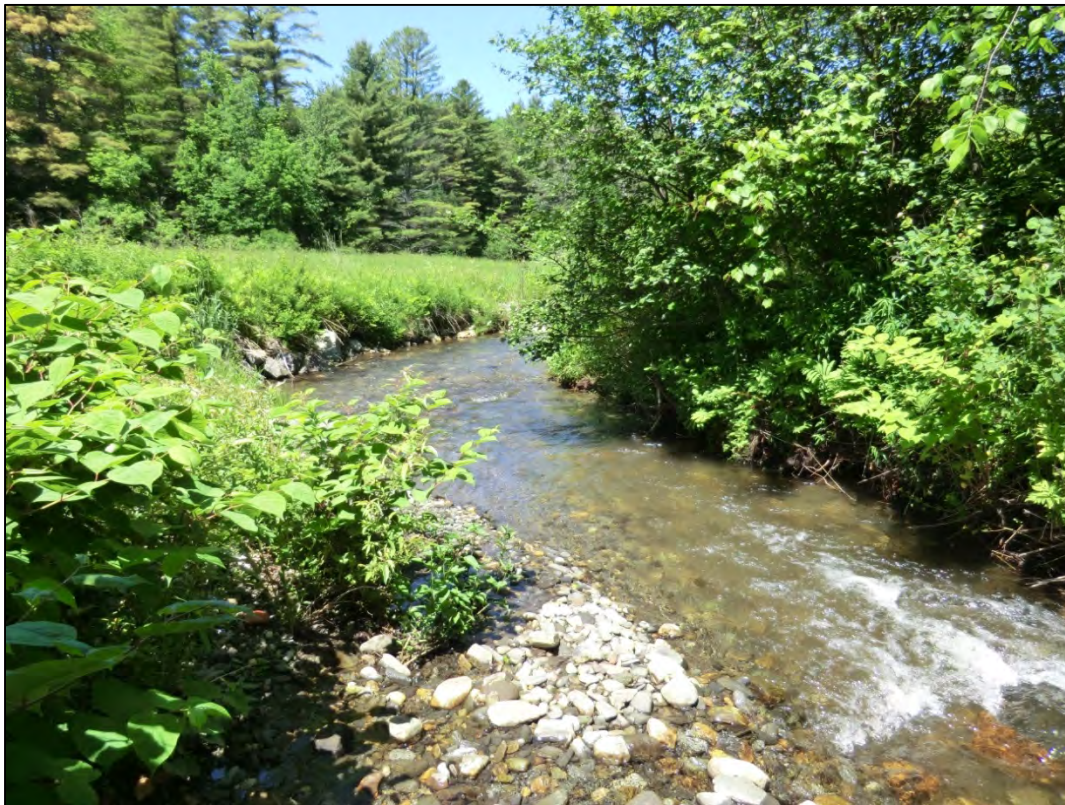
Figure 5.20. Pond Brook is a narrow wetland channel in T3.2-S3.01-C with impacted buffers.

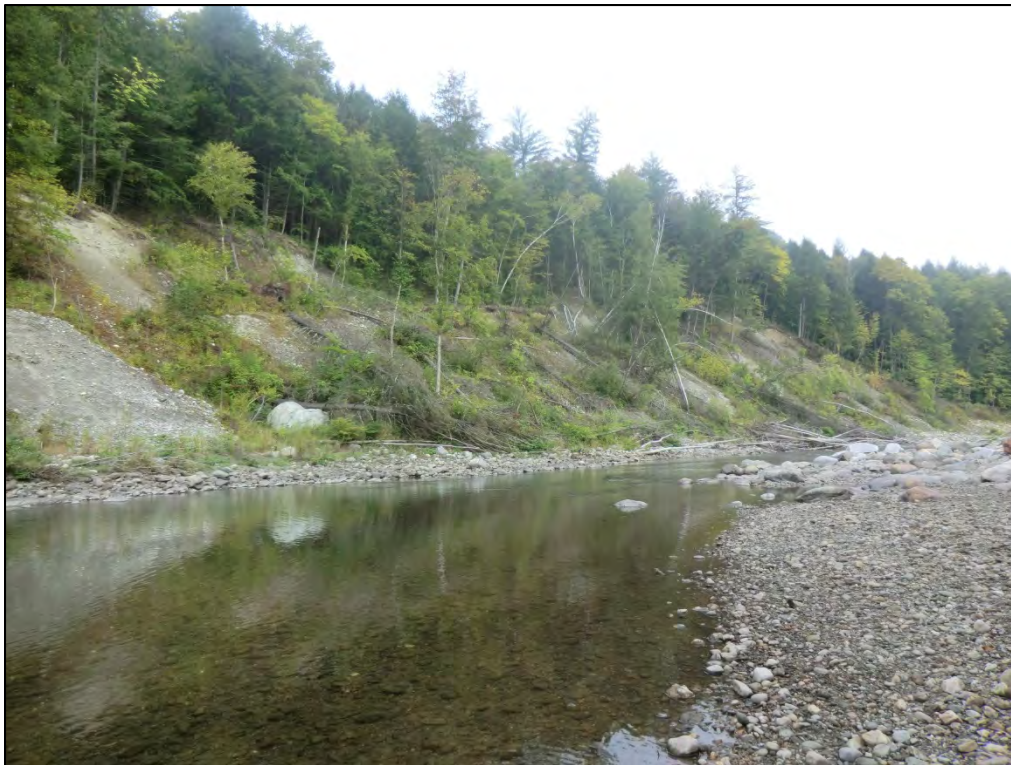
Figure 5.22. Widening has caused mass failures and bank erosion along the White River in R16-A.

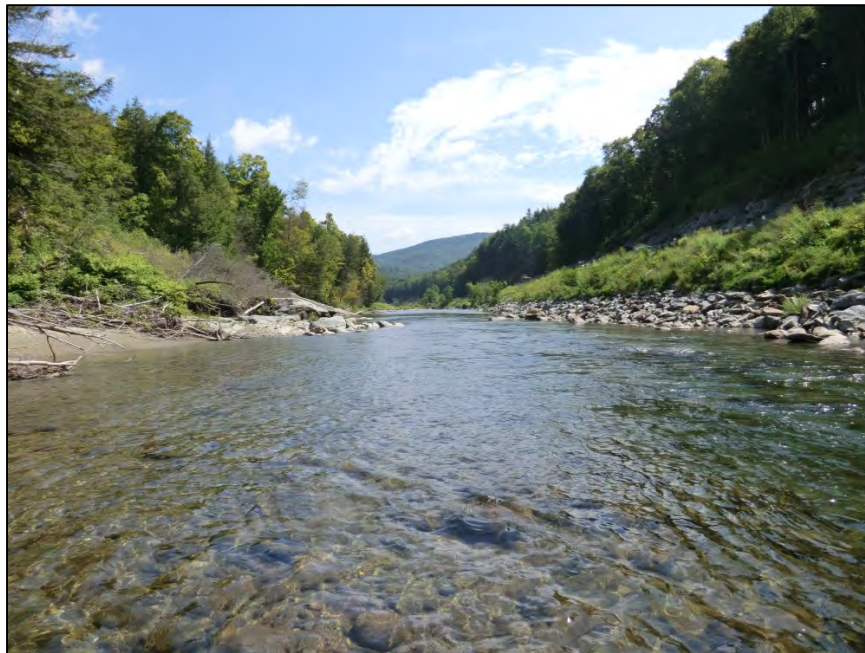
Figure 5.24. Route 107 is a significant encroachment in R16-C, creating a deep, narrow channel.

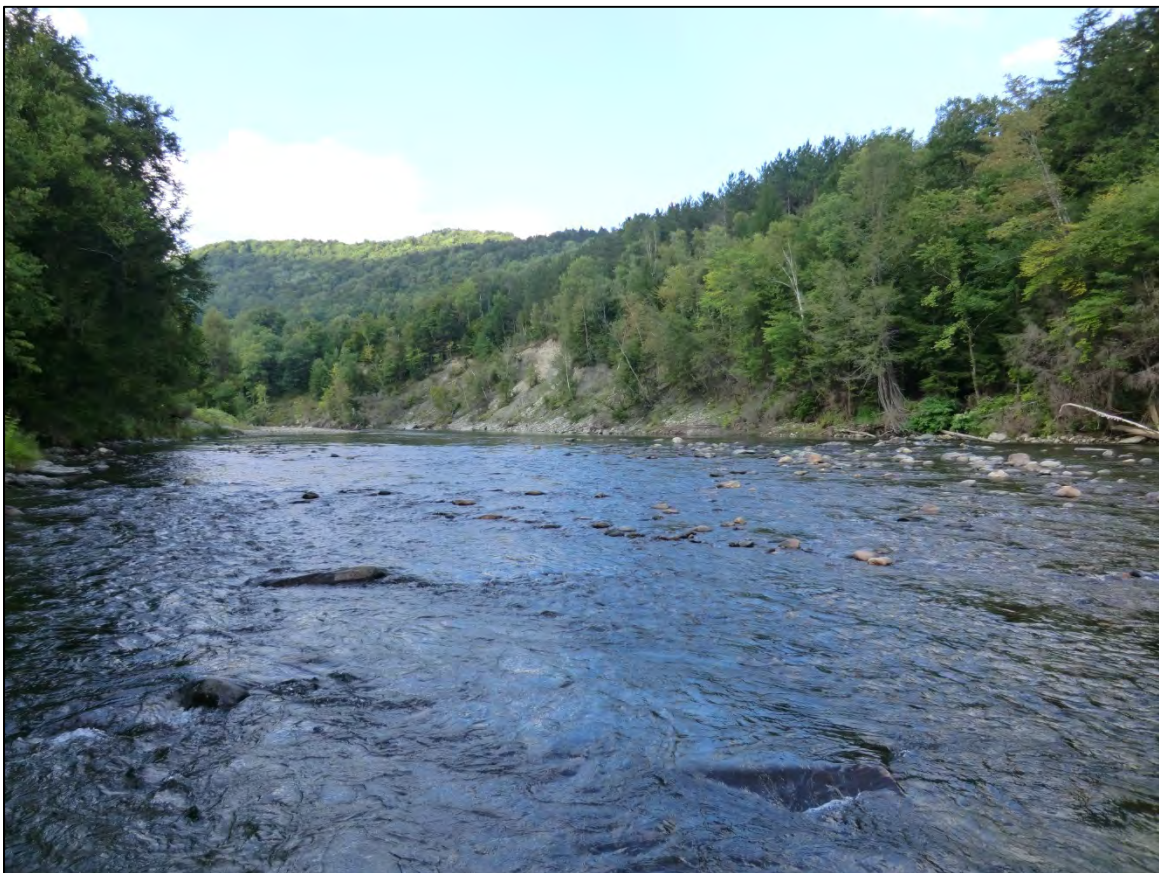
Figure 5.25. R17 has incised and widened significantly.

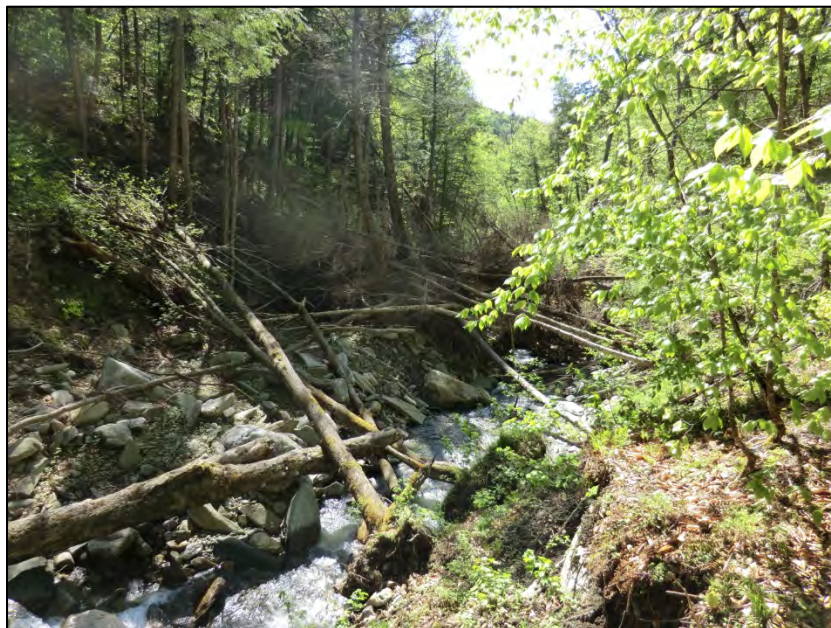
Figure 5.27. Continuous mass failures are contributing woody debris and sediment to R15-S1.01-B.

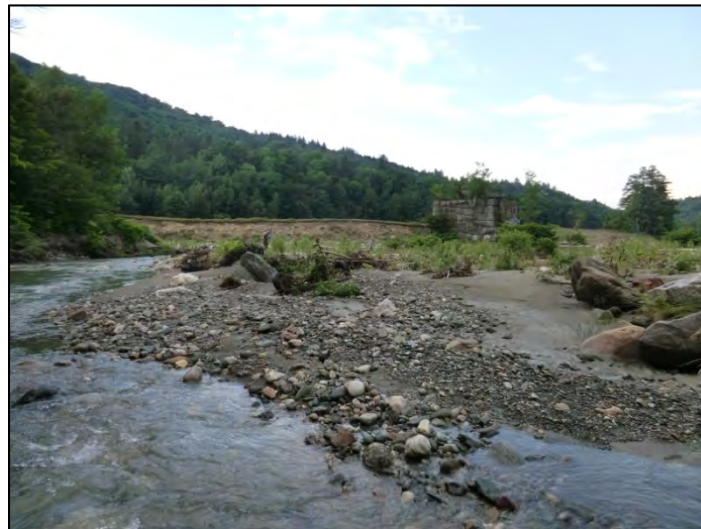
Figure 5.29. T5.01-A is highly depositional and has many old abutments throughout it.

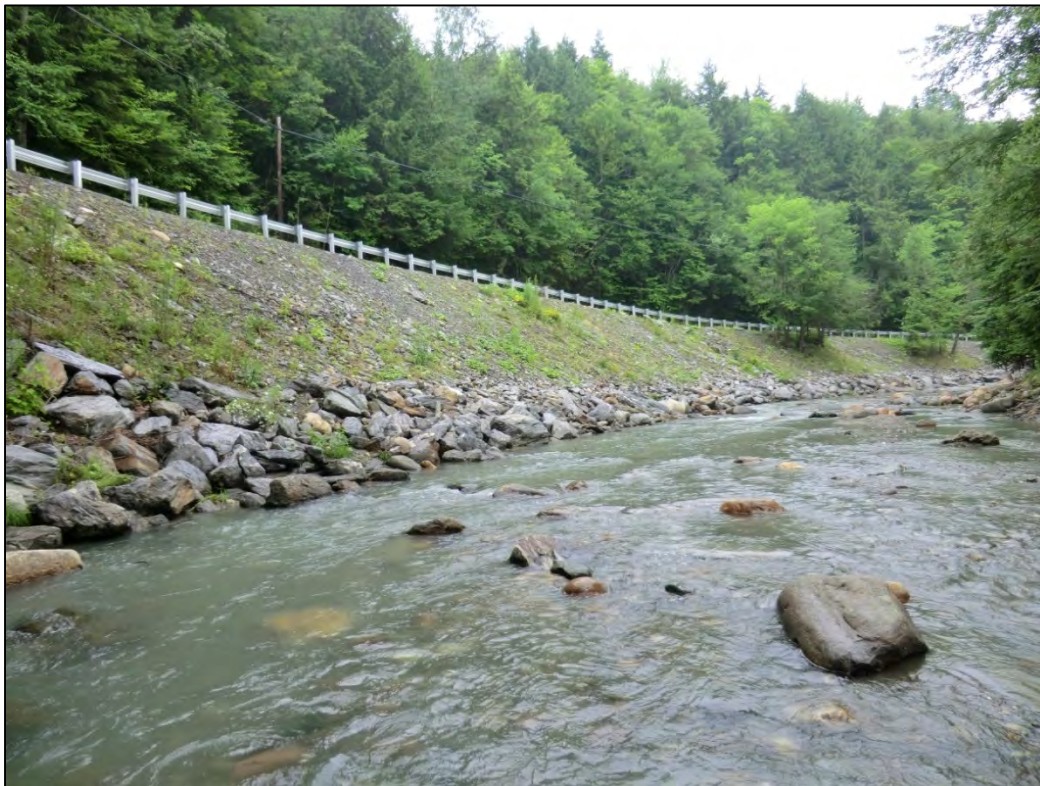
Figure 5.30. Much of T5.01-B was historically straightened along Stony Brook Road and is extremely incised.

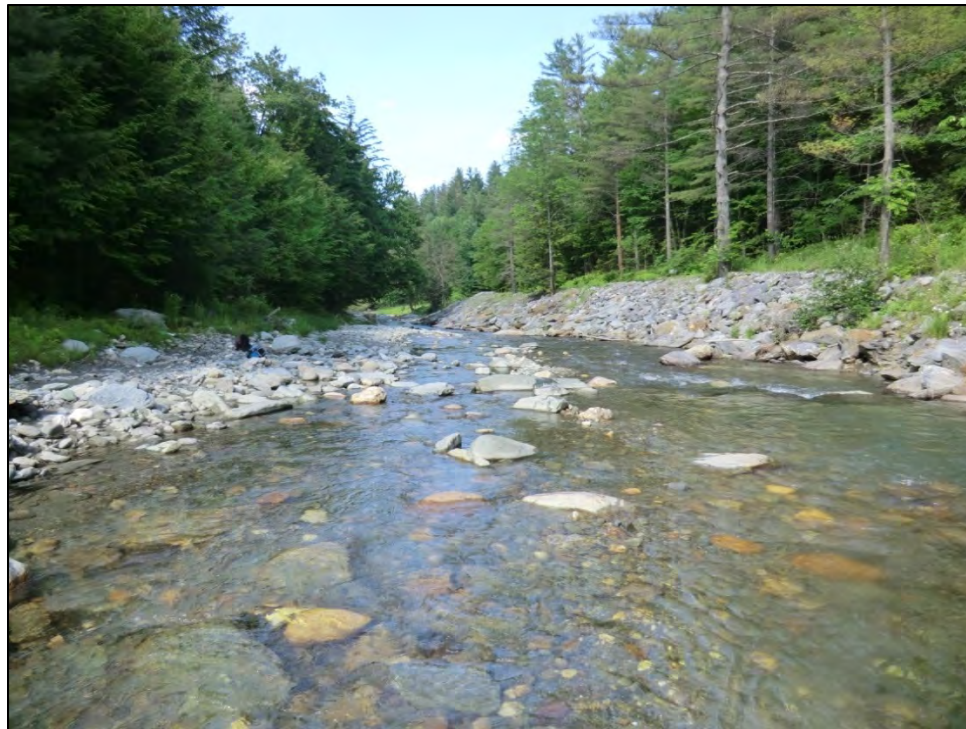
Figure 5.31. Bank armoring along Stony Brook Road is extensive in T5.02.

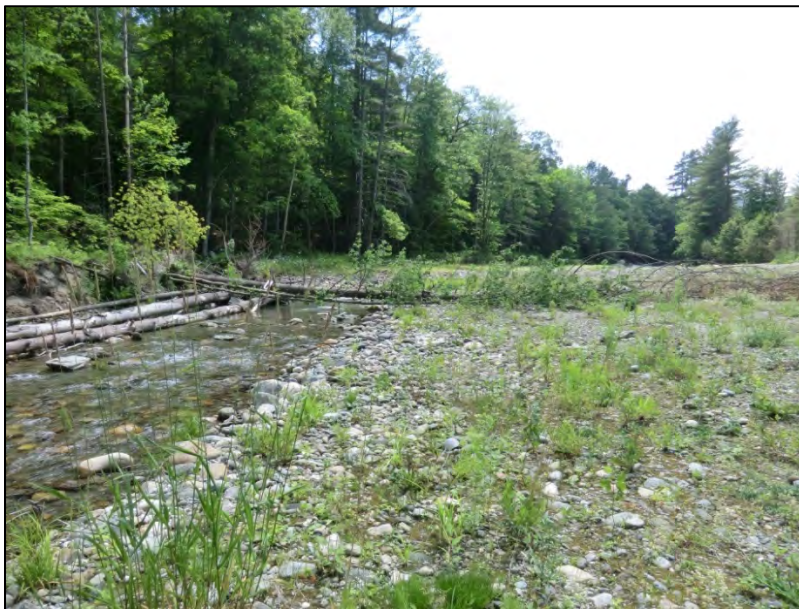
Figure 5.32. T5.03-A has undergone major deposition and widening.

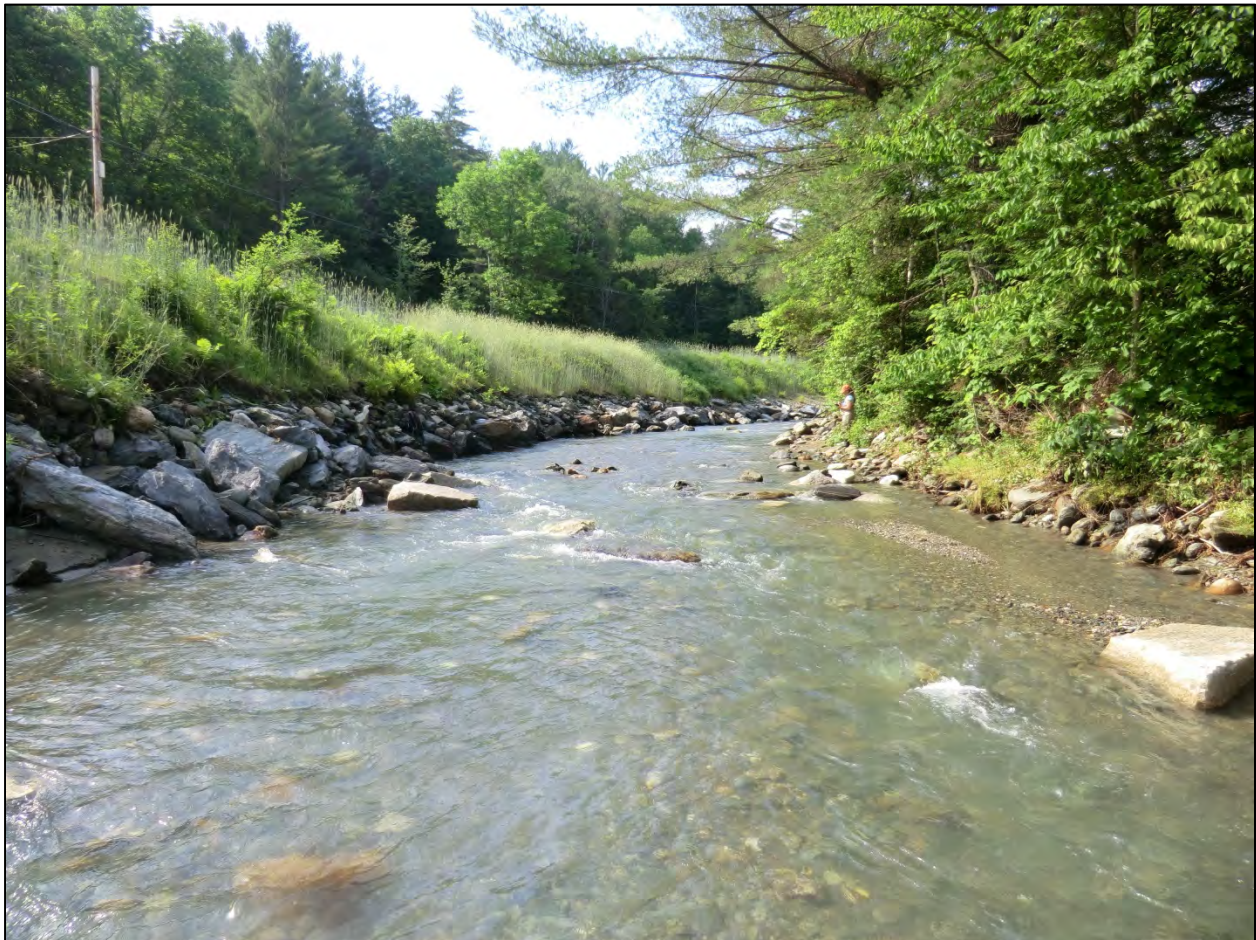
Figure 5.33. T5.03-B is extensively encroached upon by Stony Brook Road, creating a narrow channel.

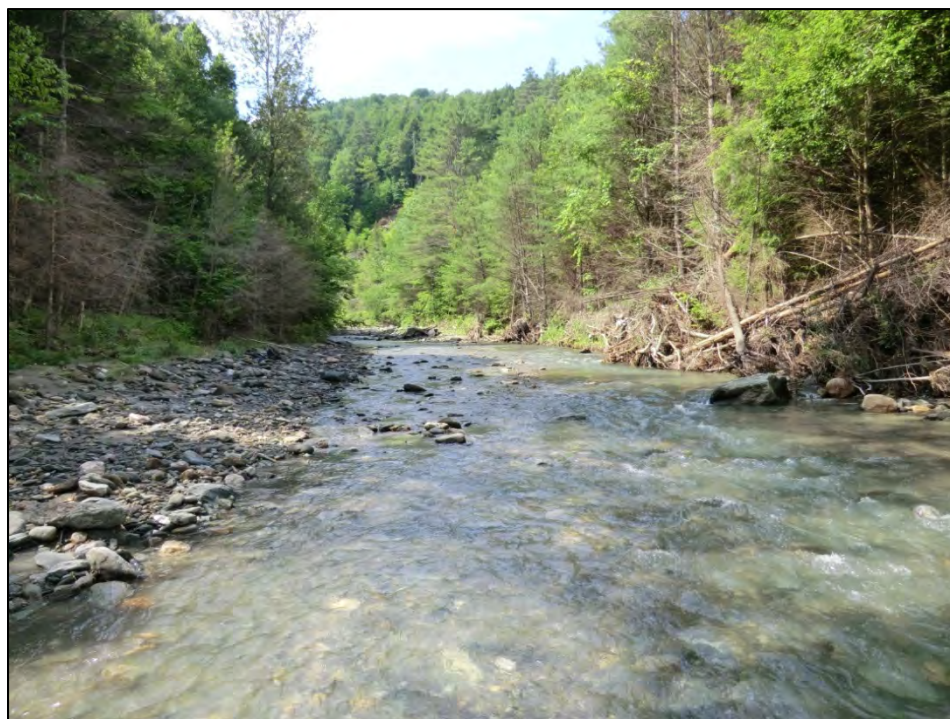
Figure 5.34. T5.04-A has widened and is actively aggrading.

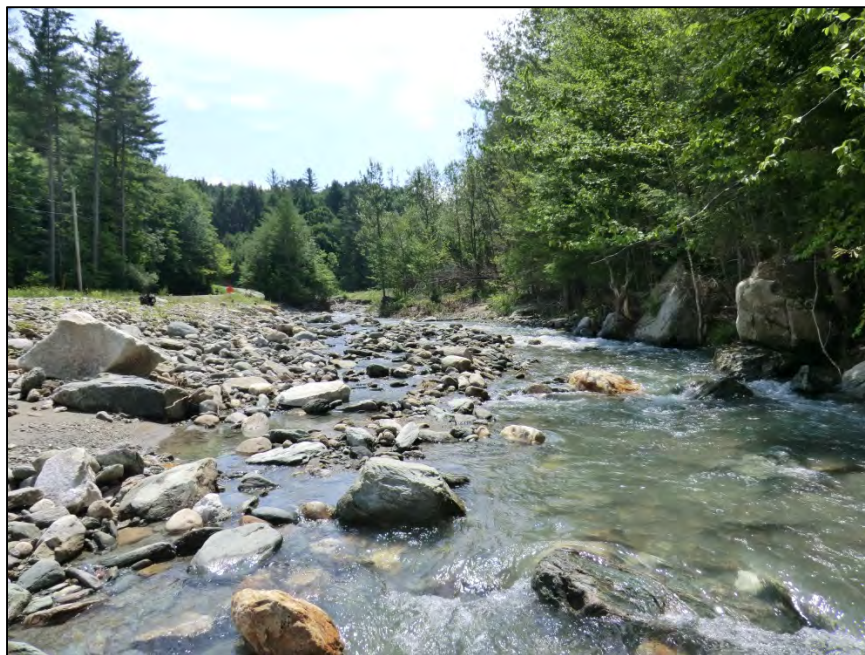
Figure 5.35. Stony Brook avulsed and destroyed a camp and Stony Brook Road in T5.04-B (left side of photo).

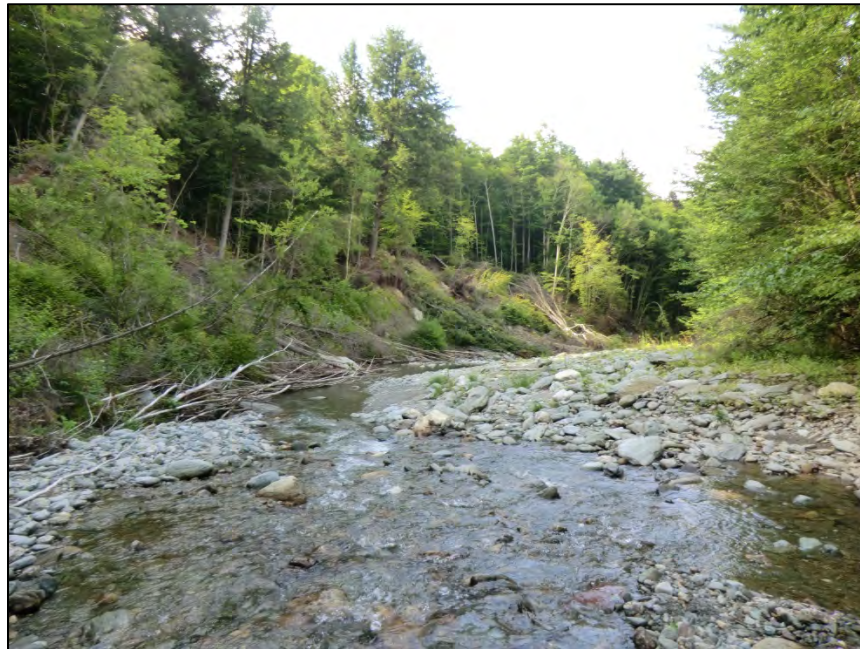
Figure 5.38. T5.06-A is majorly aggrading and building a juvenile floodplain.

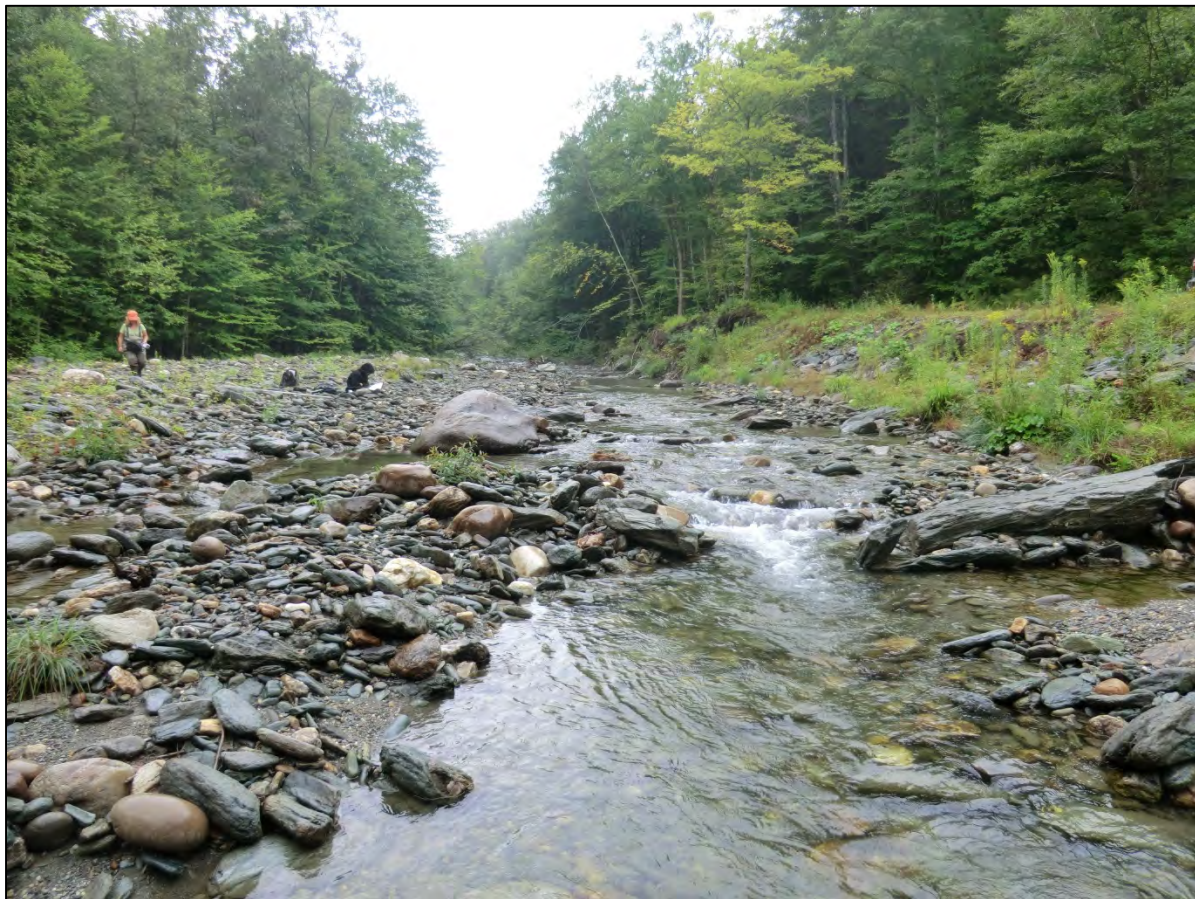
Figure 5.40. Aggradation and widening are two major processes that have occurred in T5.06-C.

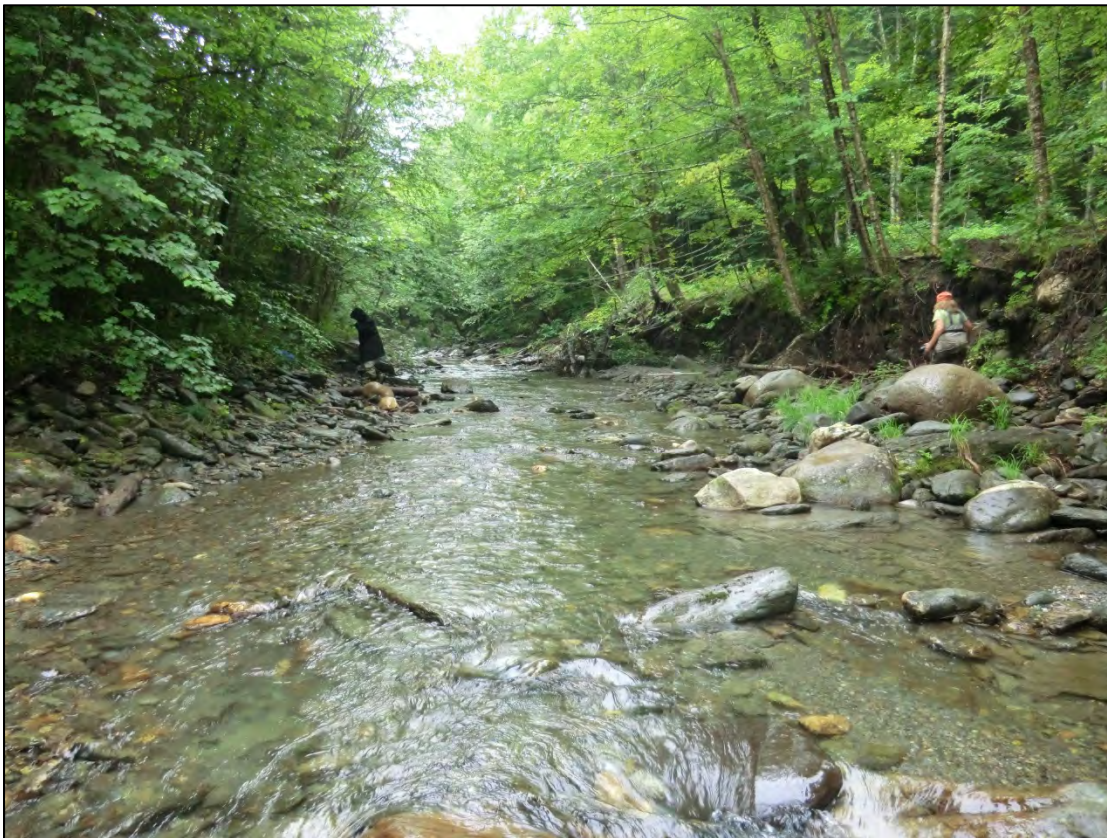
Figure 5.41. T5.06-D has incised historically and is beginning the widening process.

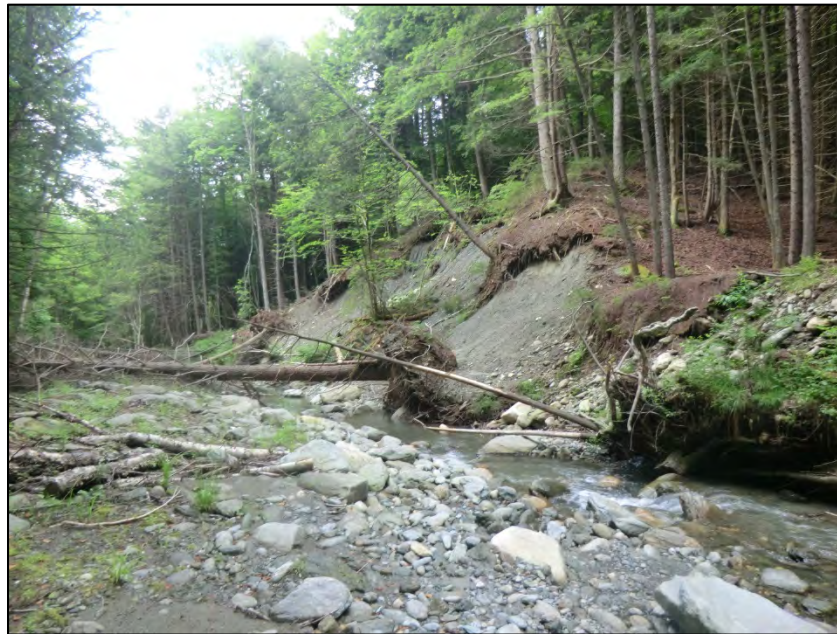
Figure 5.45. Mass failures and large depositional features are common in T5.3-S1.01-C.

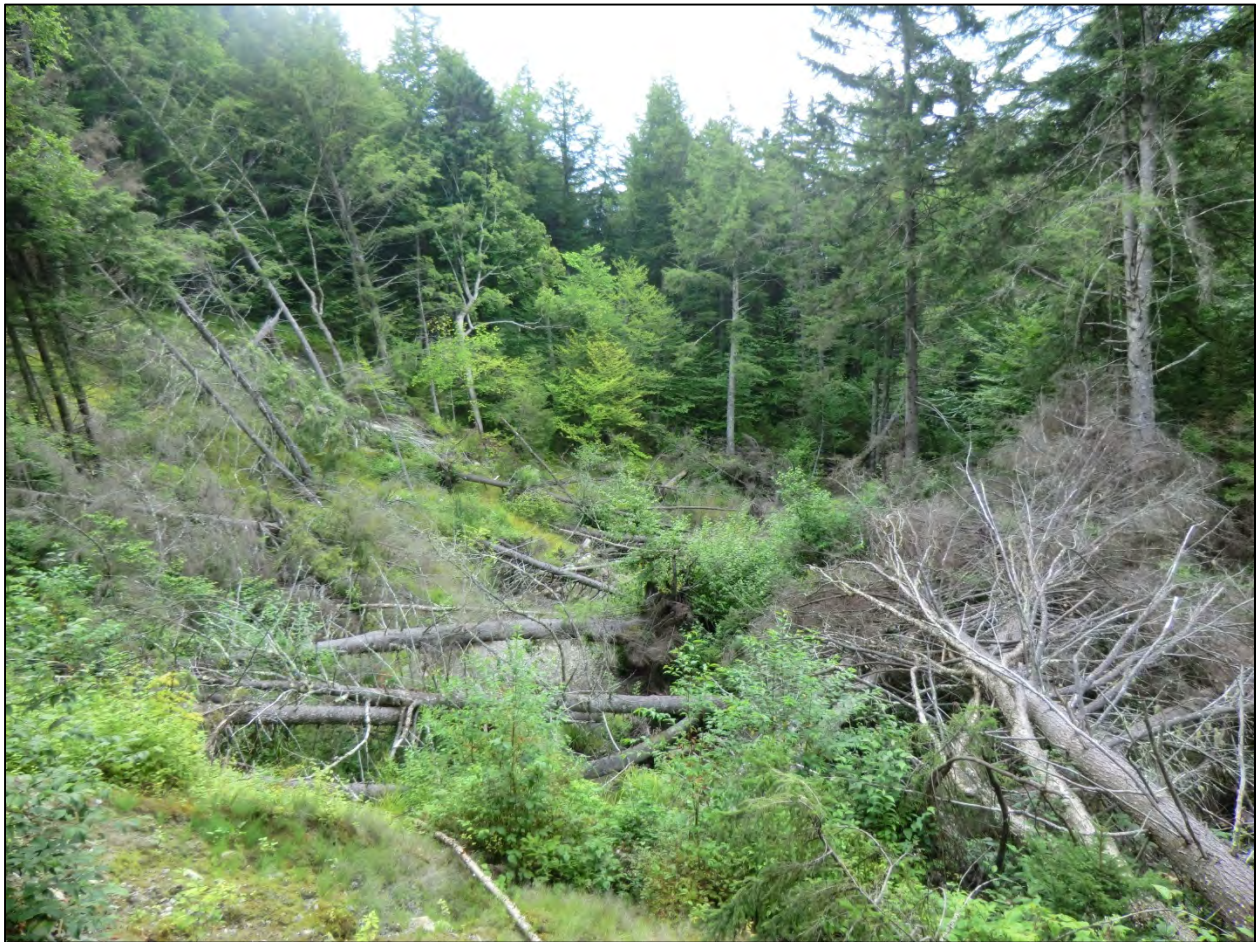
Figure 5.48. Woody debris in the channel in T6.1-S1.01-B made it inaccessible for assessment.

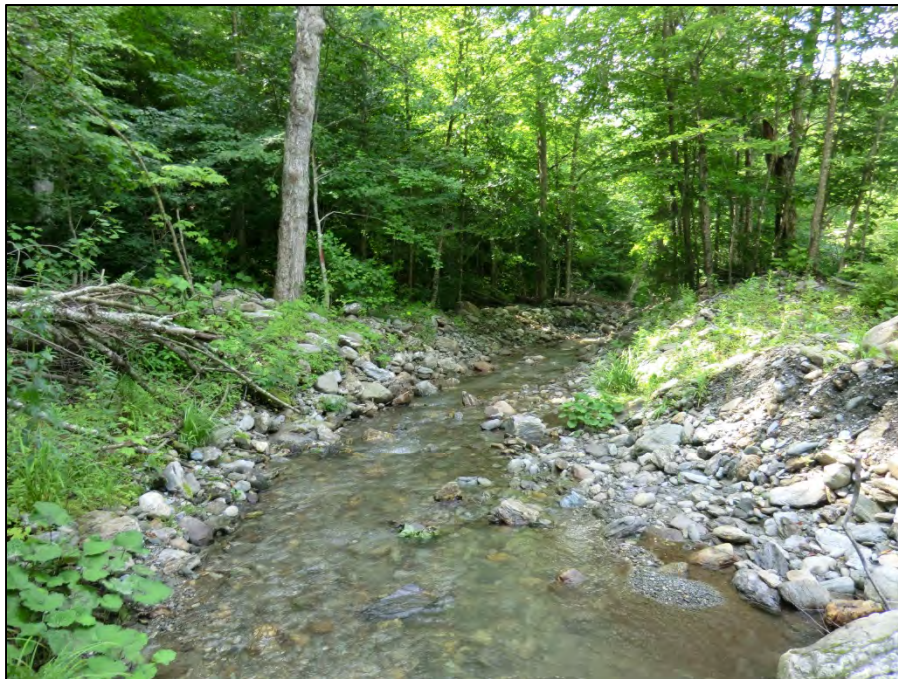
Figure 5.53. T6.4-S1.01-C was subjected to extensive windrowing and berming post-Irene.

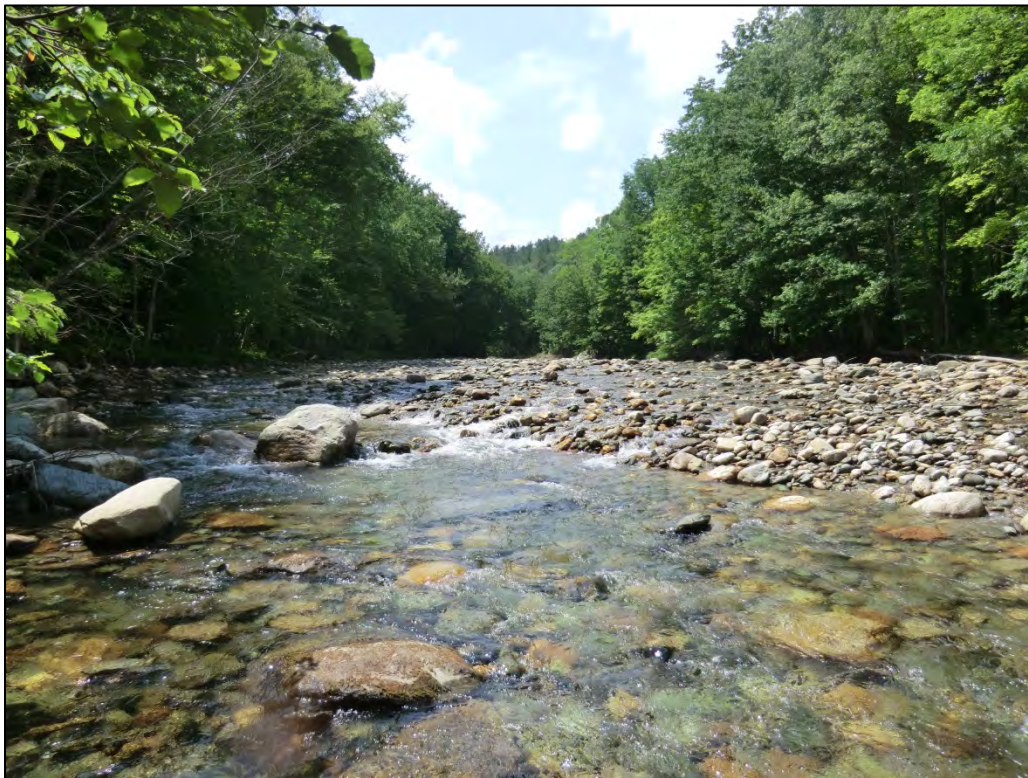
Figure 5.55. The West Branch has widened and is adjusting planform in T7.01-B.

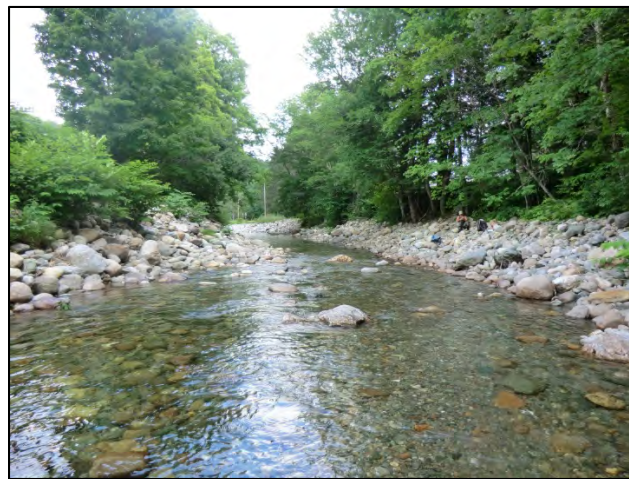
Figure 5.61. T8.01-A was extensively windrowed post-Irene.
