Upper & Middle White River Watershed Corridor Plan

Barnard, Hancock, Pittsfield, Rochester, and
Stockbridge, Vermont
July 15, 2015

Prepared by:
Bear Creek Environmental, LLC
149 State Street, Suite 3
Montpelier, Vermont 05602

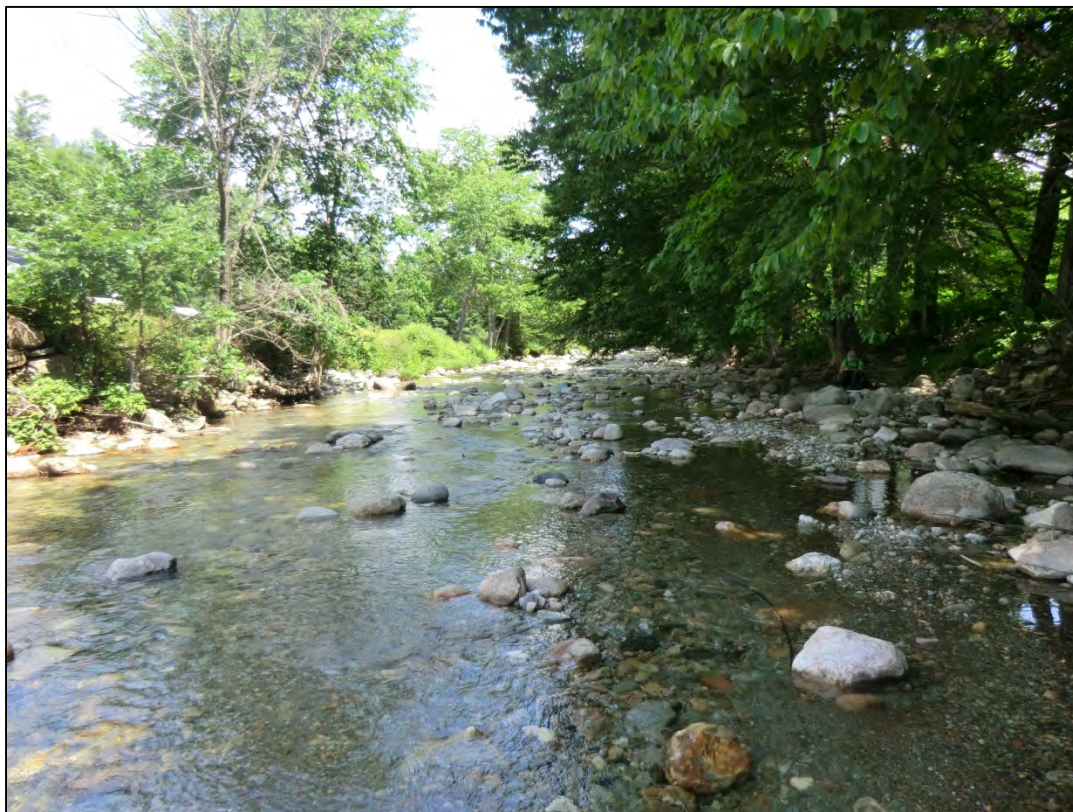
Figure 5.65. The river was straightened along Route 125 for all of T8.02-B.

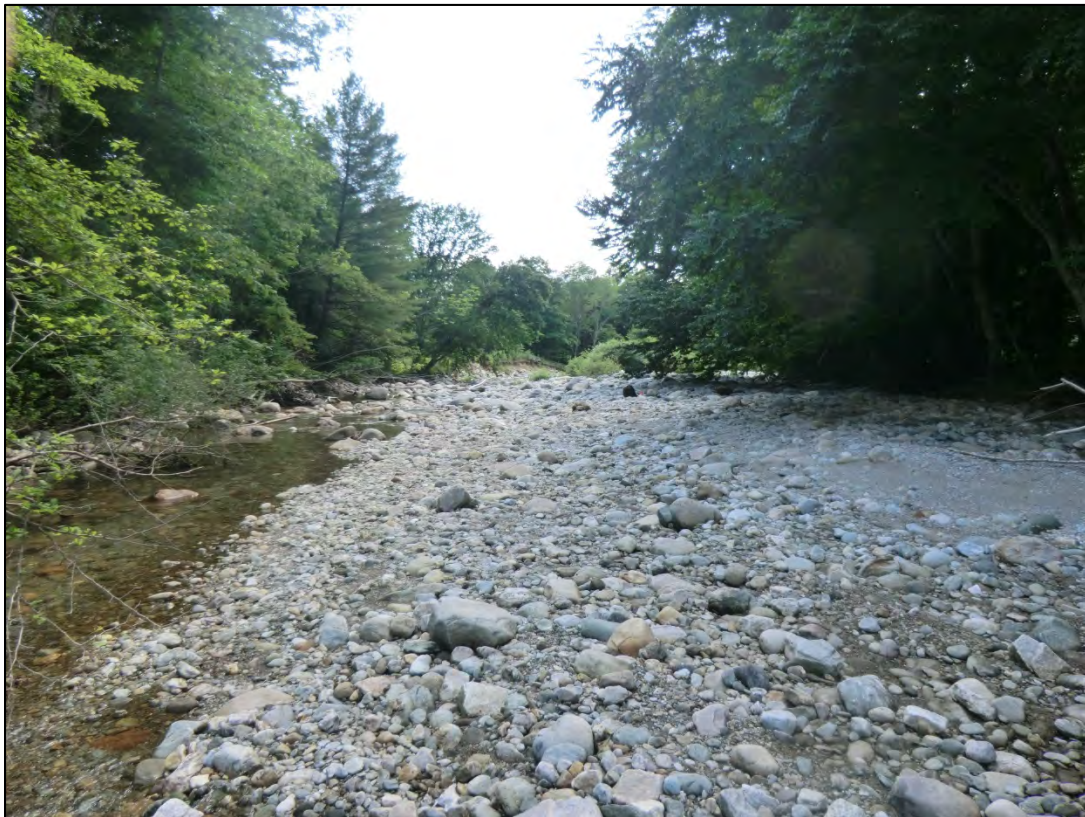
Figure 5.66. Major aggradation and a wide channel are characteristic of T8.02-C.

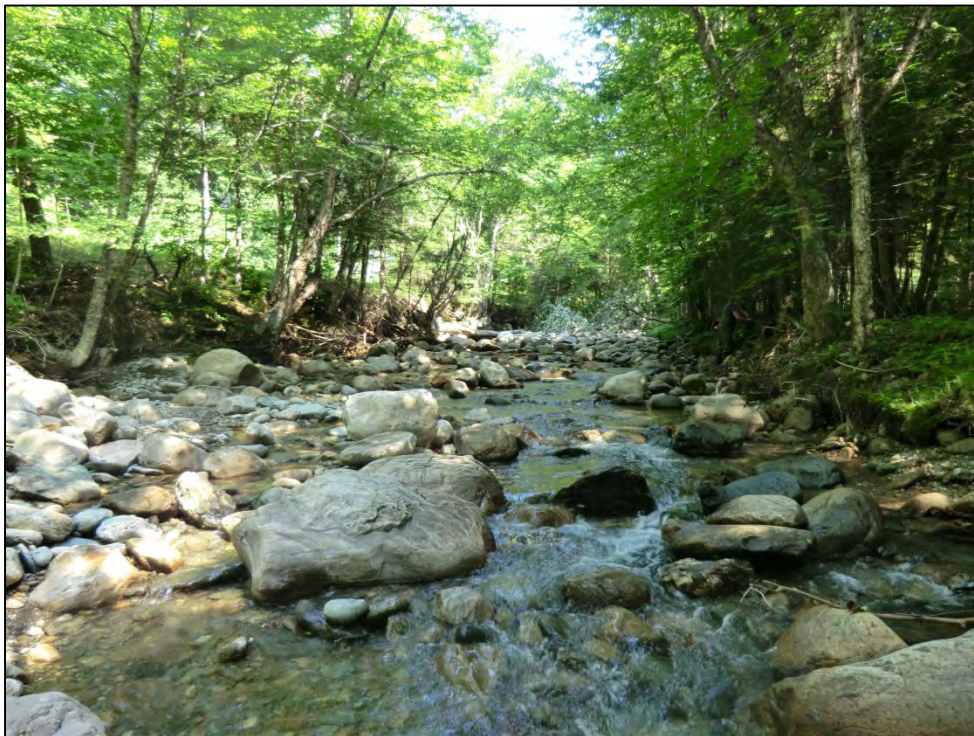
Figure 5.68. Much of T8.03-A was historically straightened along Texas Falls Road.
