2012 – 2013 Hurricane Flats Farm Riverbank Restoration Project

Project goal: Our goal is to restore 300-feet of eroding riverbank on the main stem of the White River at Hurricane Flats Farm in South Royalton while improving water quality, habitat, and flood resiliency.

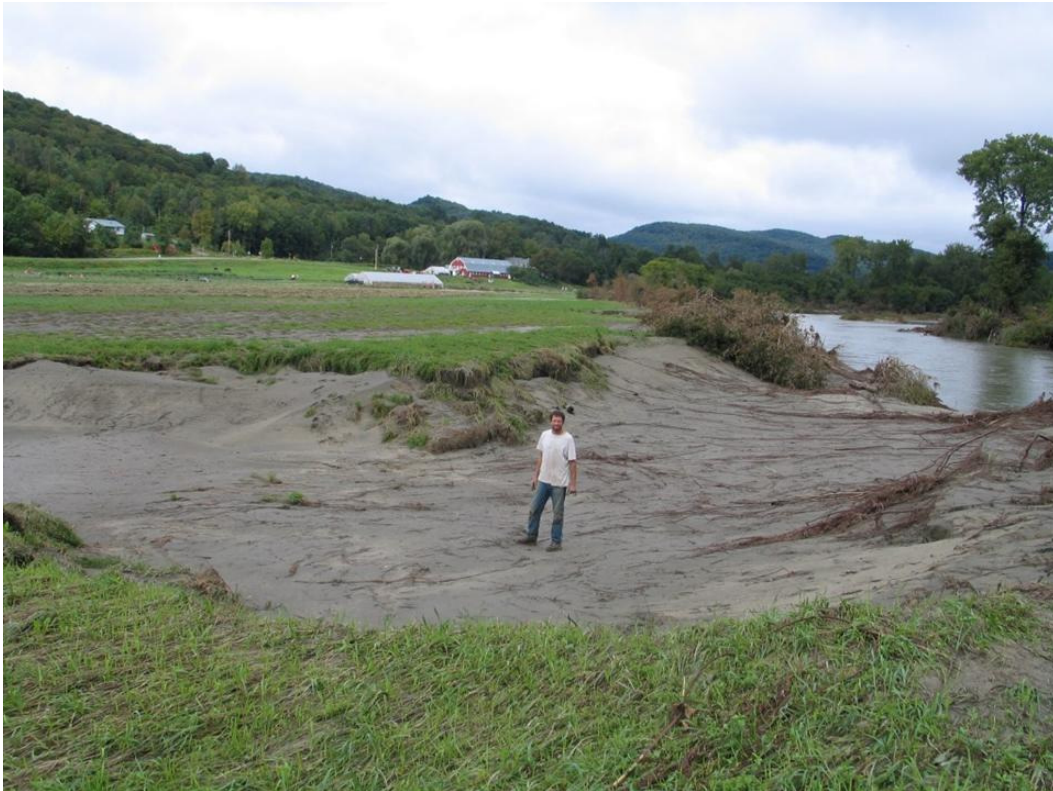
Hurricane Flats Farm co-owner Geo Honigford standing in the upstream 150-foot hole after Irene.

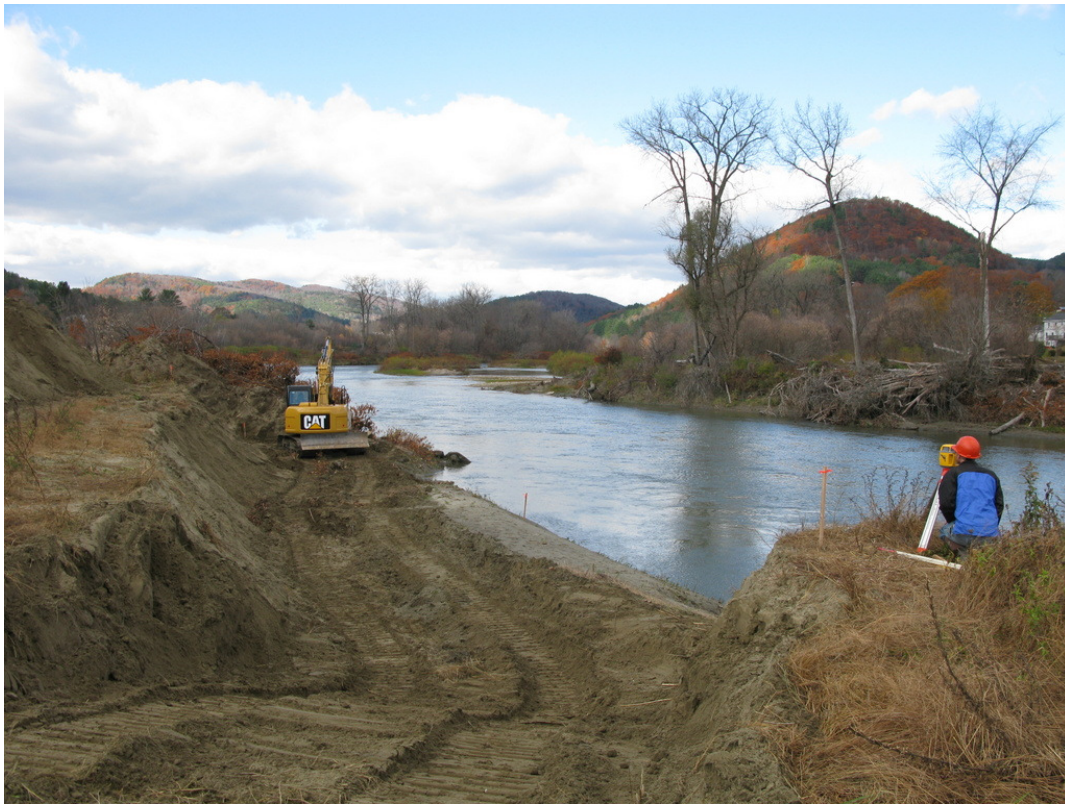
Excavating the upstream project site to the low-water elevation.

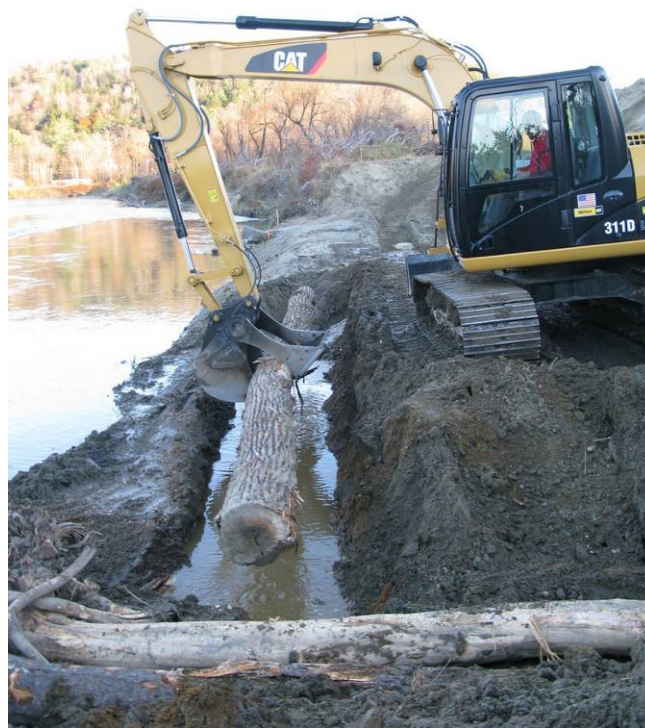
Placing a scour log parallel to and 5-feet back from the river's edge.

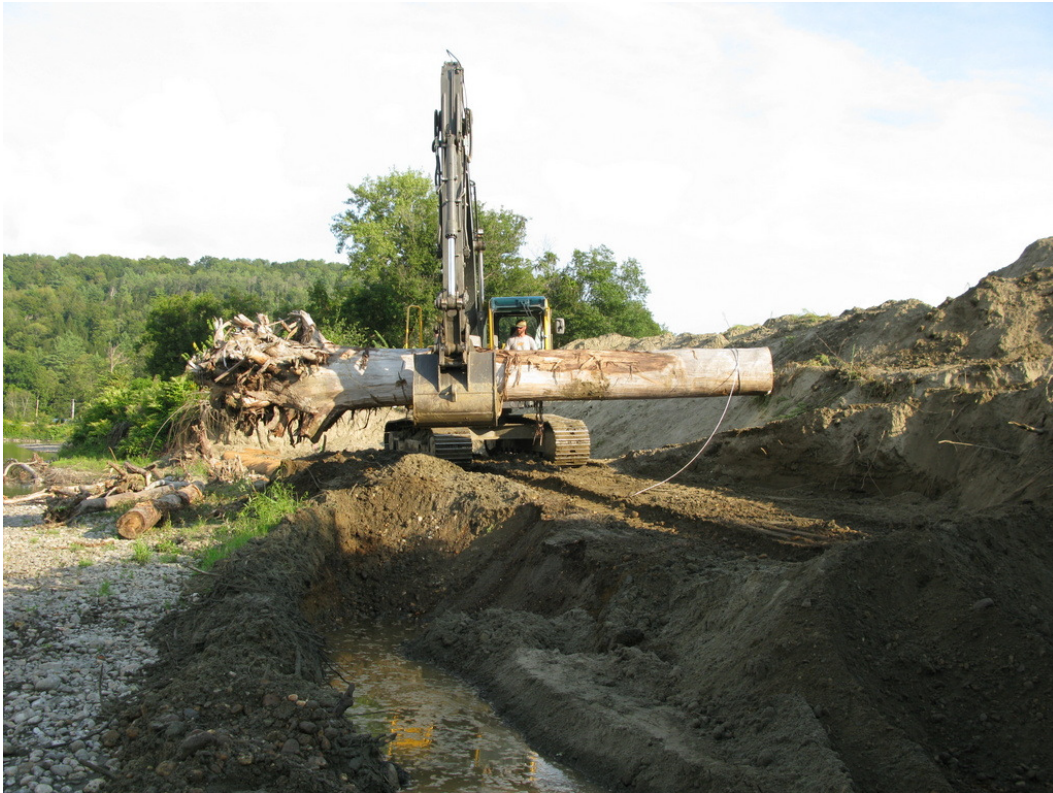
Putting a root wad in place (with deadman anchor cable attached to back end).

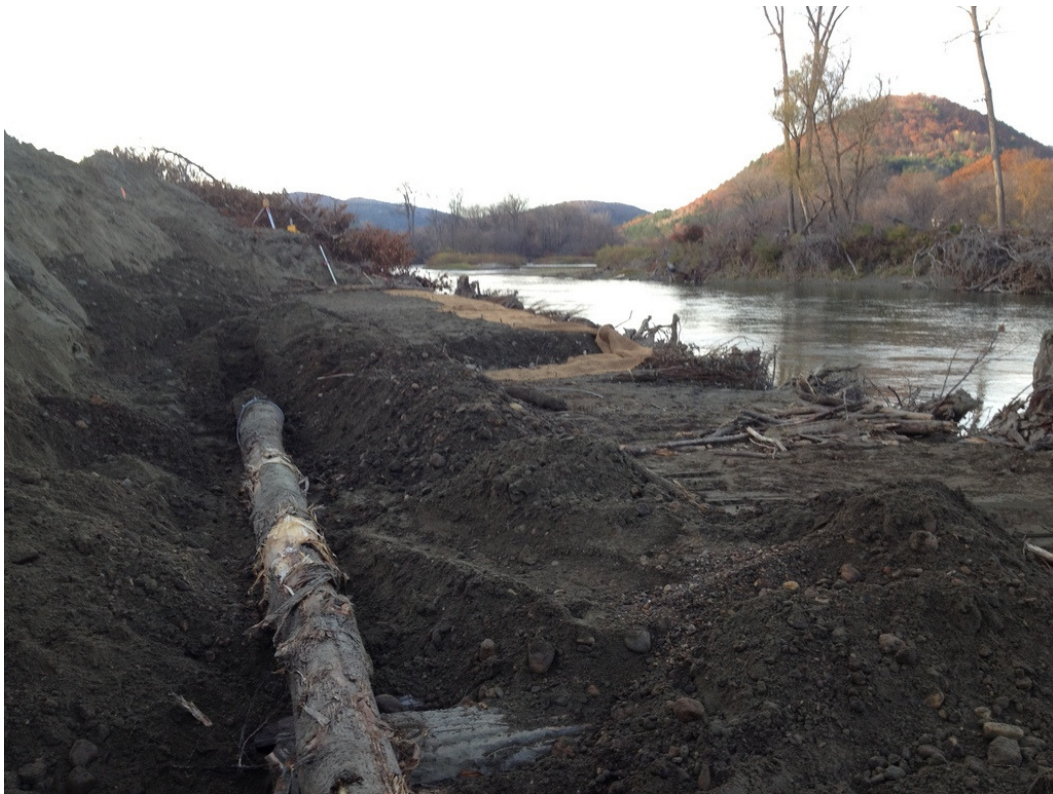
Deadman logs anchor the back of the root wads into the bank.

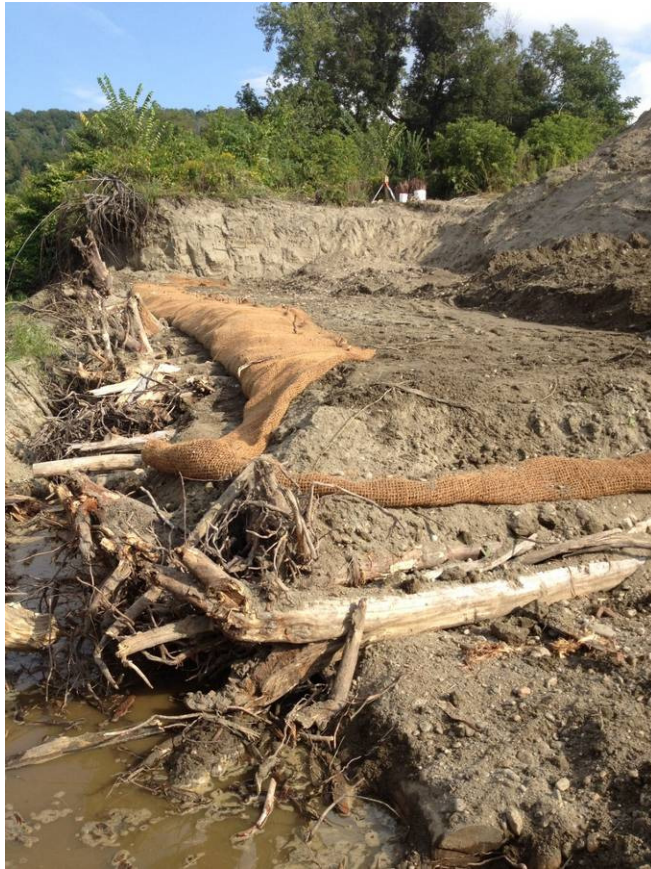
Cross-section view of project site: scour log and root wads covered with a soil lift.

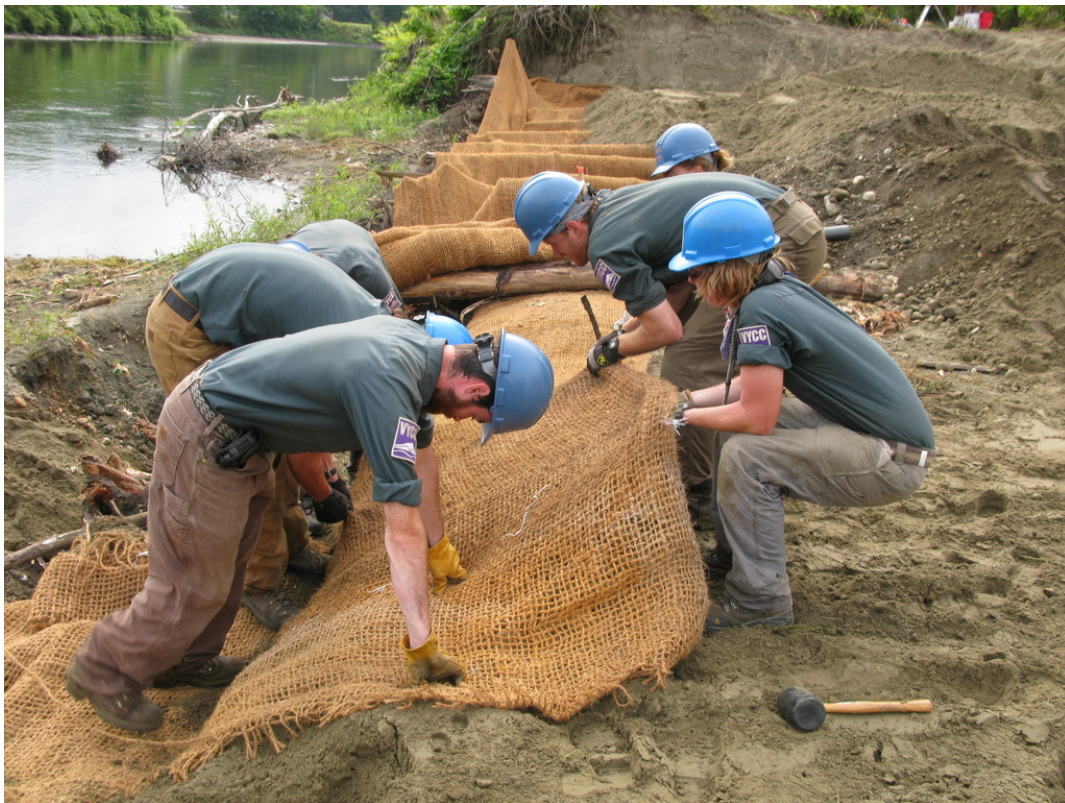
Wrapping coir fabric over compacted soil to create the second soil lift.

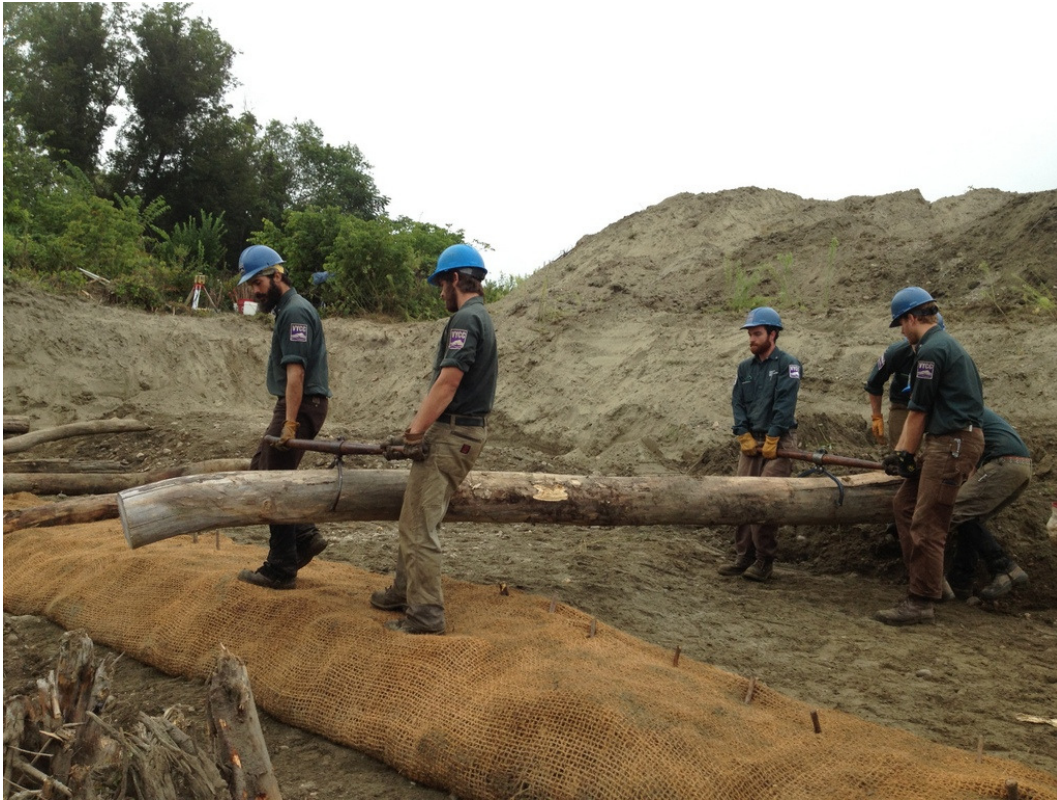
Placing an ice fender on top of a completed soil lift.

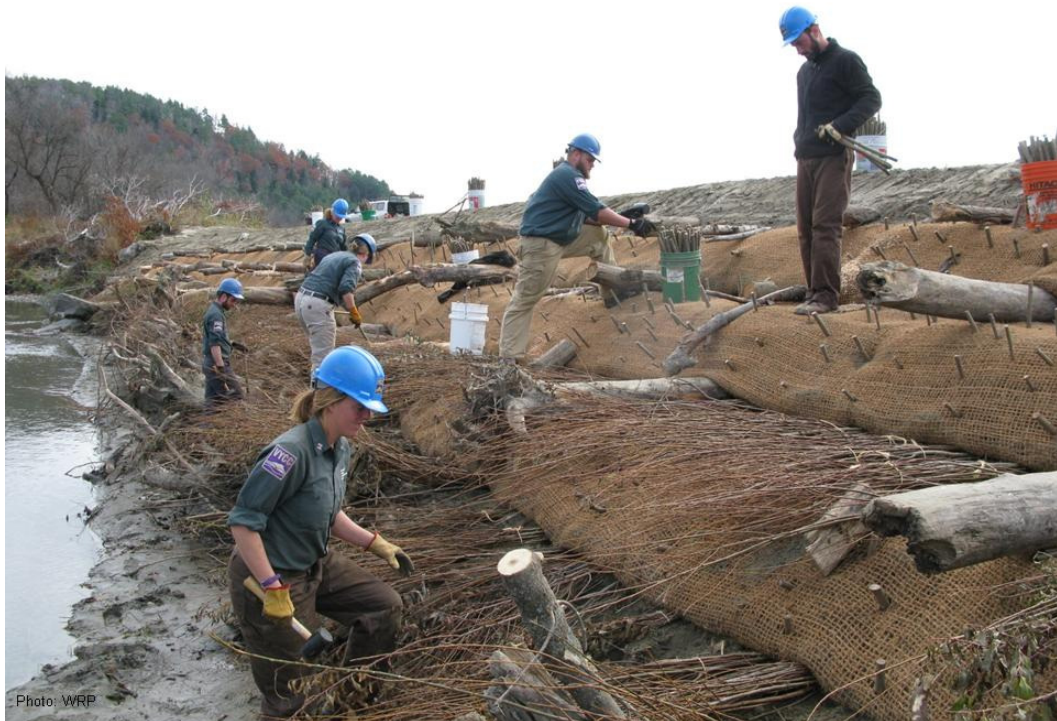
Pounding shub willow stakes to hold the coir fabric in place at the Stage 1 project site.

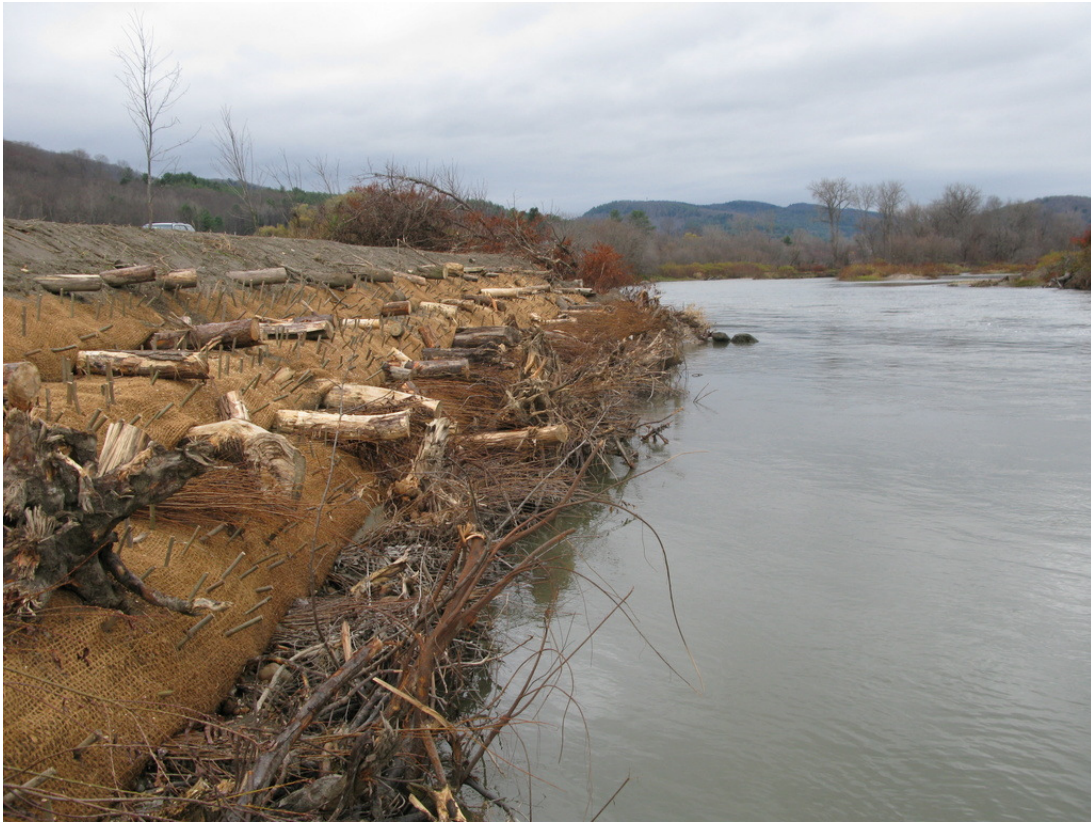
Stage 1 project site during high water flows after Tropical Storm Sandy in November 2012.

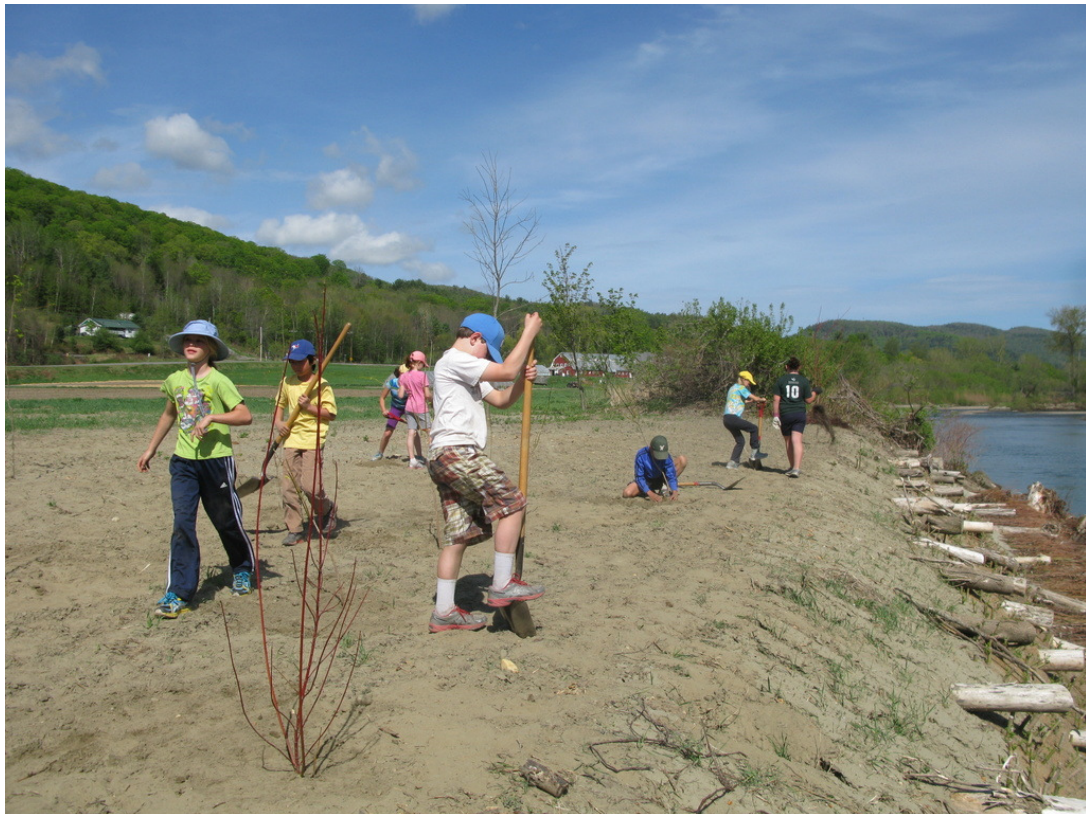
Planting native trees and shrubs to restore the riparian buffer zone at the Stage 1 project site.

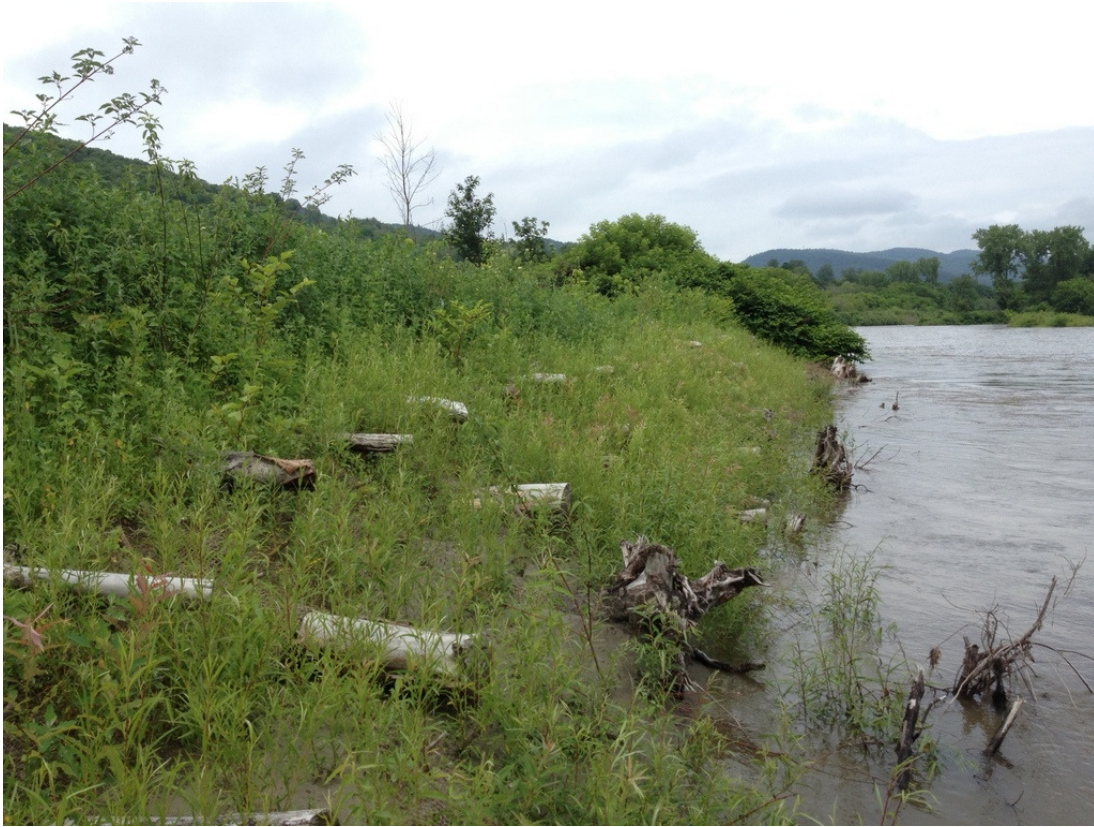
Stage 1 project site in July 2013 after leaf-out.

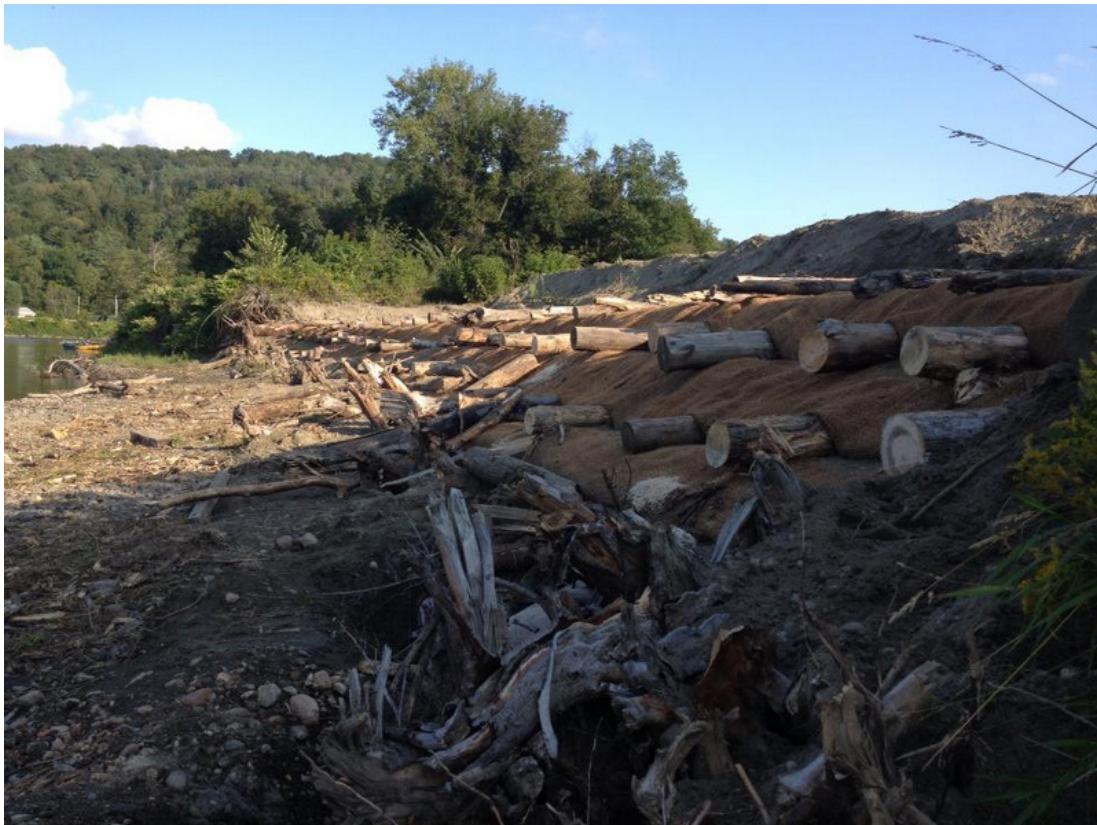
Stage 2 project site in August 2013.
