Upper & Middle White River Watershed Corridor Plan

Barnard, Hancock, Pittsfield, Rochester, and
Stockbridge, Vermont
July 15, 2015

Prepared by:
Bear Creek Environmental, LLC
149 State Street, Suite 3
Montpelier, Vermont 05602

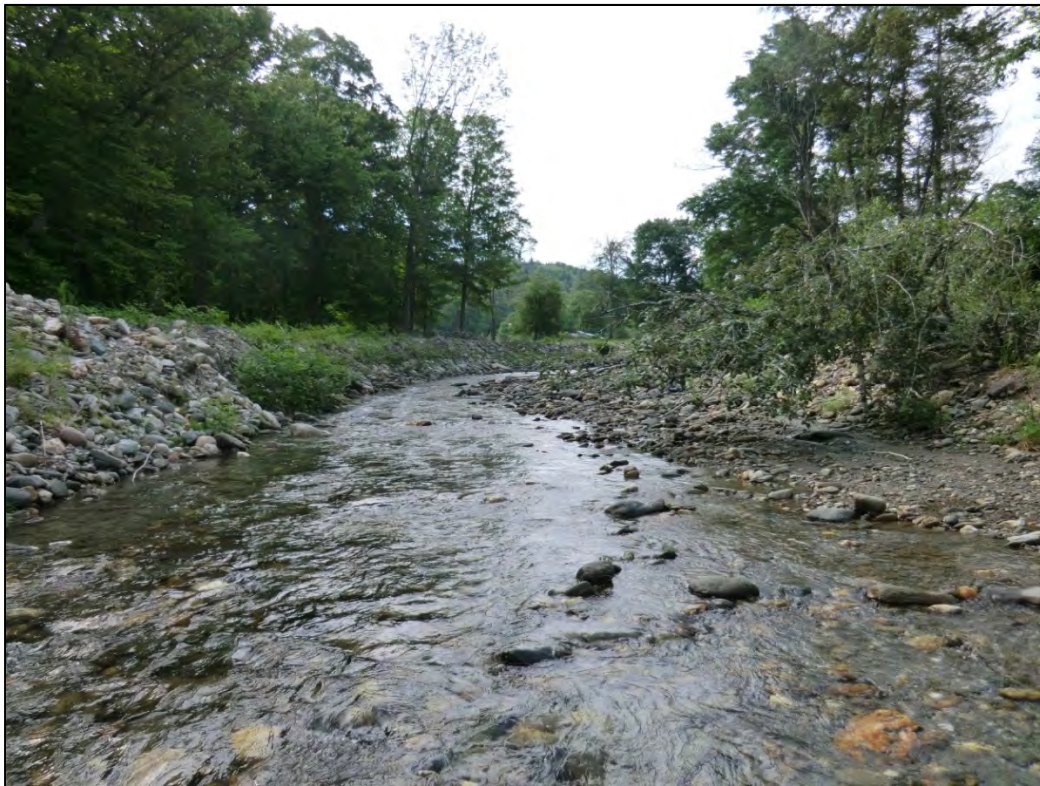
Segment T3.02-C begins just below the confluence of Pond Brook and continues upstream for 1,800 feet to just above the Rt. 12 Bridge between Mount Hunger Road and Chateauguay Road. This segment has a lower slope and wider valley than the segments just upstream of it, creating an *alluvial fan*. It is an area where significant deposition occurs due to a reduction in water velocity that allows sediment to drop out during high flows. Following Irene, this segment was extensively dredged, windrowed, and bermed, lowering the streambed and cutting off floodplain access. The Route 12 Bridge over Locust Creek was destroyed by floodwaters. The channel has widened significantly, which likely occurred due to aggradation during Irene. Planform in this segment has been drastically altered by channelization, and numerous flood chutes have been cut off by windrowing. These channel alterations have caused T3.02-C to be in **poor** geomorphic condition. The segment is in **fair** habitat condition due to a lack of diverse bed features from windrowing, as well as poorly vegetated riparian zones.

Figure 5.7. T3.02-C was extensively windrowed following Tropical Storm Irene.

T3.02-C Data Summary		Reference	Existing
Length: 1,792 ft Drainage Area: 22 sq. mi. Evolution Stage: F-III Sensitivity: Very High	Confinement	Very Broad	Very Broad
	Stream Type	C	B _C
	Entrenchment Ratio	> 2.2	2.0
	Incision Ratio	< 1.2	2.0
	Dominant Bed Material	Gravel	Gravel
	Dominant Bedform	Riffle-Pool	Riffle-Pool
Major Stressors:	Windrowing, Dredging, Bar Scalping, Channel Straightening, Poor Buffers

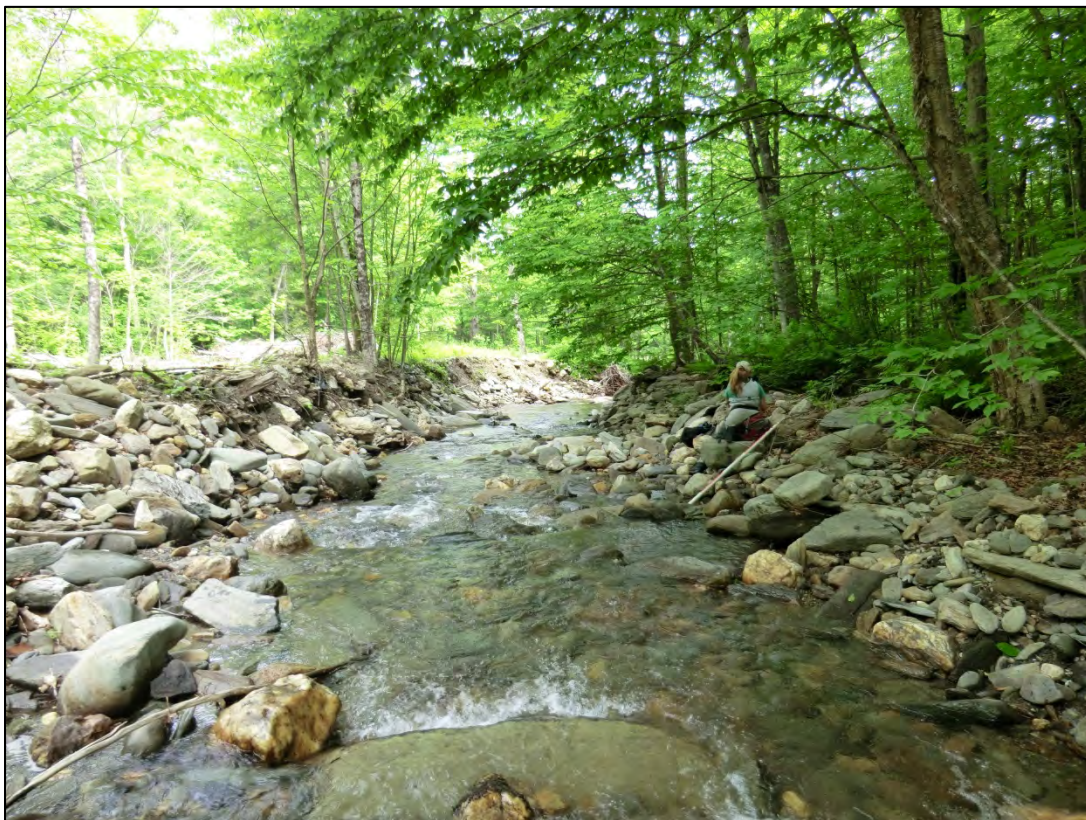
T3.05-C is a short segment between two Chateaugay Road bridges in the vicinity of Town Highway 48. This segment was a location of major aggradation during Tropical Storm Irene and was windrowed extensively after the flood. The Creek avulsed during Irene in this location, carving a new channel on the inside of a large meander bend. Post-Irene, the Creek was moved back to its old location and heavily bermed to block off the new channel. Extensive windrowing and berming has led to a narrowing of the stream channel and a stream type departure in this segment. Berms on both sides of the Creek create an incised channel with reduced floodplain access. The reference riffle-pool bedform has been altered due to channel work and now has reduced diversity of bed features, causing habitat conditions in this segment to be **fair**. The extensive channel alteration that occurred in this segment post-Irene has caused it to be in **poor** geomorphic condition.

Figure 5.15. Extensive post-flood channel alteration in T3.05-C removed aggradation from the creek and returned the channel to its pre-flood location (new channel in left of picture behind windrowing).

T3.05-C Data Summary		Reference	Existing
Length:	772 ft	Broad	Broad
Drainage Area:	6 sq. mi.	C _b	E
Evolution Stage:	F-II	> 2.2	10.2
Sensitivity:	Extreme	< 1.2	1.8
		Dominant Bed Material	Cobble
		Dominant Bedform	Riffle-Pool
Major Stressors:	Windrowing, Bank Erosion

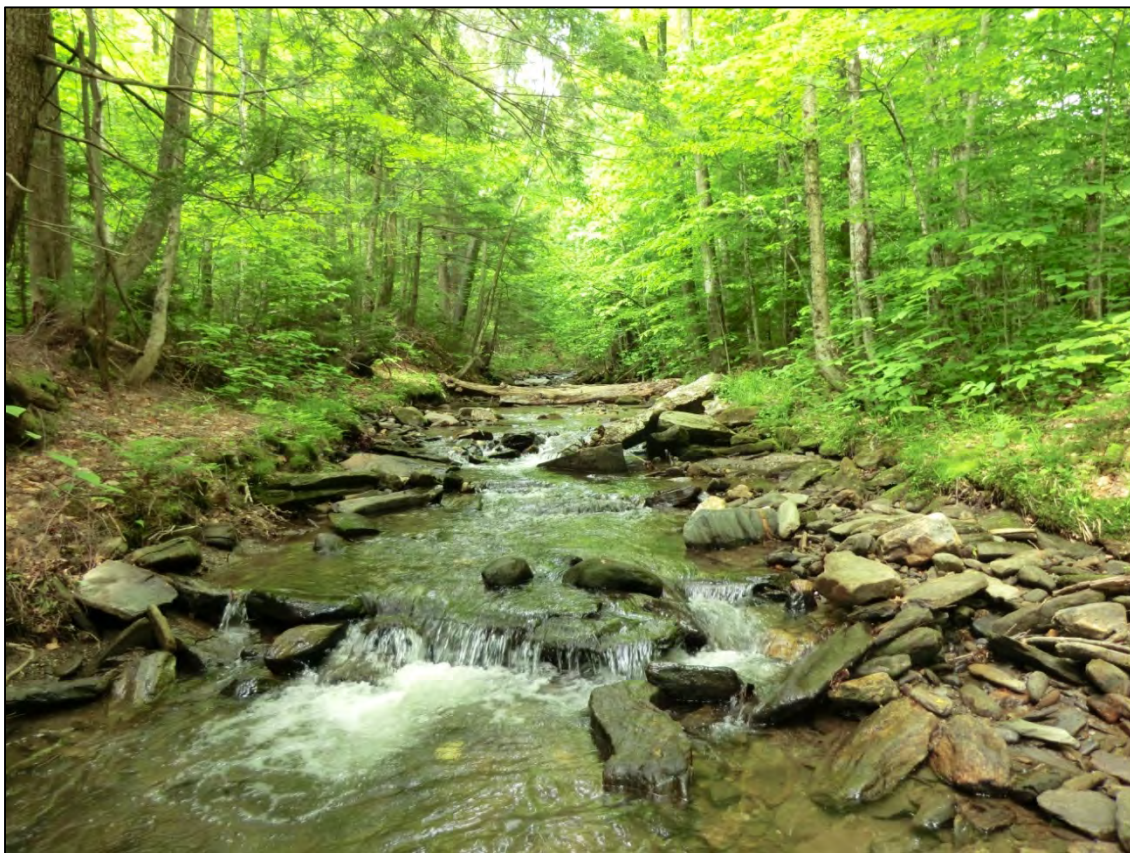
This segment is the upstream-most section of Locust Creek included in this assessment. It is 4,000 feet in length, beginning just below the upstream-most bridge over Locust Creek on Chateauguay Road. The creek flows through a densely forested area for this whole segment, with no development nearby except for Chateauguay Road. T3.05-E has excellent floodplain access and has not incised or widened. Some areas have more planform adjustment than others via flood chutes formed around downed trees. Several bedrock grade controls throughout this segment are holding the bed in place and deterring channel incision. Small areas of bank erosion are present, but overall the banks are stable and mossy. T3.05-E is in **good** geomorphic condition due to its stability and good floodplain access. It is also in **good** habitat condition due to well forested banks and buffers, abundant woody debris in the channel, and a diversity of pool and riffle habitat.

Figure 5.17. T3.05-E has excellent floodplain access and is very stable.

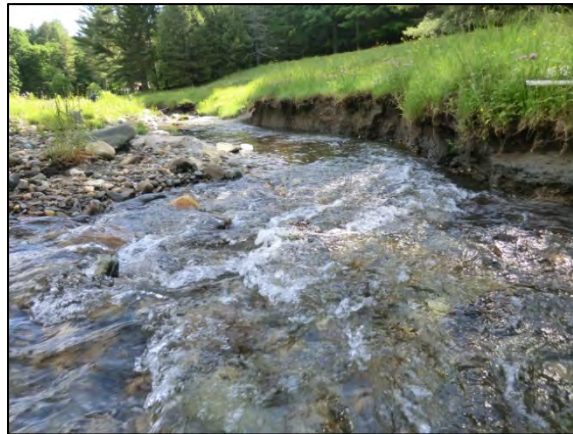
The downstream-most segment on Pond Brook begins at the confluence with Locust Creek and continues upstream for approximately 4,000 feet to where surrounding land use and reference stream type change near 7939 Route 12. Pond Brook is a narrow wetland channel by reference in segment T3.2-S3.01-A, but the majority of adjacent wetlands in this section have been converted over time to agricultural and residential land. Channel incision in this segment is moderate. The majority of the segment was historically straightened, likely to produce crop land, and the brook is now pushed up against its east valley wall in many places. A few short sections within this segment were windrowed or dredged post-Irene. There is little woody vegetation along the banks to provide root structure; subsequently the lack of riparian buffers is contributing to bank erosion. Bank armoring is scattered throughout T3.2-S3.01-A, but most of it is failing and not preventing further erosion. Three mass failures are present along the east valley wall. A constructed log dam exists within the segment and is creating a barrier for aquatic organism passage. This segment is in **fair** geomorphic condition due to historic channel management that has led to incision. It is also in **fair** habitat condition as a result of altered adjacent wetlands, unstable banks, and poor riparian buffers.

Figure 5.18. Riparian buffers are lacking in T3.2-S3.01-A and bank erosion is abundant.

T3.2-S3.01-A Data Summary		Reference	Existing
Length:	4,146 ft	Confinement	Very Broad
Drainage Area:	7 sq. mi.	Stream Type	E
Evolution Stage:	F-II	Entrenchment Ratio	> 2.2
Sensitivity:	Extreme	Incision Ratio	< 1.2
		Dominant Bed Material	Gravel
		Dominant Bedform	Riffle-Pool
Major Stressors:		Bank Erosion, Poor Bank Vegetation, Poor Buffers, Straightening

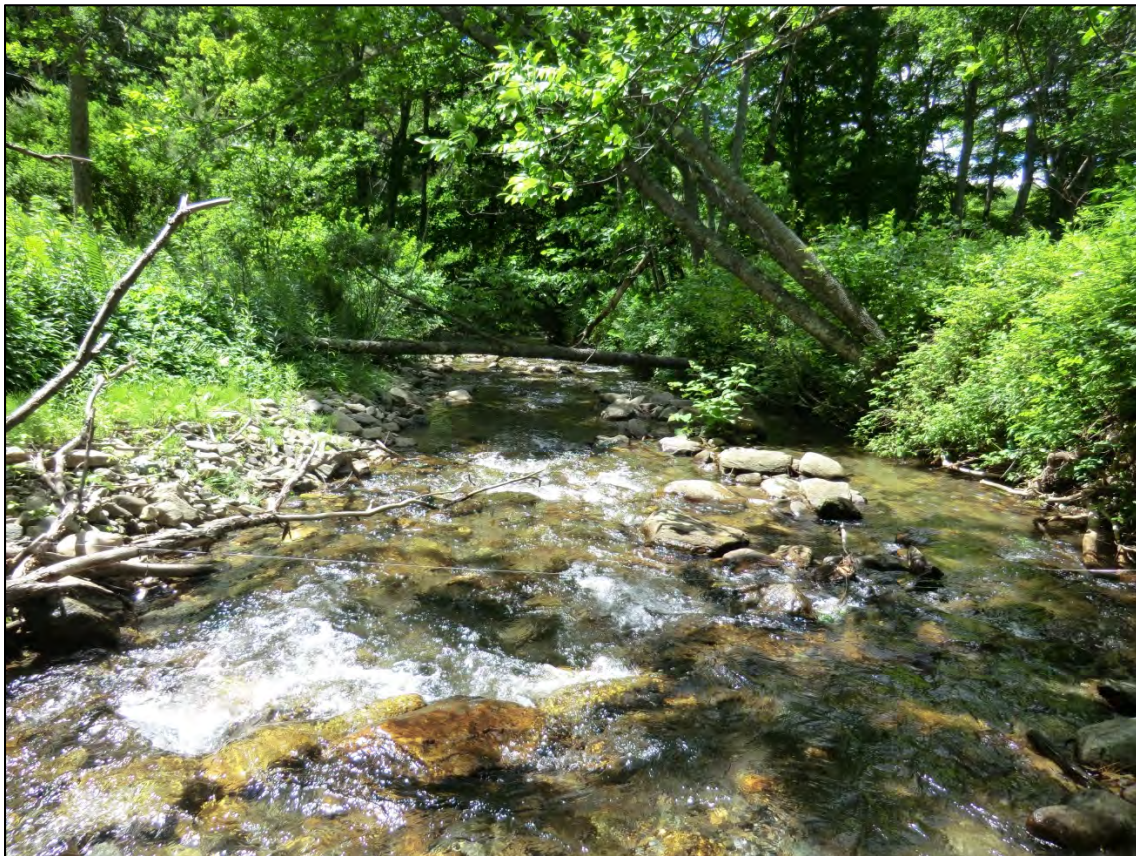
Segment B on reach one of Pond Brook flows through primarily forested land along Route 12 for 5,700 feet, ending at the Route 12 culvert near 7129 Route 12. The brook flows through a very broad valley in this segment, though the valley narrows in three locations where the channel is also slightly steeper. The brook has mostly natural planform in this segment, except for a few areas where it was historically straightened along Route 12. Segment B has incised only very slightly, and has not widened. Four channel constrictions are present and are creating extra deposition and scour features in their proximity. Overall, Pond Brook has excellent floodplain access in this segment and has not undergone much recent geomorphic change. For these reasons, segment B is in **good** geomorphic condition. It is in **fair** habitat condition due to a lack of large pools and altered adjacent wetlands.

Figure 5.19. T3.2-S3.01-B has good floodplain access and well forested buffers.

T3.2-S3.01-B Data Summary		Reference	Existing
Length: 5,669 ft Drainage Area: 7 sq. mi. Evolution Stage: F-II Sensitivity: Moderate	Confinement	Very Broad	Very Broad
	Stream Type	C	C
	Entrenchment Ratio	> 2.2	9.0
	Incision Ratio	< 1.2	1.3
	Dominant Bed Material	Cobble	Cobble
	Dominant Bedform	Riffle-Pool	Riffle-Pool
Major Stressors:	Bank Erosion, Encroachments, Channel Straightening, Stormwater Inputs

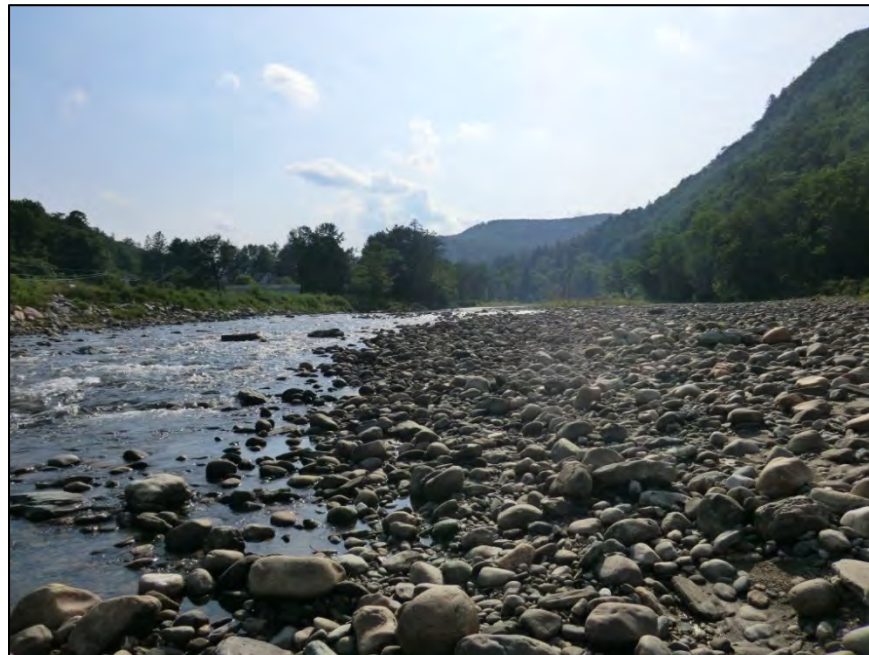
The downstream-most reach on the White River included in this assessment is reach fourteen in Stockbridge. It begins just above the confluence of Lilliesville Brook and continues upstream for 7,300 feet to just below the Gaysville Bridge. The lower half of R14 was historically straightened due to the construction of River Road and Vermont Route 107 within the White River valley. The upper portion of the reach has a more natural, sinuous planform. Historic channel alteration, such as straightening, has led to moderate historic incision within R14. Despite this, the White River retains good floodplain access throughout this reach. The river has aggraded and widened substantially and will continue to do so as it moves toward a least erosive state. During Tropical Storm Irene, floodwaters caused the formation of a mass failure along the river’s northern valley wall. The storm also likely contributed to the aggradation and widening observed during assessment. Bank armoring is continuous where the river flows along River Road and Route 107. Due to historic and active channel adjustment processes within R14, the reach is in **fair** geomorphic condition. The over-widened channel present in R14 lacks diverse bed features, in-stream woody debris, and well forested riparian buffers, which causes it to be in **fair** habitat condition.

Figure 5.21. Reach R14 on the White River is very wide and aggradational.

R14 Data Summary		Reference	Existing
Length:	7,257 ft	Broad	Broad
Drainage Area:	227 sq. mi.	C	C
Evolution Stage:	F-III	> 2.2	4.0
Sensitivity:	High	< 1.2	1.5
		Dominant Bed Material	Cobble
		Dominant Bedform	Riffle-Pool
Major Stressors:	Straightening, Encroachments, Poor Buffers, Erosion, Revetments

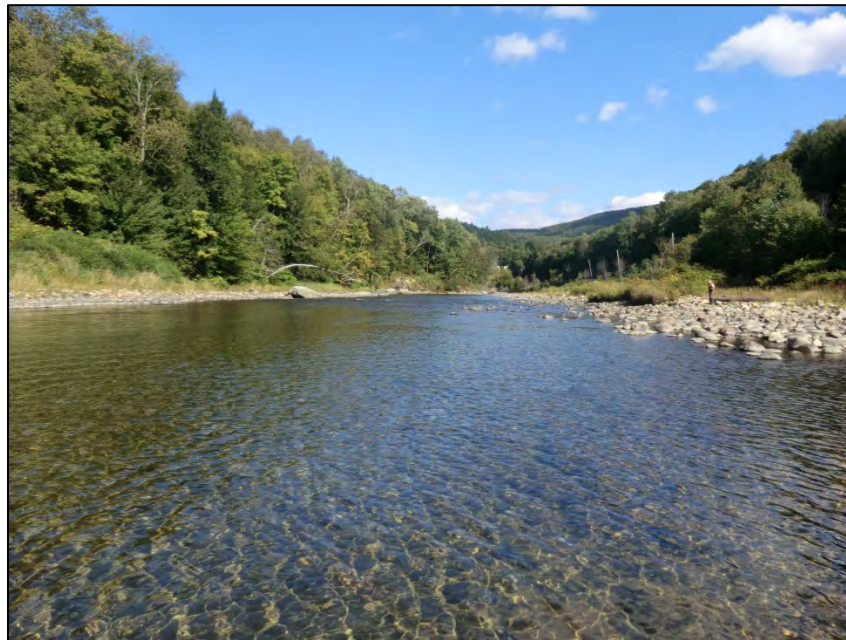
The second segment on reach sixteen of the White River is characterized by continuous corridor encroachment by Route 107 and extensive historic channel straightening. It begins at the Blackmer Boulevard Bridge and extends upstream 2,900 feet to where the river channel becomes narrower. The straightening and encroachment that the White River has been subjected to due to Route 107 have led to extreme historic incision and loss of floodplain access. The majority of the southern bank of the river has been riprapped along Route 107. The river has widened to the north where there is no bank armoring to prevent it, creating extensive bank erosion. This segment is aggrading and building a juvenile floodplain on its large bars. Major infrastructure damage occurred within R16-B during Tropical Storm Irene. The Blackmer Boulevard Bridge was damaged due to a landslide that occurred adjacent to the bridge. The Route 107 embankment was also damaged in at least two locations and had to be rebuilt post-flood. It is likely that gravel mining occurred within R16-B during flood recovery work, though it is difficult to identify exactly where. The severe incision and widening present in R16-B have caused it to be in **fair** geomorphic condition. This segment is also in **fair** habitat condition because its overly-wide channel provides little cover and lacks a diversity of bed features.

Figure 5.23. The White River is overly-wide in R16-B and is building large bars.

R16-B Data Summary		Reference	Existing
Length: 2,929 ft Drainage Area: 198 sq. mi. Evolution Stage: F-IV Sensitivity: Extreme	Confinement	Semi-Confined	Narrowly Confined
	Stream Type	B _c	F
	Entrenchment Ratio	1.4 – 2.2	1.2
	Incision Ratio	< 1.2	2.8
	Dominant Bed Material	Cobble	Gravel
	Dominant Bedform	Riffle-Pool	Riffle-Pool
Major Stressors:	Encroachment, Straightening, Revetments, Bank Erosion, Stormwater Inputs

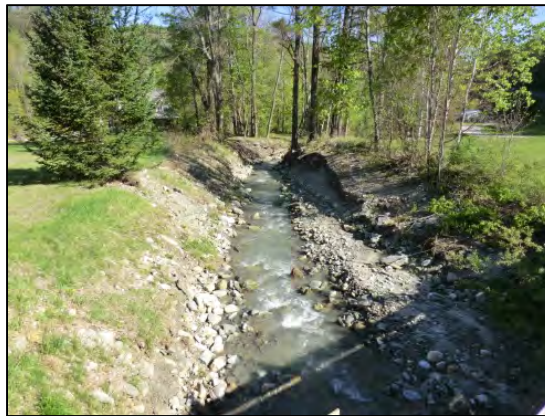
The downstream-most segment on reach one of Little Stony Brook extends from the confluence with the White River upstream about 1,100 feet to above the Route 107 bridge. This segment is an alluvial fan, which forms due to a significant drop in channel slope and widening of the valley as it opens up into the White River valley. Segment A is a natural area of significant deposition and has a braided bedform by reference. Development is abundant along this section of Little Stony Brook, and as a result it has been historically managed to be a single-thread channel. During Irene, major deposition occurred within this segment. To protect the houses on the banks of the brook, the channel was dredged and windrowed. Bank failure occurred on the north bank just above the confluence during Irene, and riprap was installed post-flood to protect a house on the bank. Three headcuts are present within R15-S1.01-A due to recent channel excavation. The water surface of the White River is substantially lower than that of Little Stony Brook at its mouth. The White River was extensively riprapped post-Irene in this location, creating a riprap cascade at the mouth of Little Stony Brook. This segment is in **poor** geomorphic condition due to major historic and recent channel alteration. Habitat is in **fair** condition due to a loss of bedform resulting from extensive channel work.

Figure 5.26. Extensive dredging and windrowing create an incised channel in R15-S1.01-A.

R15-S1.01-A Data Summary		Reference	Existing
Length:	1,059 ft	Confinement	Very Broad
Drainage Area:	2 sq. mi.	Stream Type	D
Evolution Stage:	F-III	Entrenchment Ratio	N/A
Sensitivity:	Extreme	Incision Ratio	< 1.2
		Dominant Bed Material	Gravel
		Dominant Bedform	Braided
Major Stressors:	Straightening, Windrowing, Encroachments, Revetments, Erosion

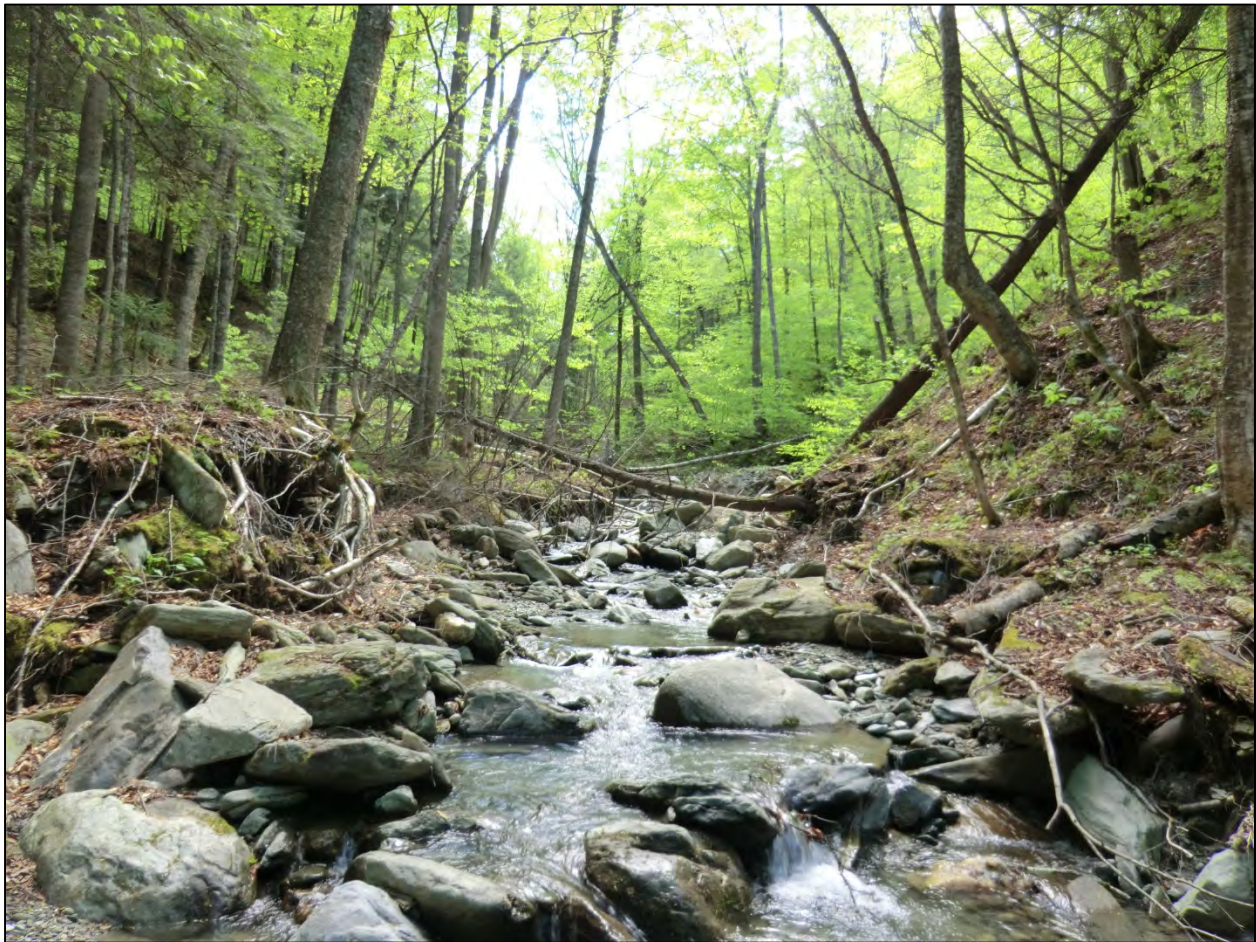
The upper-most segment on Little Stony Brook included in this study was not fully assessed due to its remote location and lack of human impacts. It flows through a vast expanse of forested land with no nearby development. Qualitative observations taken from the downstream end of this segment suggest that it is very similar to segment B in terms of stream type and geomorphic condition. It appears to have undergone historic incision and a stream type departure.

Figure 5.28. The upper segment on reach one of Little Stony Brook was not fully assessed, but appears to be very similar to segment B.

R15-S1.01-C Data Summary		*NOT ASSESSED	Reference	Existing
Length:	3,258 ft	Confinement	Semi-Confined	Semi-Confined
Drainage Area:	2 sq. mi.	Stream Type	C _a	F _a
Evolution Stage:	N/A	Entrenchment Ratio	> 2.2	N/A
Sensitivity:	N/A	Incision Ratio	< 1.2	N/A
		Dominant Bed Material	Cobble	Gravel
		Dominant Bedform	Step-Pool	Step-Pool
Major Stressors:		Mass Failures, Erosion

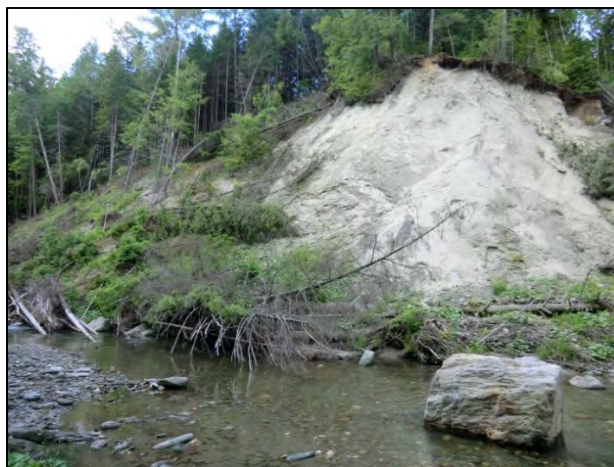
The downstream segment on reach five of Stony Brook is naturally confined between Driscolls Road and Stony Brook Road. It extends from the reach break upstream approximately 2,400 feet to where the river valley widens significantly. A section of the segment was historically straightened along Driscolls Road, which has contributed to the severe historic incision observed during the assessment. Major widening has also occurred in T5.05-A, most of which likely happened during Tropical Storm Irene. The valley walls in this segment are very steep and unstable, which has led to the formation of nine mass failures. Many of these mass failures have occurred along Stony Brook Road and Driscolls Road, putting them at risk of future damage. In two locations, mass failures occurred along Stony Brook Road during Irene, washing out the road and requiring large amounts of embankment armoring post-flood. For most of the segment, aggradation is minor, however, at the bottom of T5.05-A, a bedrock pinch point has created a sediment plug with localized aggradation. The Driscolls Road Bridge over Stony Brook is a significant channel constriction and was damaged by TSI floodwaters. Historic incision has resulted in a loss of floodplain access in T5.05-A and a stream type departure. In combination with widening, this segment is in **fair** geomorphic condition. Habitat condition is also **fair** as a result of unstable banks, impacted buffers, and an over-widened channel.

Figure 5.36. One of many large mass failures contributing sediment to Stony Brook in T5.05-A.

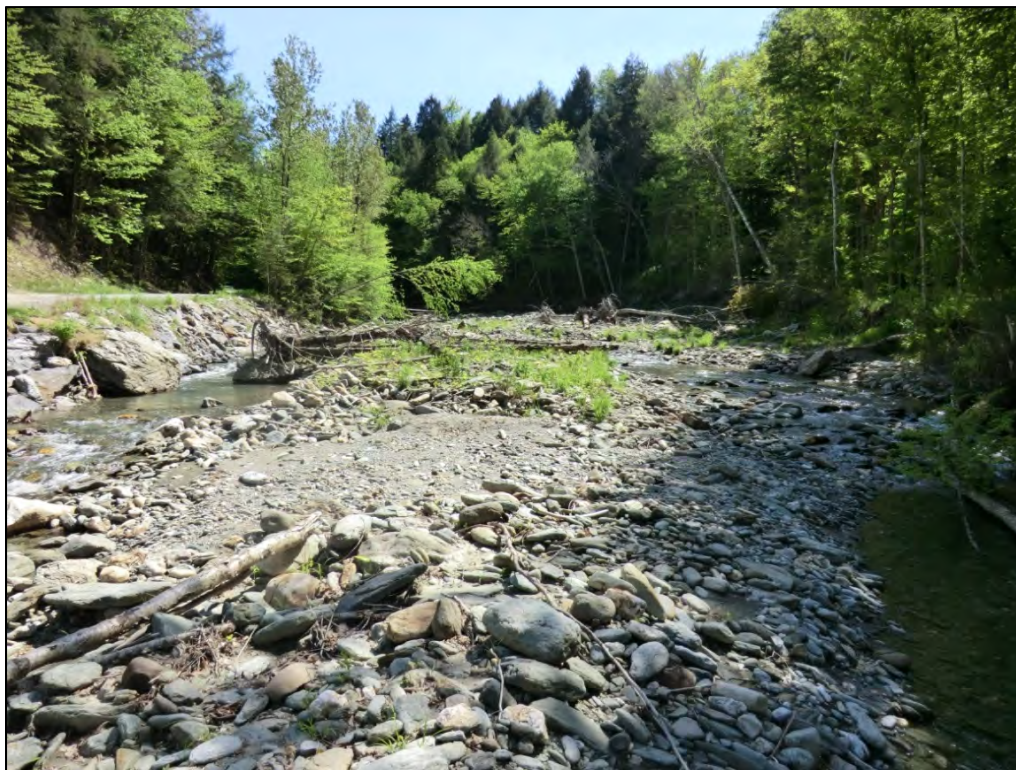
The upstream segment on T5.05 flows through a wider valley than the downstream segment and is lower gradient. It begins slightly upstream of the Driscolls Road Bridge and continues upstream for 3,900 feet to just above the second Stony Brook Road Bridge in reach five. Stony Brook Road was built into the river valley in T5.05-B and the majority of this segment was straightened along the road when it was built. Major historic downcutting has led to a stream type departure and partial loss of floodplain access. Aggradation is major throughout segment B, and widening is occurring in most places, with it – extensive bank erosion. Sections of T5.05-B that have been straightened along Stony Brook Road have lost their reference bedform and are featureless plane bed rather than riffle pool. The majority of this segment is building a juvenile floodplain on large bars and adjusting laterally via flood chutes. These adjustments have resulted in T5.05-B being in **fair** geomorphic condition. Habitat condition is also **fair**. In-channel woody debris is lacking, bedform has been altered, and banks and buffers are unstable and lacking vegetation.

Figure 5.37. Aggradation is abundant throughout T5.05-B.

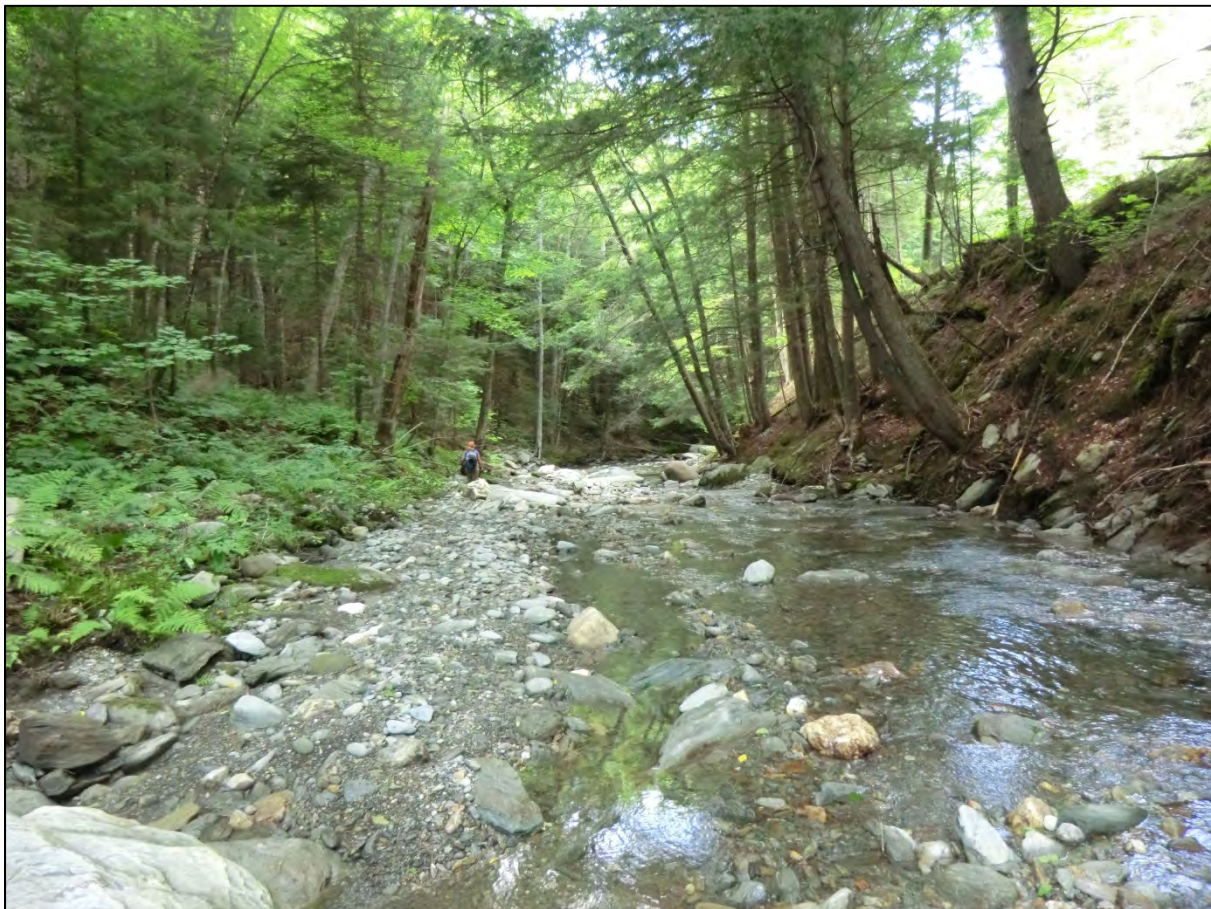
This segment flows through a narrow valley and has a steeper channel slope than segment A. T5.06-B spans approximately 2,000 feet in the vicinity of 5095 Stony Brook Road. It has incised only slightly and has not widened for the majority of the segment. Some sections are more incised and/or wider, but these are not dominant. A short portion of this segment was windrowed post-Irene in the vicinity of the Stony Brook Road Bridge. Three mass failures exist within T5.06-B and erosion is scattered throughout. Bank armoring is minimal and limited to the vicinity of the bridge. T5.06-B is in **fair** geomorphic condition as a result of minor aggradation and planform adjustment. It is in **good** habitat condition because of a well-defined riffle-pool bedform, ample woody debris cover, and good hydrologic characteristics.

Figure 5.39. T5.06-B flows through a narrow valley is not very incised.

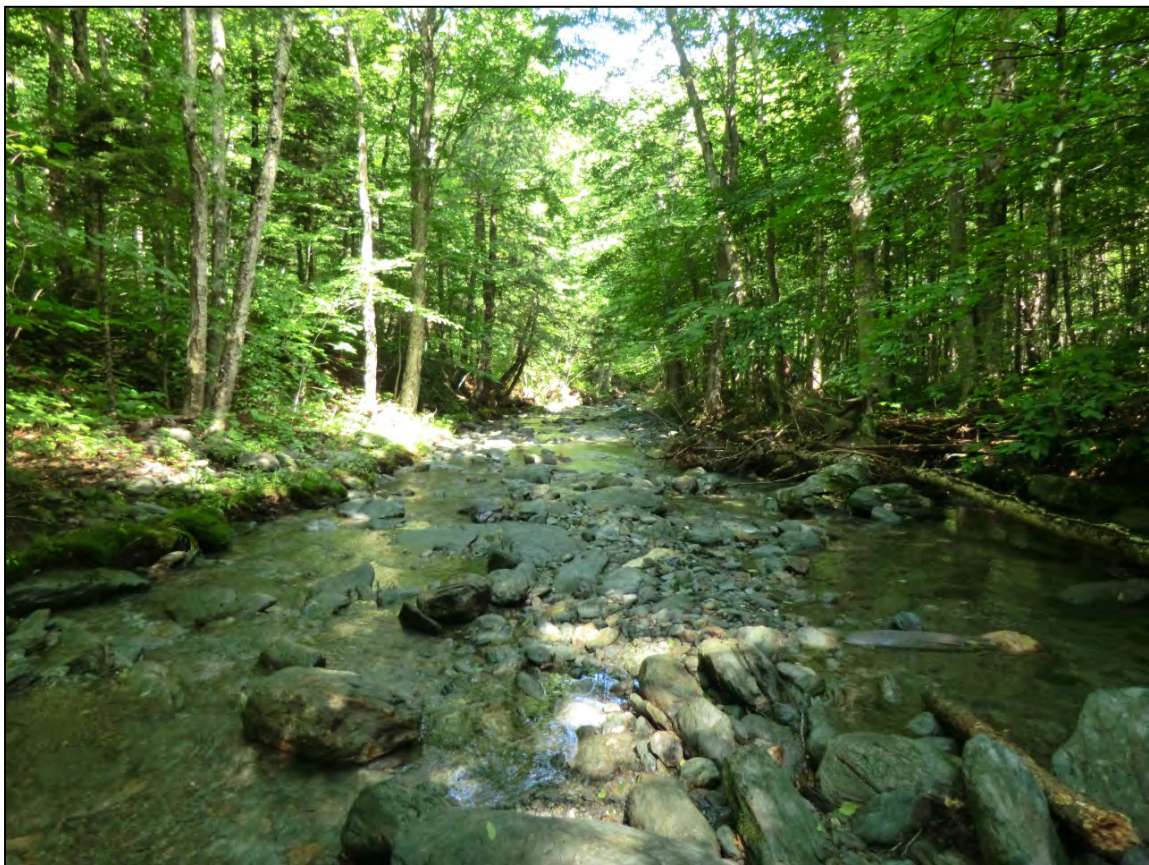
Segment E on reach six is the upstream-most segment on Stony Brook included in this assessment. It is in very stable condition and has not incised. Two bedrock grade controls provide vertical stability to this segment. Stony Brook road encroaches upon the brook for the majority of the segment, but it does not appear to be having significant impacts on the brook. Stormwater inputs from Stony Brook Road are abundant in this segment, and could be delivering sediment to the brook. T5.06-E is in **good** geomorphic condition due to its stability and lack of active adjustment. It is also in **good** habitat condition as a result of diverse bed features and minimal human impacts.

Figure 5.42. T5.06-E is very stable and has good floodplain access.

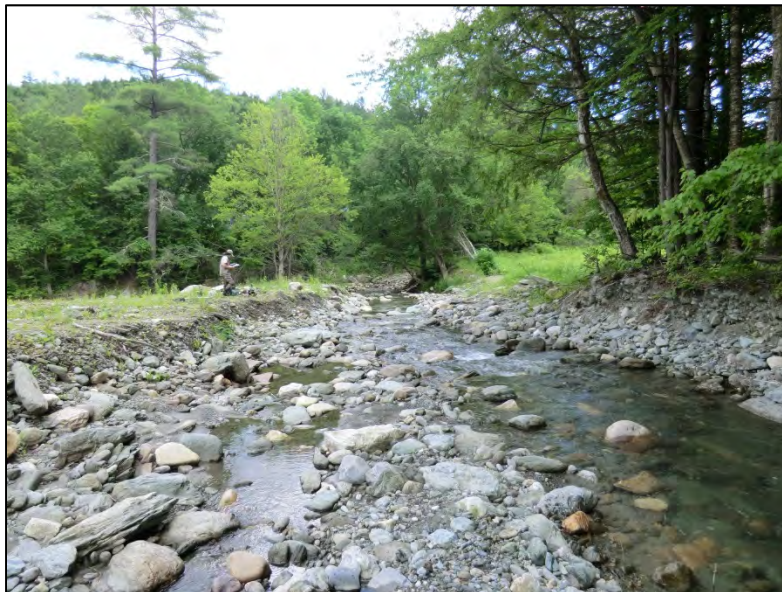
The downstream-most segment on Fletcher Brook is approximately 500 feet in length, extending from the mouth upstream to where the river valley narrows. This segment is an alluvial fan, occurring as the Fletcher Brook valley widens to meet the Stony Brook valley and the channel slope drops. T5.3-S1.01-A is an area of continual deposition that is very dynamic. During Tropical Storm Irene, major aggradation occurred in this location, causing the brook to rapidly adjust planform. A house on the north bank of the brook was destroyed as floodwaters flowed out from the channel. After the flood, recovery work aimed at returning the brook to a single thread channel. Sediment deposition was windrowed and dredged out of the brook as it was channelized. Major channel alteration post-Irene has caused this segment to be in **poor** geomorphic condition. Channel work also caused a loss of bedform and conversion to a featureless, plane bed system. For this reason, T5.3-S1.01-A is in **fair** habitat condition.

Figure 5.43. Fletcher Brook was extensively dredged and windrowed at the alluvial fan in T5.3-S1.01-A after Irene.

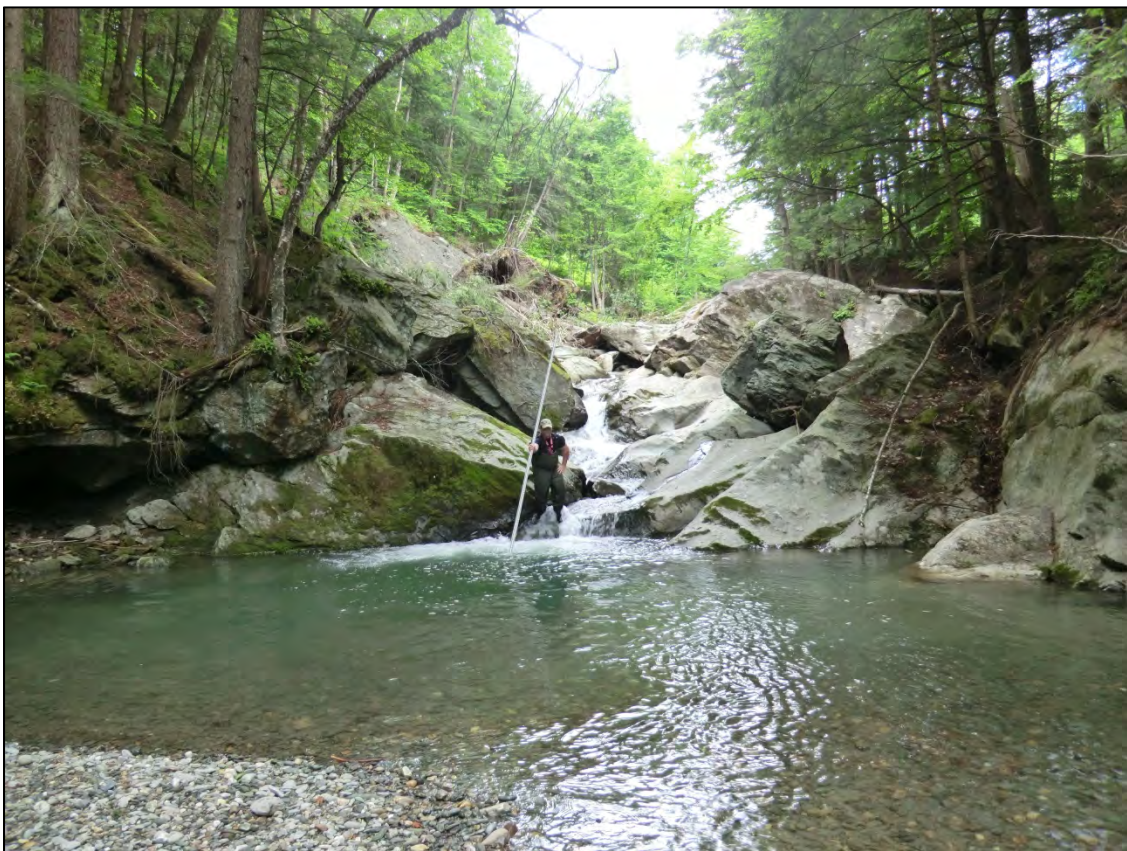
Segment B on reach one of Fletcher Brook flows through a narrow valley from above the alluvial fan in segment A upstream 2,200 feet to near 231 Blanchard Road. Bedrock grade controls are present throughout this segment, and a short bedrock gorge exists at the downstream end. Moderate channel incision has occurred in between these grade controls. Short areas of the segment were historically straightened along Fletcher Brook Road, but mostly planform is natural. Six mass failures are present along the southern valley wall. Fletcher Brook Road washed out in at least one location during Irene within this segment. Road rebuilding and armoring led to a narrowing of the channel in areas. Aggradation is present immediately upstream of grade controls but is not a major process. Historic channel incision has caused T5.3-S1.01-B to be in **fair** geomorphic condition. Habitat is also in **fair** condition due to unstable banks and a lack of large pools.

Figure 5.44. Many bedrock grade controls are present within T5.3-S1.01-B.

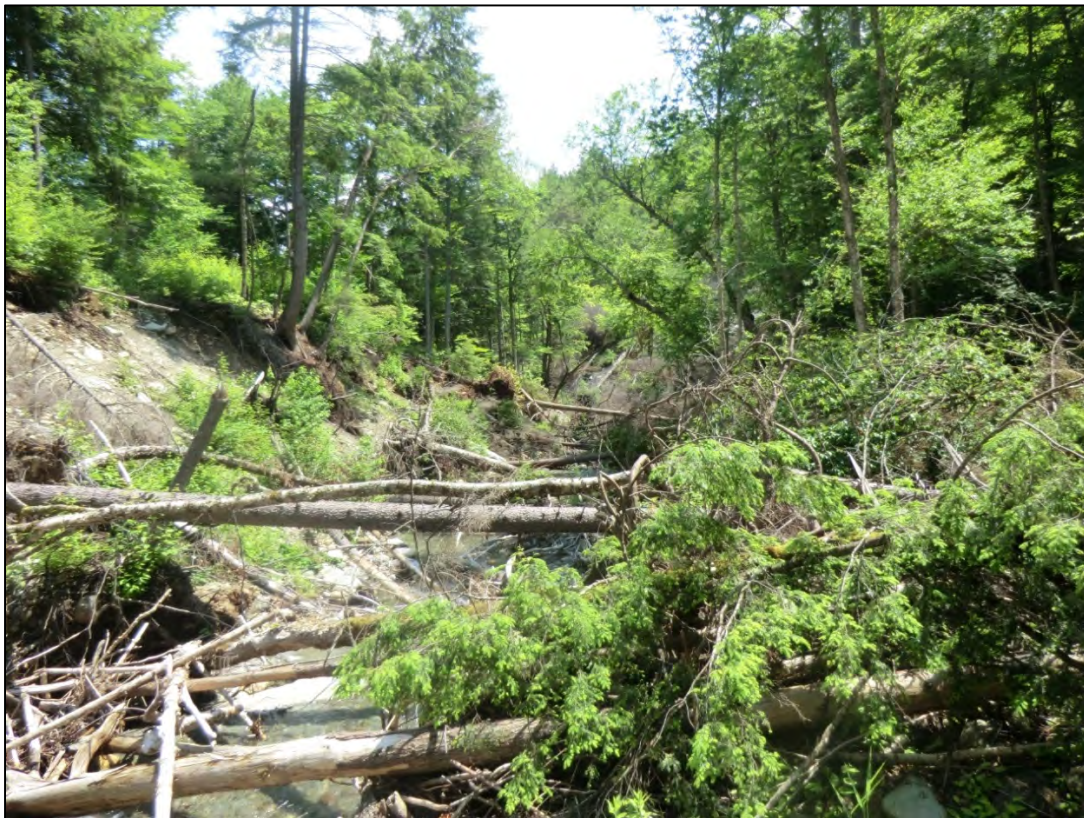
The upstream-most segment included in the assessment of Fletcher Brook begins near 135 Spiegel Road and continues upstream for 2,700 feet to the reach break. This segment has not been subjected to any straightening along Fletcher Brook Road and retains its natural planform. Despite this, the brook has undergone moderate historic incision in this segment and is currently widening. A short bedrock gorge is present in the middle of this segment, which is holding the grade and likely reducing further incision. Bank erosion is nearly continuous throughout the segment and large mass failures are common. The mass failures are sources of sediment and woody debris for the brook, and have led to the formation of numerous debris jams. Minor planform adjustment is occurring in the vicinity of these jams. T5.3-S1.01-D is in **fair** geomorphic condition due to historic incision and active widening. Habitat is in **good** condition, as the brook has an abundance of woody debris that is creating plunge pools and in-stream cover, well vegetated buffers, and diverse bed features.

Figure 5.46. Woody debris from the valley walls lines Fletcher Brook in T5.3-S1.01-D.

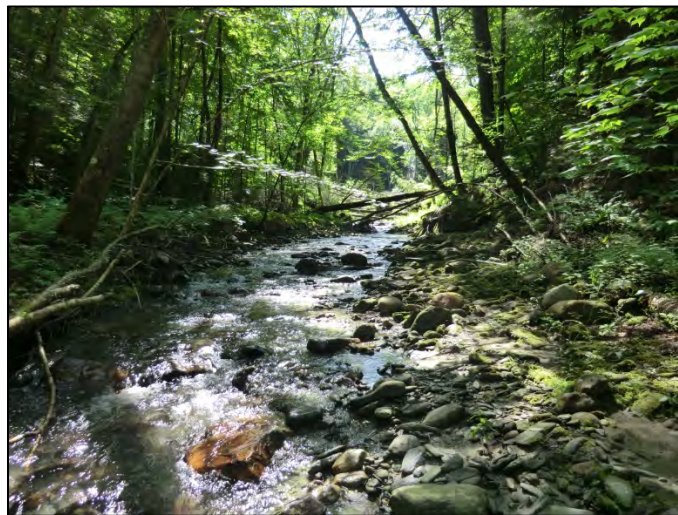
The downstream-most segment on Bartlett Brook is approximately 3,000 feet in length, beginning at the mouth of the brook and continuing upstream to where the stream becomes inaccessible due to woody debris in the channel. T6.1-S1.01-A flows through a broad valley and is currently in very stable condition. The brook has incised slightly, which could be due to channel alteration on the Tweed River just below the confluence. Saturated soils on the valley walls have led to the formation of several mass failures, which are contributing sediment and woody debris to the channel. Debris jams are abundant, and are causing minor planform adjustment and some bank erosion. The brook has good floodplain access in this area. T6.1-S1.01 is in **good** geomorphic condition because channel adjustment is minimal. The brook is also in **good** habitat condition in this location as a result of ample woody debris and good bed cover.

Figure 5.47. T6.1-S1.01-A is geomorphically stable and has good floodplain access.

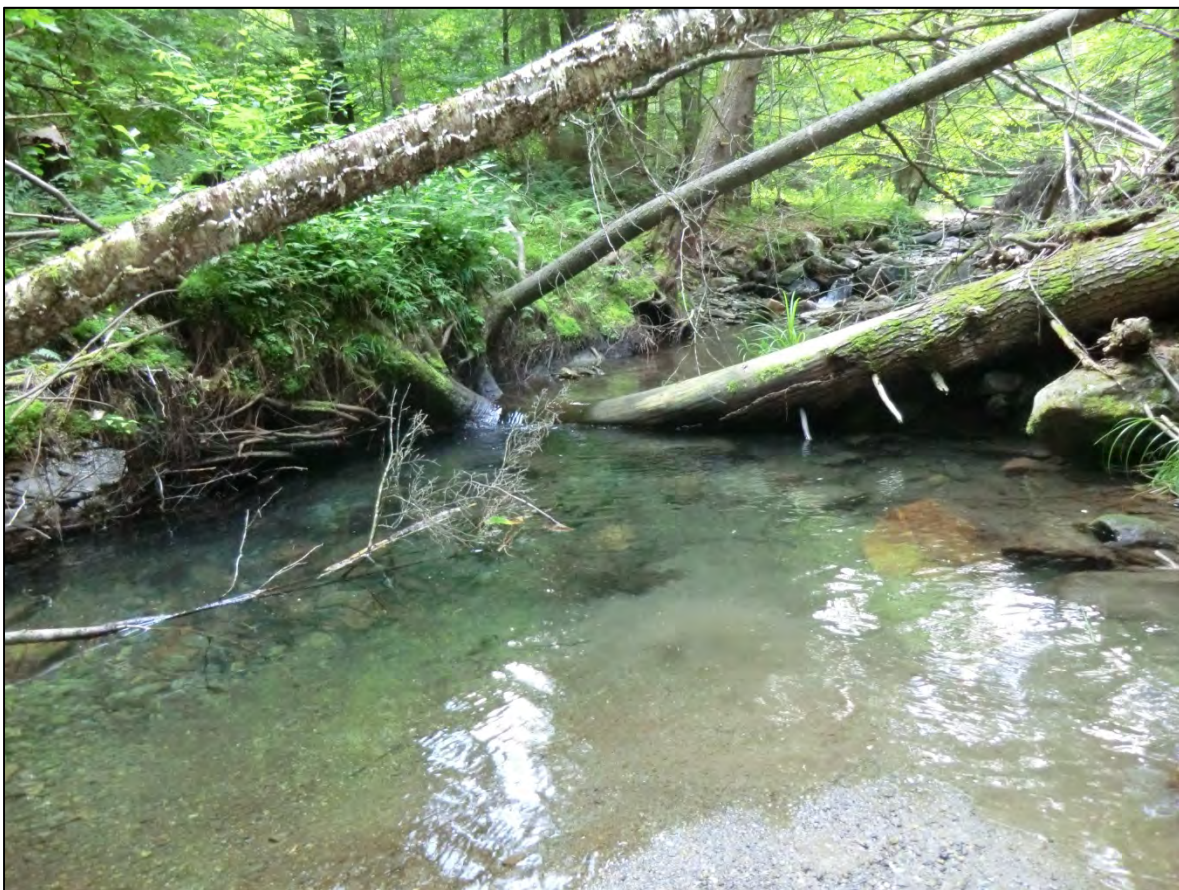
This segment flows through a broad river valley and is approximately 4,000 feet in length. The brook has not incised or widened in this location, but it is undergoing aggradation and planform adjustment. Sections of T6.1-S1.01-C are braided around large depositional features formed by brief decreases in channel slope. Numerous flood chutes cross bars throughout this segment. A logging road runs along Bartlett Brook for some sections of this segment, but its impacts are minor. Overall, the segment retains excellent floodplain access and natural channel planform. Small areas of bank erosion are scattered throughout T6.1-S1.01-C, as are three mass failures. This segment is in **good** geomorphic condition due to a lack of incision and human impacts. It is also in **good** habitat condition, with excellent woody debris cover, ample pool and riffle habitat, and good floodplain connectivity.

Figure 5.49. T6.1-S1.01-C has great habitat features, including abundant plunge pools.

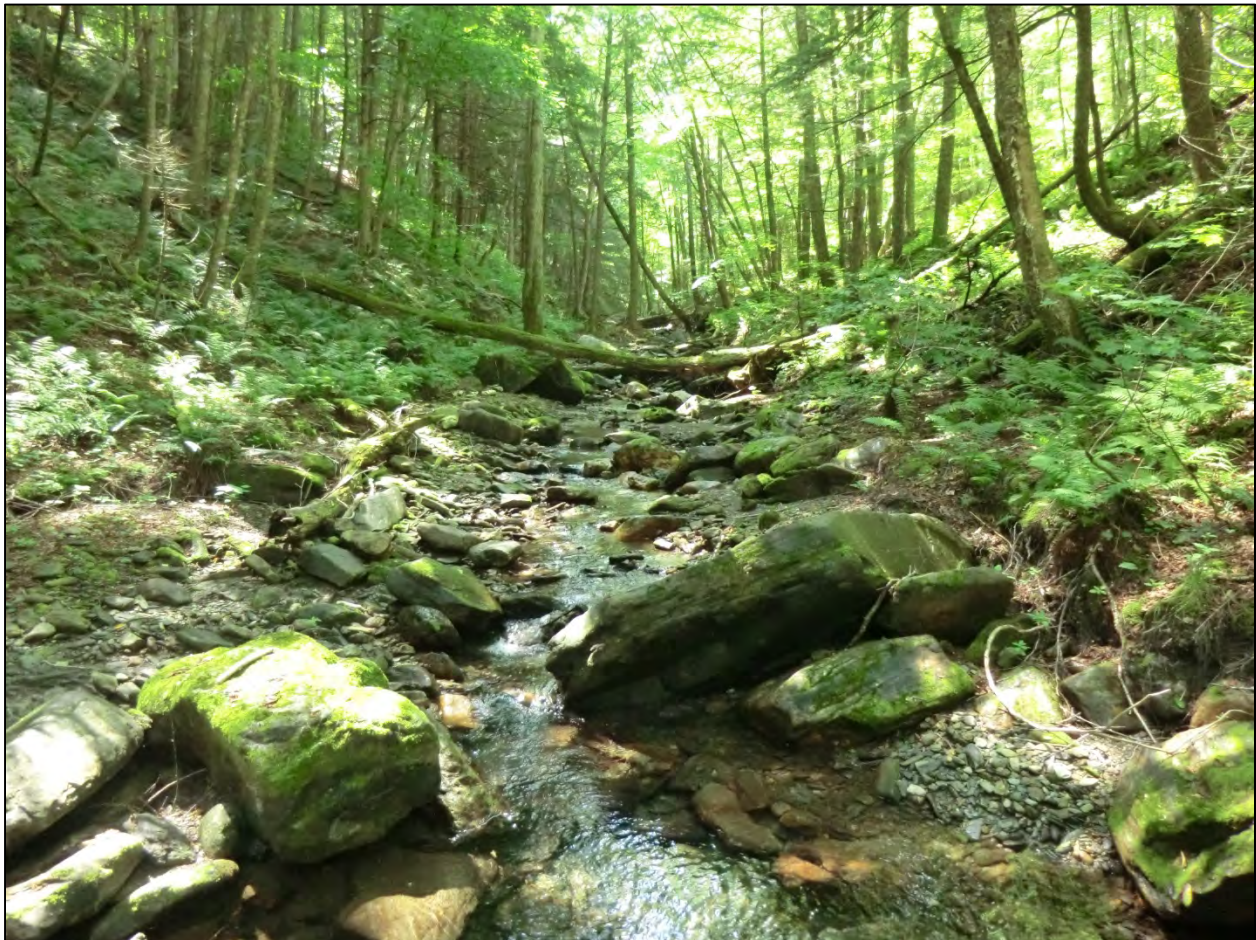
The upstream-most portion of Bartlett Brook included in this study was not fully assessed due to its remote location, lack of human impacts, and stable condition. The segment is approximately 2,000 feet in length. Qualitative observations were taken at the downstream end of the segment to characterize it. The brook is very stable in this location and appears to be in **reference** geomorphic condition with a step-pool bedform.

Figure 5.50. T6.1-S1.01-D was not fully assessed, but is in very stable condition.

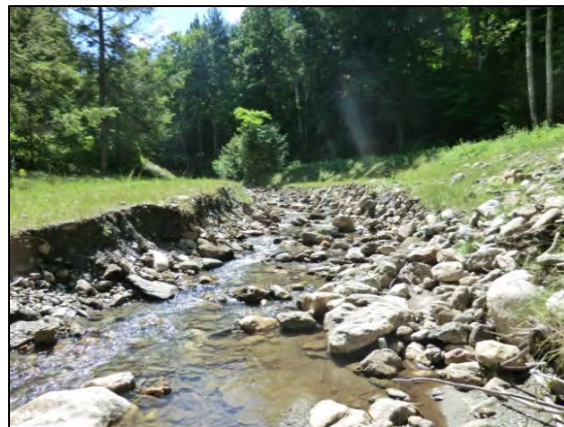
The downstream-most segment on Johnson Brook forms an alluvial fan as it meets the Tweed River. The channel slope is less than the segment above and the river valley is wider. Naturally, this segment would be a highly aggradational area where large amount of sediment from upstream is deposited. Due to the presence of a culvert under Vermont Route 100 and houses on the northern bank, Johnson Brook has been historically and recently managed in a way that has caused it to lose its alluvial fan characteristics. T6.4-S1.01-A has been channelized to flow as a single thread channel, when naturally it would be a braided system. During Tropical Storm Irene, large amounts of sediment deposited within this segment. To protect infrastructure, the brook was dredged and windrowed following the flood. This recent channel alteration, in combination with historic channel management, has caused the brook to incise significantly. Bank erosion indicates that the channel is beginning to widen in some areas in response to this incision. The aforementioned factors have caused T6.4-S1.01-A to be in **fair** geomorphic condition. Recent channel dredging and windrowing have resulted in a loss of reference bedform and conversion to a featureless plane bed system. Habitat is in **fair** condition as a result of this.

Figure 5.51. T6.4-S1.01-A was subjected to windrowing and dredging post-Irene.
