Upper & Middle White River Watershed Corridor Plan

Barnard, Hancock, Pittsfield, Rochester, and
Stockbridge, Vermont
July 15, 2015

Prepared by:
Bear Creek Environmental, LLC
149 State Street, Suite 3
Montpelier, Vermont 05602

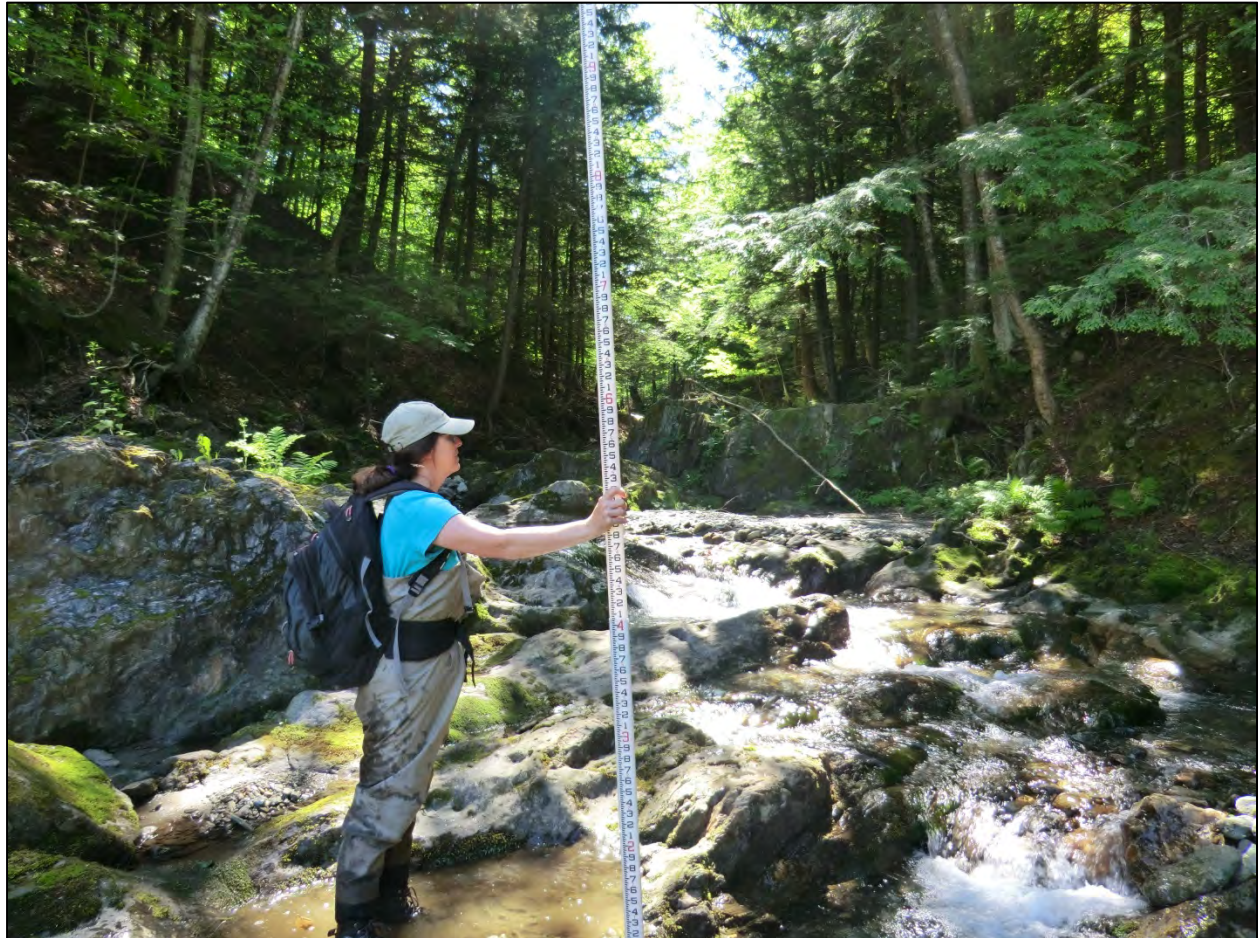
Segment B on reach one of Johnson Brook is a short bedrock gorge that exists where the valley walls pinch in before widening to meet the Tweed River valley in segment A. This segment is characterized by continuous bedrock on the bed, which is creating a very stable channel. For this reason, T6.4-S1.01-B was not fully assessed. Qualitative observations suggest that this segment is in **good** geomorphic condition and is not undergoing major adjustment. Small areas of bank erosion exist where bedrock is not present on the banks. The brook flows through a semi-confined valley in this location.

Figure 5.52. T6.4-S1.01-B was not fully assessed due to the presence of a bedrock gorge.

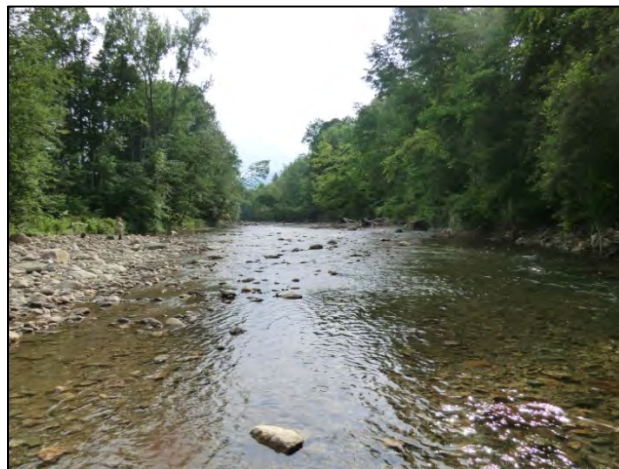
The downstream-most segment on the West Branch is an alluvial fan, forming as the channel slope drops and valley walls widen to meet the White River. The river flows through a very broad valley in this segment, but was historically straightened for its entirety due to Route 73 and adjacent farm fields. This historic straightening led to major channel incision, loss of floodplain access, and a stream type departure. Tropical Storm Irene deposited large amounts of sediment in the channel and on adjacent lands within this segment. The stream was subjected to windrowing after the flood at its downstream end to remove some of the deposited material from the stream channel. This material has created large bars in the channel and contributed to extreme widening. Bank erosion is abundant within this segment. Historic and recent channel alteration in T7.01-A have led to a major deviation from reference conditions. Because of this, the segment is in **poor** geomorphic condition. A loss of bedform has also occurred in T7.01-A, and the featureless plane bed channel has caused the segment to be in **fair** habitat condition.

Figure 5.54. The West Branch is overly wide and highly aggradational in T7.01-A.

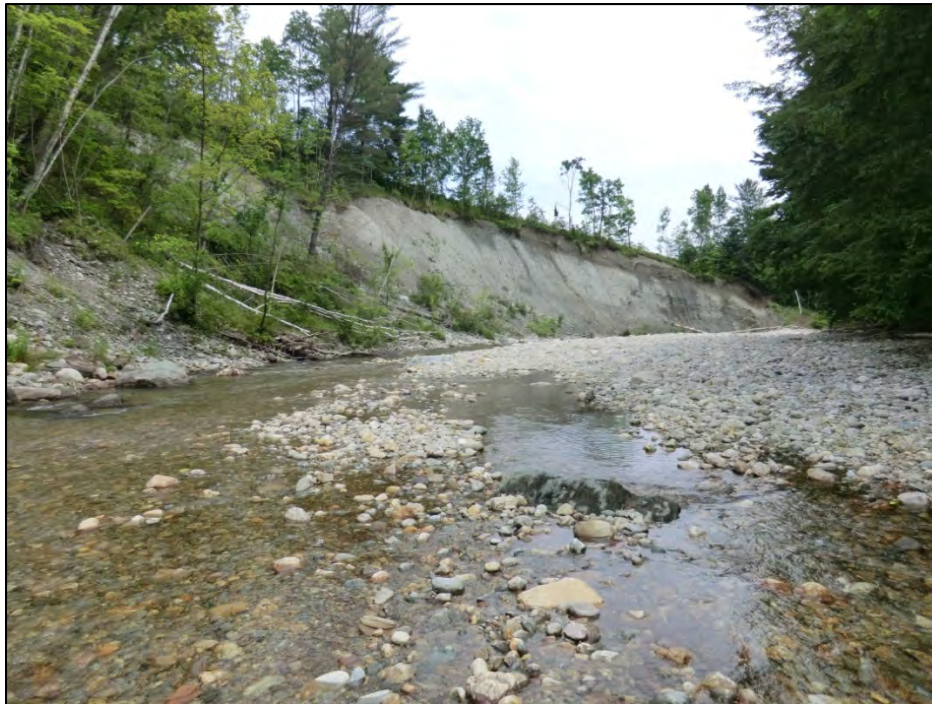
The downstream-most segment on reach two of the West Branch is characterized by major historic straightening undergone to create agricultural fields. The river forms an alluvial fan in this segment, created by abrupt widening of the river valley and a drop in channel slope. The channel has not incised in this location, but due to large amounts of aggradation during Irene, has widened considerably. Two sections of the river in T7.02-B are braiding over large depositional features, and flood chutes are common. Windrowing and gravel mining took place in the vicinity of a Route 73 Bridge in this segment post-Irene. The river avulsed within T7.02-A, cutting a new channel toward the downstream end of the segment likely during TSI. T7.02-A is in **fair** geomorphic condition as a result of aggradation, widening, and channel alteration. Habitat is also in **fair** condition due to lacking bed cover and poor bank and buffer vegetation.

Figure 5.56. A wide, aggradational channel is characteristic of T7.02-A.

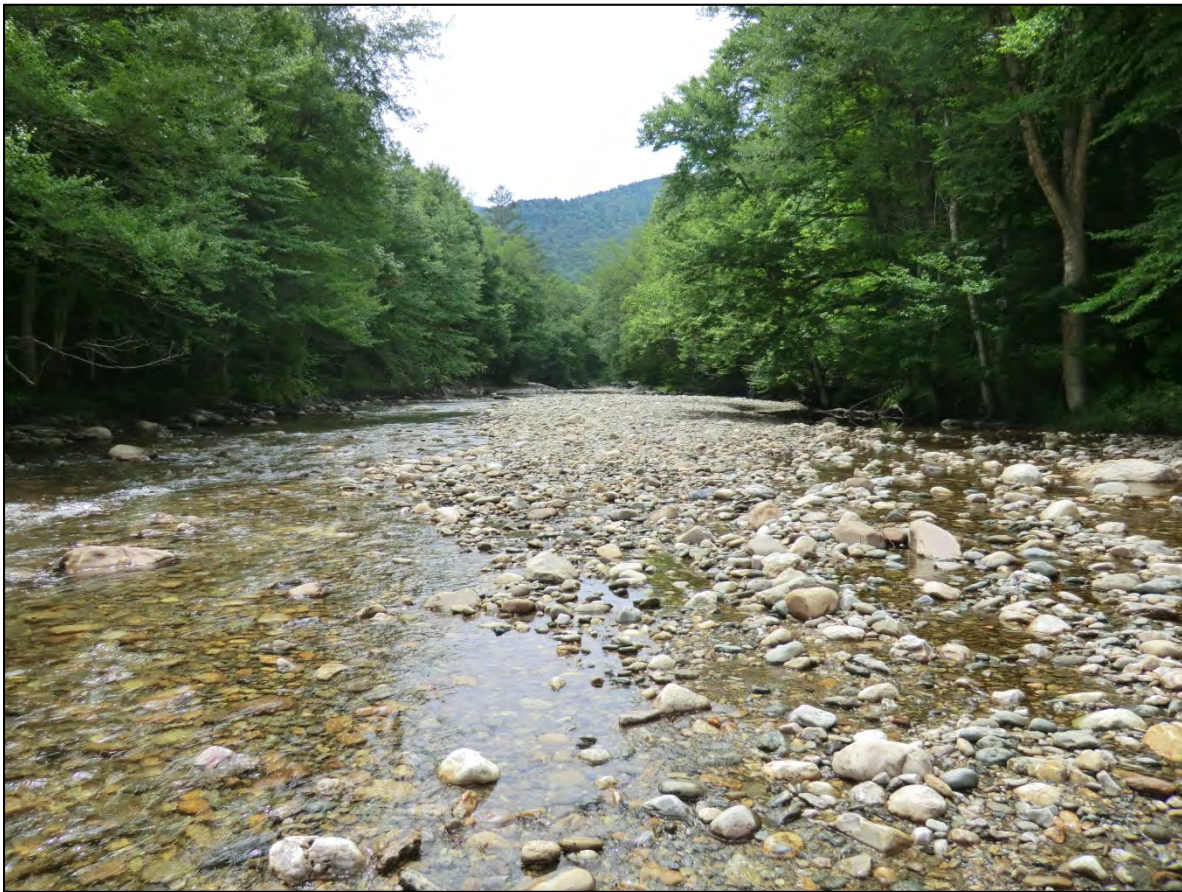
T7.02-B begins approximately 2,500 feet upstream of the Route 73 Bridge in segment A and continues upstream 1,500 feet to just above the confluence of Corporation Brook. This segment flows through a narrow river valley and has fewer human impacts than the surrounding segments. T7.02-B has not been subjected to recent or historic channel straightening and retains a natural planform. Major deposition occurred in this segment during Irene, followed by extreme channel widening. Bank erosion is common within T7.02-B. One section of this segment has become braided due to major aggradation. Overall, this segment is in **fair** geomorphic condition due to aggradational and widening processes occurring. Lacking woody debris cover and unstable banks have contributed to T7.02-B being in **fair** habitat condition.

Figure 5.57. Typical channel in T7-02B.

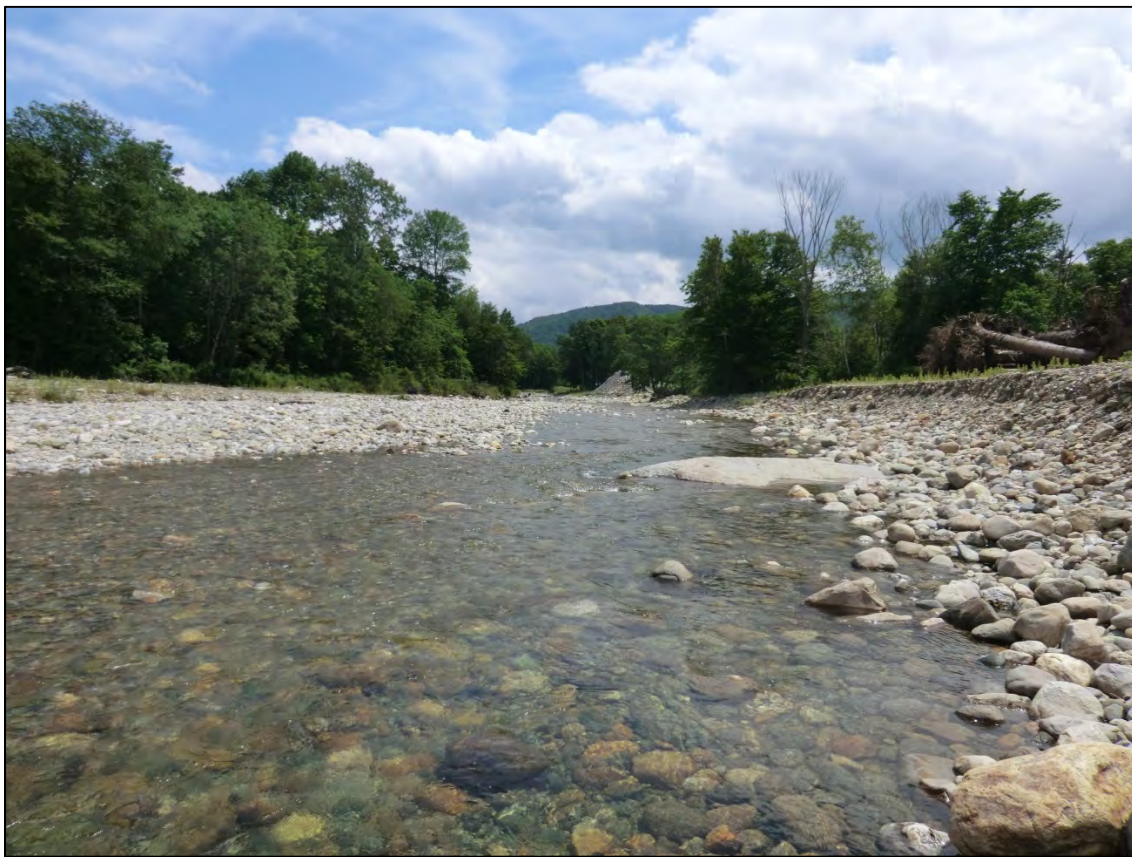
Segment C on reach two of the West Branch flows through a very broad valley for 2,700 feet in the vicinity of the Green Mountain National Forest Civilian Conservation Corps camp in Rochester. This area of the West Branch underwent extreme aggradation and widening during Tropical Storm Irene. Following TSI, the entire segment was subjected to windrowing and gravel mining, some of which created berms along the banks of the river. Slight incision has occurred in T7.02-C, but the river retains good floodplain access where berms do not exist. Due to extensive channel excavation, the river’s reference riffle-pool bedform has been converted to a featureless, plane bed system. Geomorphic condition is **poor** as a result of extensive recent channel alteration. T7.02-C is in **fair** habitat condition also due to windrowing and dredging, which have destroyed habitat features.

Figure 5.58. T7.02-C was subjected to extensive windrowing and gravel mining post-Irene.

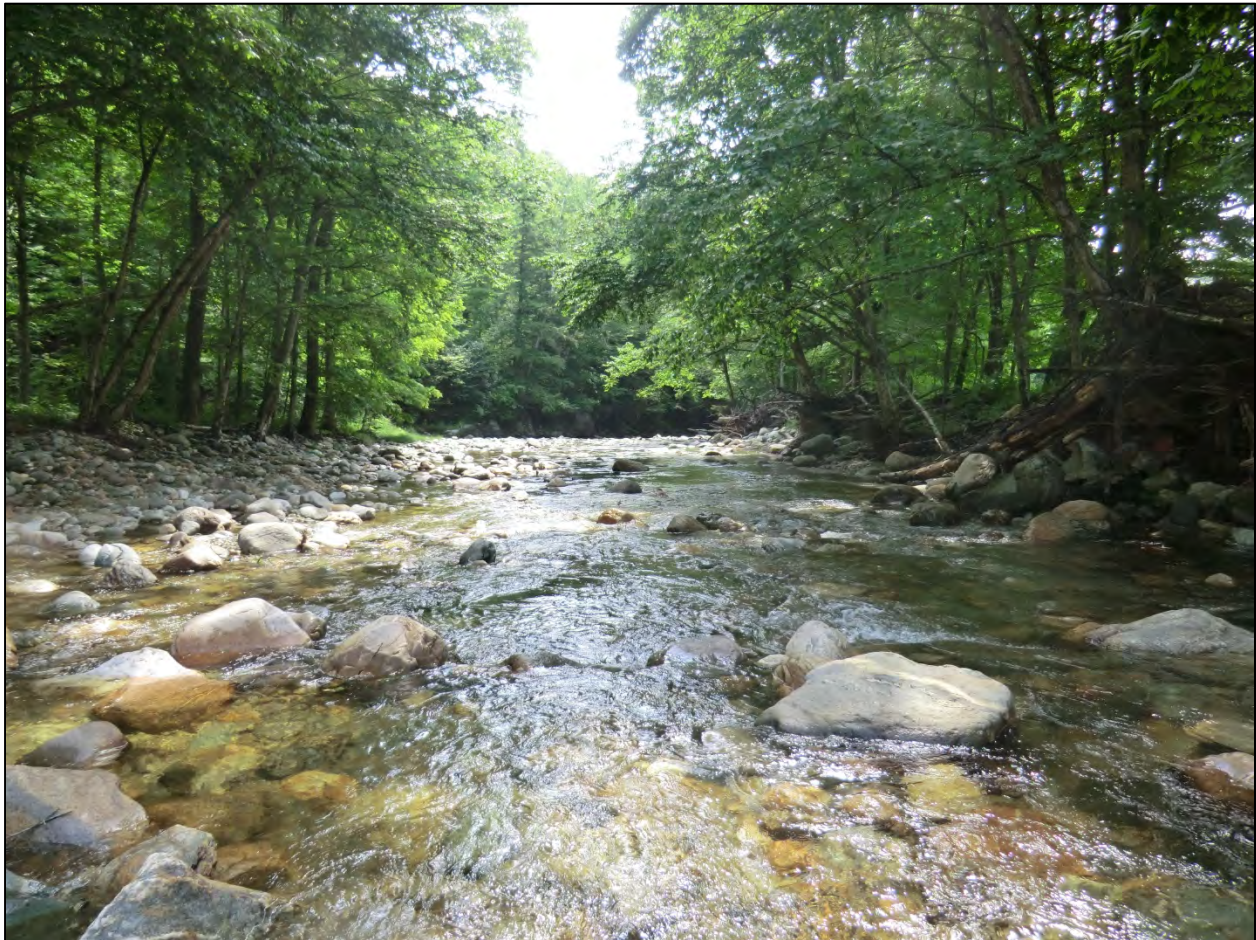
This segment flows through a very broad valley for approximately 2,500 feet downstream of King Farm Road. T7.02-D was not fully assessed due to restricted property access throughout the segment. Using aerial photographs, it was possible to determine that the majority of the segment was historically straightened along the northern valley wall to create agricultural fields. Qualitative field observations suggest that T7.02-D has good floodplain access and has not undergone a stream type departure. It has, however, lost its reference riffle-pool bedform, which has been converted to featureless plane bed. The upstream end of the segment was windrowed post-Irene.

Figure 5.59. T7.02-D could not be fully assessed due to a lack of property access.

T7.02-D Data Summary		*NOT ASSESSED	Reference	Existing
Length:	2,446 ft	Confinement	Very Broad	Very Broad
Drainage Area:	42 sq. mi.	Stream Type	C	C
Evolution Stage:	N/A	Entrenchment Ratio	> 2.2	N/A
Sensitivity:	N/A	Incision Ratio	< 1.2	N/A
		Dominant Bed Material	Cobble	Cobble
		Dominant Bedform	Riffle-Pool	Plane Bed
Major Stressors:		Straightening, Poor Buffers, Windrowing

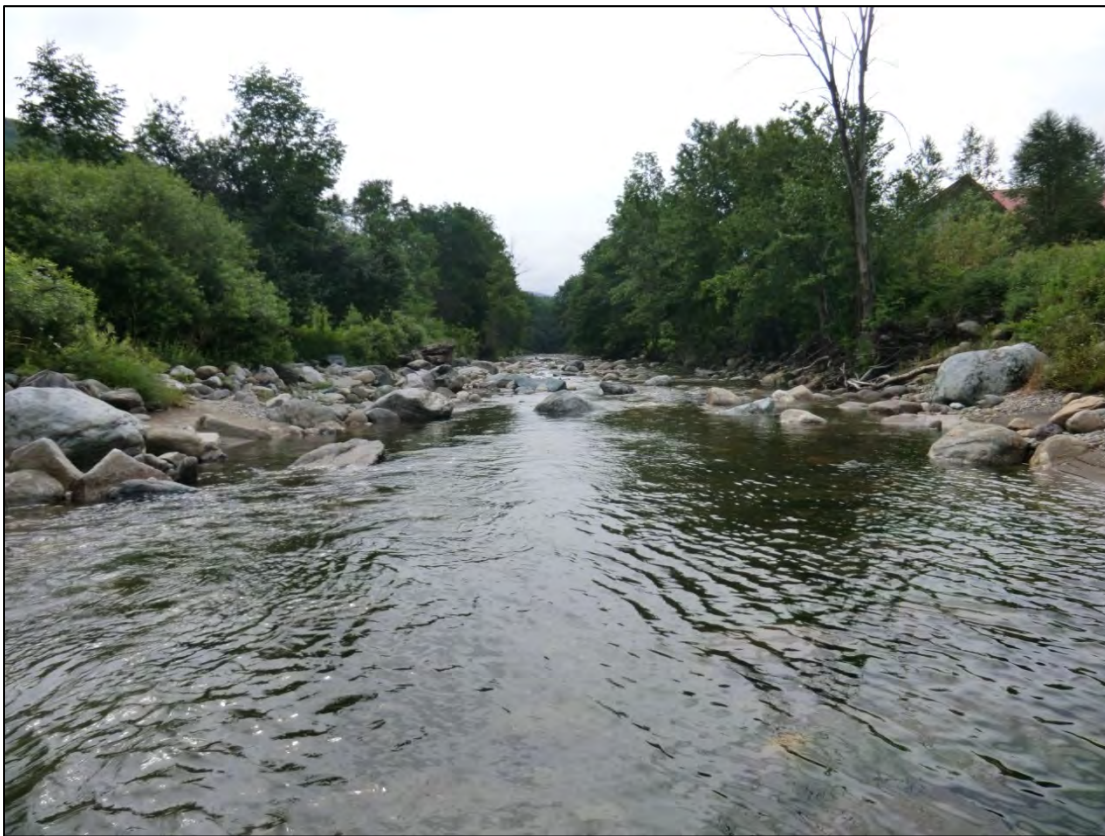
The upstream-most segment on the West Branch included in this assessment begins downstream of the King Farm Road Bridge and continues upstream 2,400 feet to just above the confluence of Bingo Brook. The river flows through a very broad valley in T7.02-E, where it has been straightened extensively due to the presence of Route 73 and King Farm Road. This straightening has led to moderate incision and a loss of bedform. The West Branch has widened slightly in this segment, but riprap is preventing further widening in some areas. T7.02-E was windrowed and dredged post-Irene in multiple locations. One headcut is present within the segment, but a bedrock grade control is providing some channel stability. T7.02-E is in **fair** geomorphic condition as a result of extensive historic channel straightening and recent alteration. It is also in **fair** habitat condition due to the loss of riffle-pool bedform and conversion to featureless plane bed.

Figure 5.60. Extensive historic straightening in T7.02-E has created a featureless, plane bed channel.

T7.02-D Data Summary		Reference	Existing
Length:	2,416 ft	Confinement	Very Broad
Drainage Area:	42 sq. mi.	Stream Type	C
Evolution Stage:	F-II	Entrenchment Ratio	> 2.2
Sensitivity:	High	Incision Ratio	< 1.2
		Dominant Bed Material	Cobble
		Dominant Bedform	Riffle-Pool
Major Stressors:	Straightening, Encroachments, Revetments, Erosion, Stormwater Inputs, Windrowing, Dredging

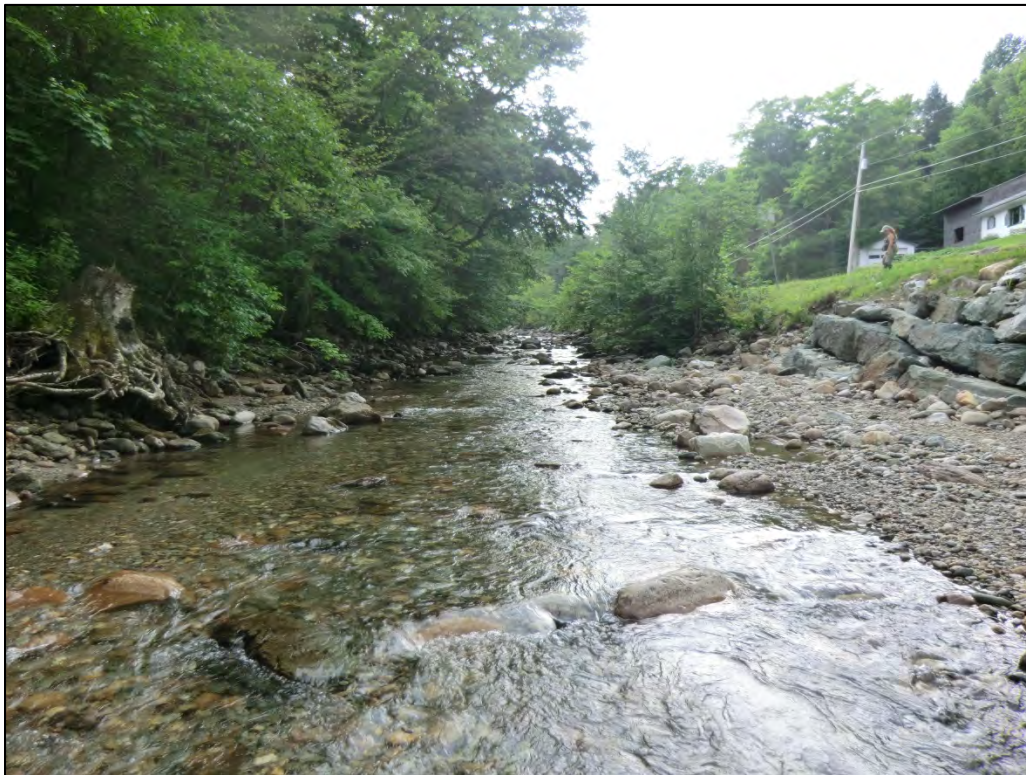
Segment B on reach one of the Hancock Branch begins near the pond at Camp Killooleet and continues upstream along Route 125 for 2,800 feet, ending above the old Killooleet Dam. The entire segment was historically straightened along Route 125, which is a significant corridor encroachment. T8.01-B has majorly incised due to this historic straightening. The river has lost all floodplain access here and has undergone a stream type departure. Post-Irene windrowing throughout half of the segment has exacerbated this incision. Riprap lines the northern bank of the river and is scattered along the southern bank. This armoring is preventing widening to the north. Despite the riprap, erosion is extensive, especially on the southern bank. Overall, the channel has not begun major widening due to recent channel excavation and boundary factors. An old dam is present within T8.01-B, which blew out several years ago. Overall, this segment is in **fair** geomorphic condition because of extensive channel straightening and major incision. It is also in **fair** habitat condition due to a lack of diverse bed features.

Figure 5.62. T8.01-B was historically straightened along Route 125.

T8.01-B Data Summary		Reference	Existing
Length:	2,809 ft	Confinement	Very Broad
Drainage Area:	22 sq. mi.	Stream Type	C
Evolution Stage:	F-II	Entrenchment Ratio	> 2.2
Sensitivity:	Extreme	Incision Ratio	< 1.2
		Dominant Bed Material	Cobble
		Dominant Bedform	Riffle-Pool
Major Stressors:		Straightening, Encroachments, Windrowing, Revetments, Stormwater Inputs, Poor Buffers

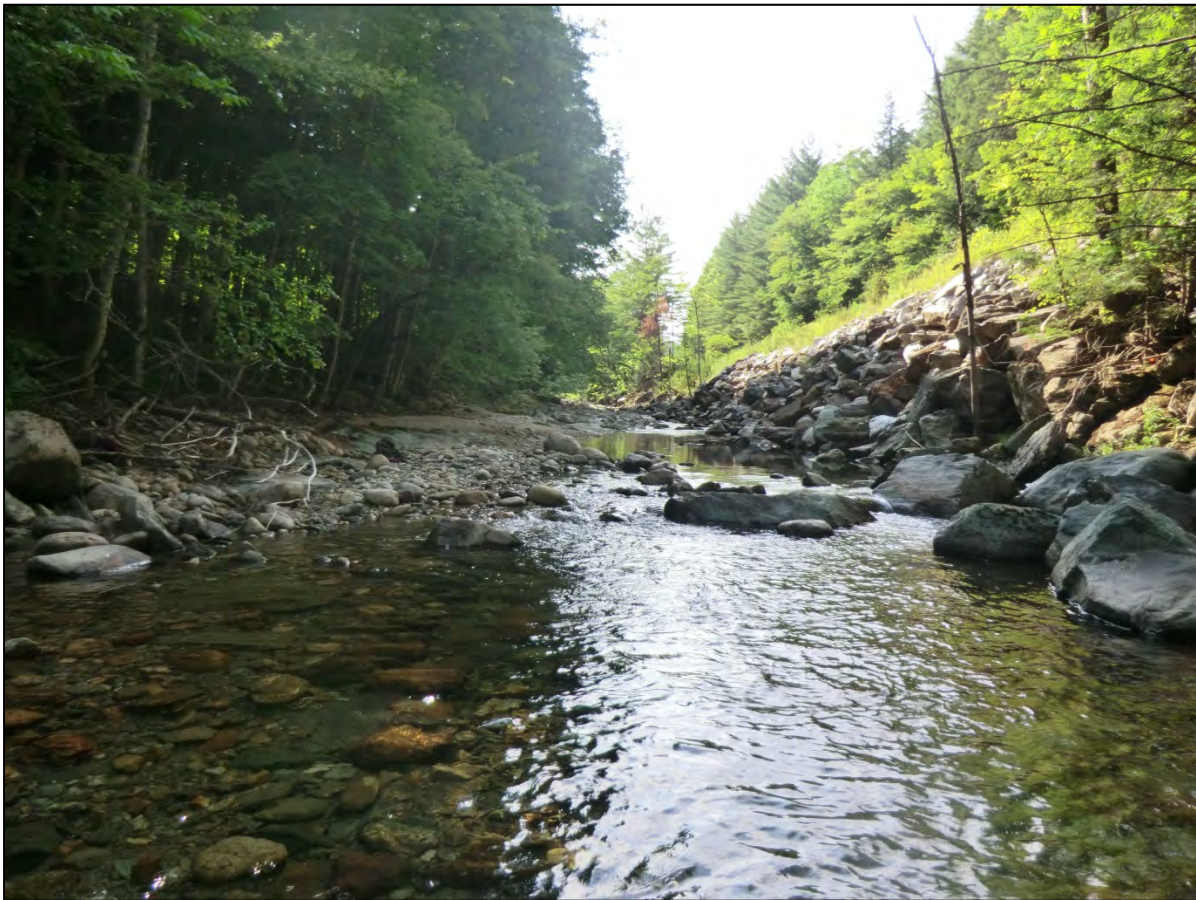
The upstream-most segment on reach one of the Hancock Branch flows through a narrower valley than its surrounding segments. It is approximately 2,000 feet long and flows through a semi-confined valley on the southern side of Route 125. Sections of this segment were historically straightened along Route 125. Bank armoring is abundant along the road, which is built into the northern valley wall for most of the segment. The Hancock Branch is fairly stable in T8.01-C, and a bedrock grade control holds the bed in place toward the upstream end. The river has not incised or widened here, so it is in **good** geomorphic condition. The segment is lacking in-channel woody debris and has impacted buffers, which has caused it to be in **fair** habitat condition.

Figure 5.63. T8.01-C flows through a semi-confined valley along Route 125.

T8.01-C Data Summary		Reference	Existing
Length:	2,018 ft	Semi-Confined	Semi-Confined
Drainage Area:	22 sq. mi.	F	F
Evolution Stage:	F-II	< 1.4	1.4
Sensitivity:	Very High	< 1.2	1.2
		Dominant Bed Material	Cobble
		Dominant Bedform	Riffle-Pool
Major Stressors:	Straightening, Encroachments, Revetments, Poor Buffers

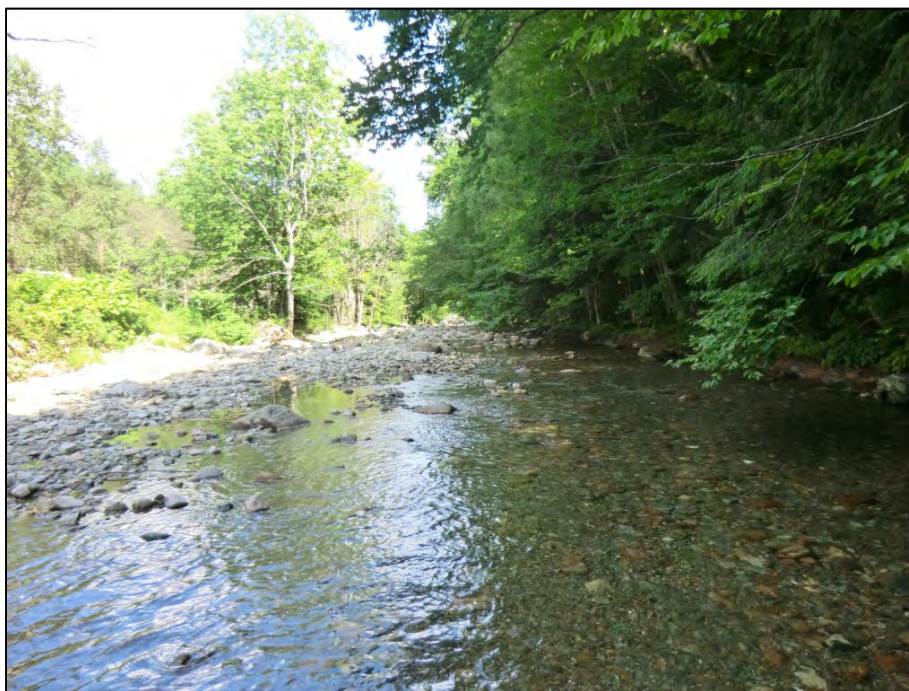
The first segment on reach two of the Hancock Branch begins near the intersection of Tucker Brook Road and Route 125, continues upstream for about 1,800 feet, and ends where the river is straightened along Route 125. The majority of T8.02-A was historically straightened along its southern valley wall to create residential land on the north bank. Likely due to this historic channelization, the river has incised slightly and widened substantially. Erosion lines the banks for the majority of the segment. Development is abundant within the river corridor in T8.02-A. Toward the upstream end of T8.02-A, major aggradation occurred during Tropical Storm Irene that created a sediment plug in the channel. This filling in of the channel caused the river to avulse and cut a new channel on the inside of a meander bend. Overall, T8.02-A is in **fair** geomorphic condition due to channel widening and alteration of planform. Habitat condition is also **fair**, as woody debris and pool features are lacking.

Figure 5.64. The Hancock Branch was straightened along its southern valley wall in T8.02-A.

T8.02-A Data Summary		Reference	Existing
Length:	1,831 ft	Confinement	Very Broad
Drainage Area:	21 sq. mi.	Stream Type	C
Evolution Stage:	F-III	Entrenchment Ratio	> 2.2
Sensitivity:	Very High	Incision Ratio	< 1.2
		Dominant Bed Material	Gravel
		Dominant Bedform	Riffle-Pool
Major Stressors:		Straightening, Erosion, Poor Buffers, Encroachments

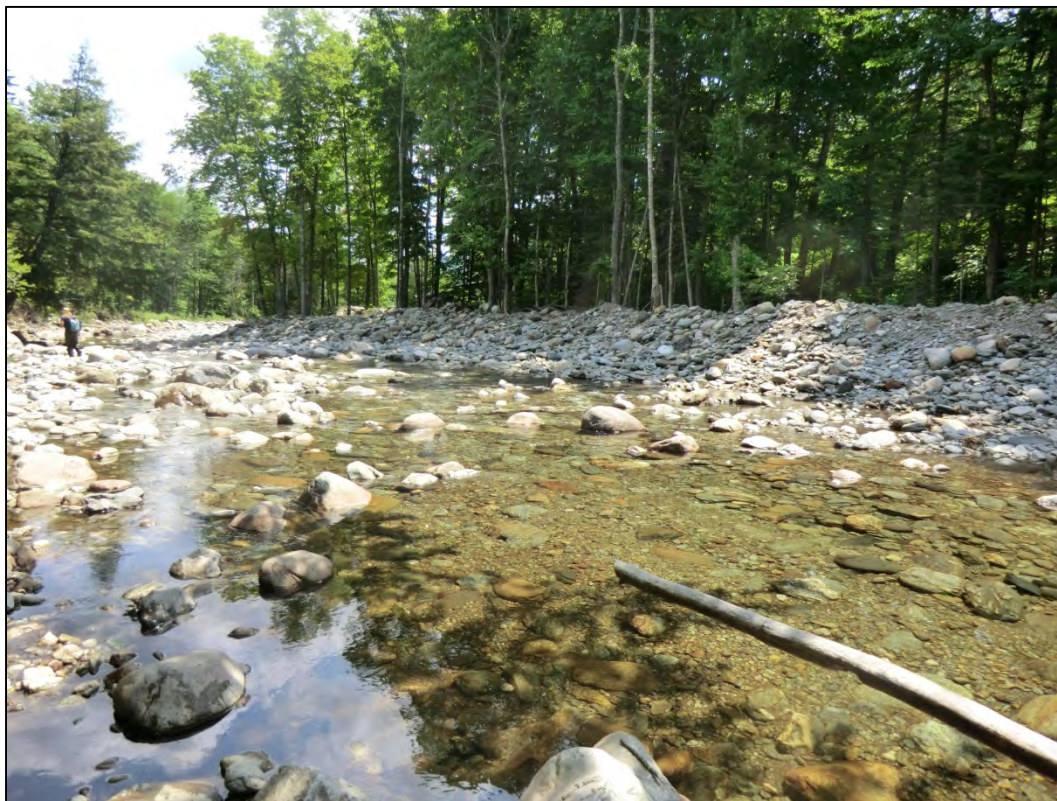
The upstream-most segment on reach two of the Hancock Branch is approximately 1,300 feet in length, beginning near 2796 Route 125 and ending upstream just above the Robbins Branch confluence. This entire segment was historically straightened along Route 125 and Texas Falls Road. Moderate historic incision has occurred in T8.02-D due to this channelization. Bank armoring is abundant along the two roads that encroach upon the Hancock Branch in this segment. The stream channel seems to have widened during Irene, but riprapping and windrowing that occurred post-flood have narrowed the channel once more. Berms are present along both sides of the stream. Geomorphic condition in T8.02-D is **fair** due to extensive historic straightening and recent windrowing. These alterations have led to a loss of bedform in this segment and conversion to a featureless, plane bed system. For this reason, habitat is also in **fair** condition.

Figure 5.67. Windrowing is common in T8.02-D.

T8.02-D Data Summary		Reference	Existing
Length: 1,294 ft Drainage Area: 21 sq. mi. Evolution Stage: F-II Sensitivity: High	Confinement	Broad	Narrow
	Stream Type	C	C
	Entrenchment Ratio	> 2.2	2.8
	Incision Ratio	< 1.2	1.5
	Dominant Bed Material	Gravel	Cobble
	Dominant Bedform	Riffle-Pool	Plane Bed
Major Stressors:	Straightening, Encroachments, Windrowing, Revetments, Stormwater Inputs

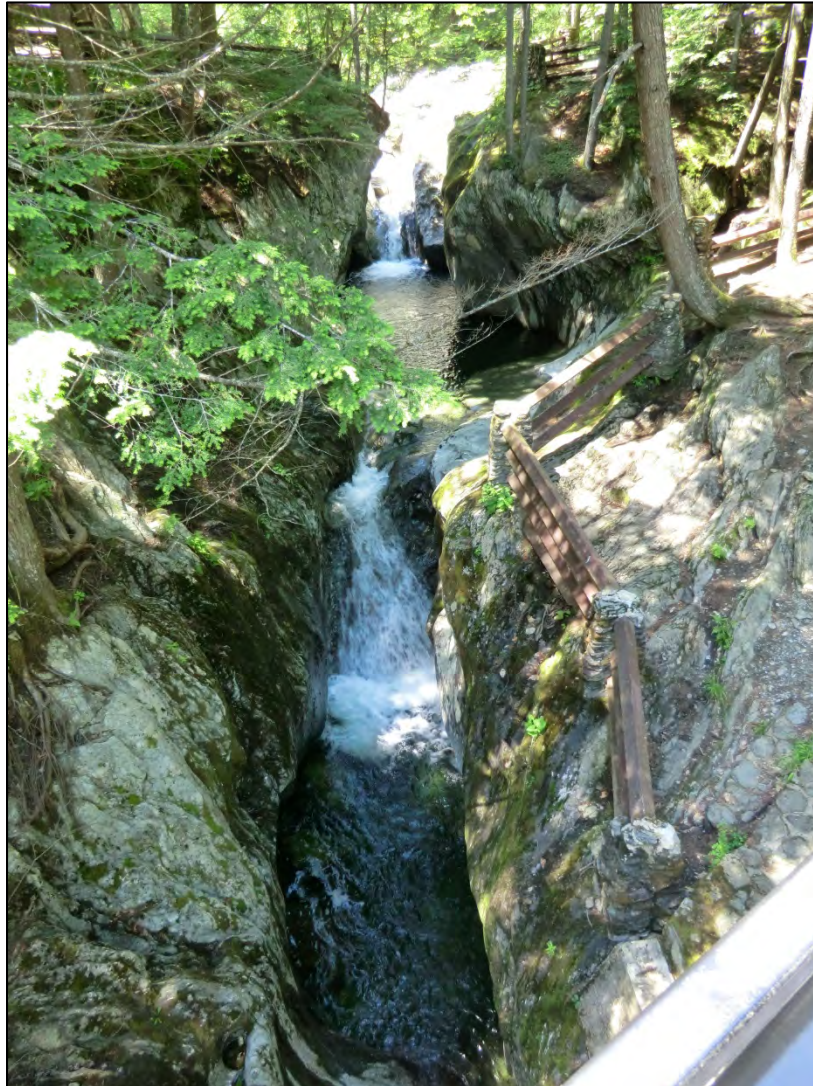
Segment B is approximately 1,000 feet in length and flows through a narrowly confined valley. The Hancock Branch forms Texas Falls as it flows through a bedrock gorge in this segment. For this reason, T8.03-B was not fully assessed for this study. Continuous bedrock on the bed and banks provide stability to the river in this segment. Qualitative observations taken in the field suggest that this segment is in **reference** geomorphic condition.

Figure 5.69. T8.03-B contains the renowned Texas Falls.

T8.03-B Data Summary		*NOT ASSESSED	Reference	Existing
Length:	1,053 ft	Confinement	Narrowly Confined	Narrowly Confined
Drainage Area:	9 sq. mi.	Stream Type	A	A
Evolution Stage:	N/A	Entrenchment Ratio	< 1.4	N/A
Sensitivity:	N/A	Incision Ratio	< 1.2	N/A
		Dominant Bed Material	Bedrock	Bedrock
		Dominant Bedform	Cascade	Cascade
Major Stressors:		None

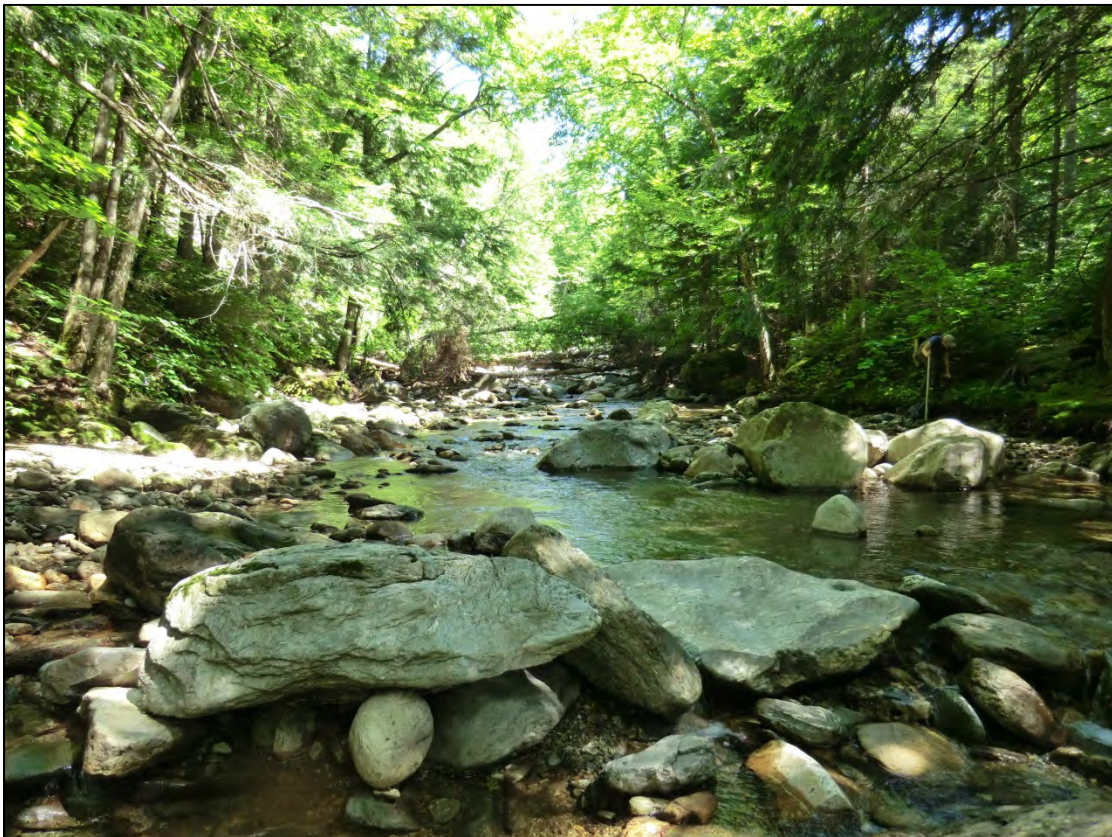
The upstream-most segment included in this assessment begins at the top of Texas Falls and continues upstream for 3,200 feet. It flows through Green Mountain National Forest Land, which includes a campground. The river has a mostly natural planform, except for small areas where it has been straightened along Texas Falls Road. Hancock Branch flows through a very broad valley, but is naturally entrenched between a high terrace and the western valley wall. The river has not incised despite areas of historic straightening. During Irene, the river aggraded and avulsed just above the Texas Falls Road Bridge in T8.03-C, flowing across the road and destroying a section of it. After Irene, the river was set back to its original path, riprapped, and bermed to prevent it from taking that course again. Overall, the segment is in **good** geomorphic condition due to its stability and lack of adjustment throughout most of the segment. Habitat is also in **good** condition, as the Hancock Branch has minimal human impacts in this area.

Figure 5.70. T8.03-C flows through the Green Mountain National Forest and has very few human impacts.

T8.03-C Data Summary		Reference	Existing
Length:	3,243 ft	Confinement	Very Broad
Drainage Area:	9 sq. mi.	Stream Type	F _b
Evolution Stage:	F-I	Entrenchment Ratio	< 1.4
Sensitivity:	High	Incision Ratio	< 1.2
		Dominant Bed Material	Cobble
		Dominant Bedform	Riffle-Pool
Major Stressors:		Encroachments, Revetments, Erosion, Straightening

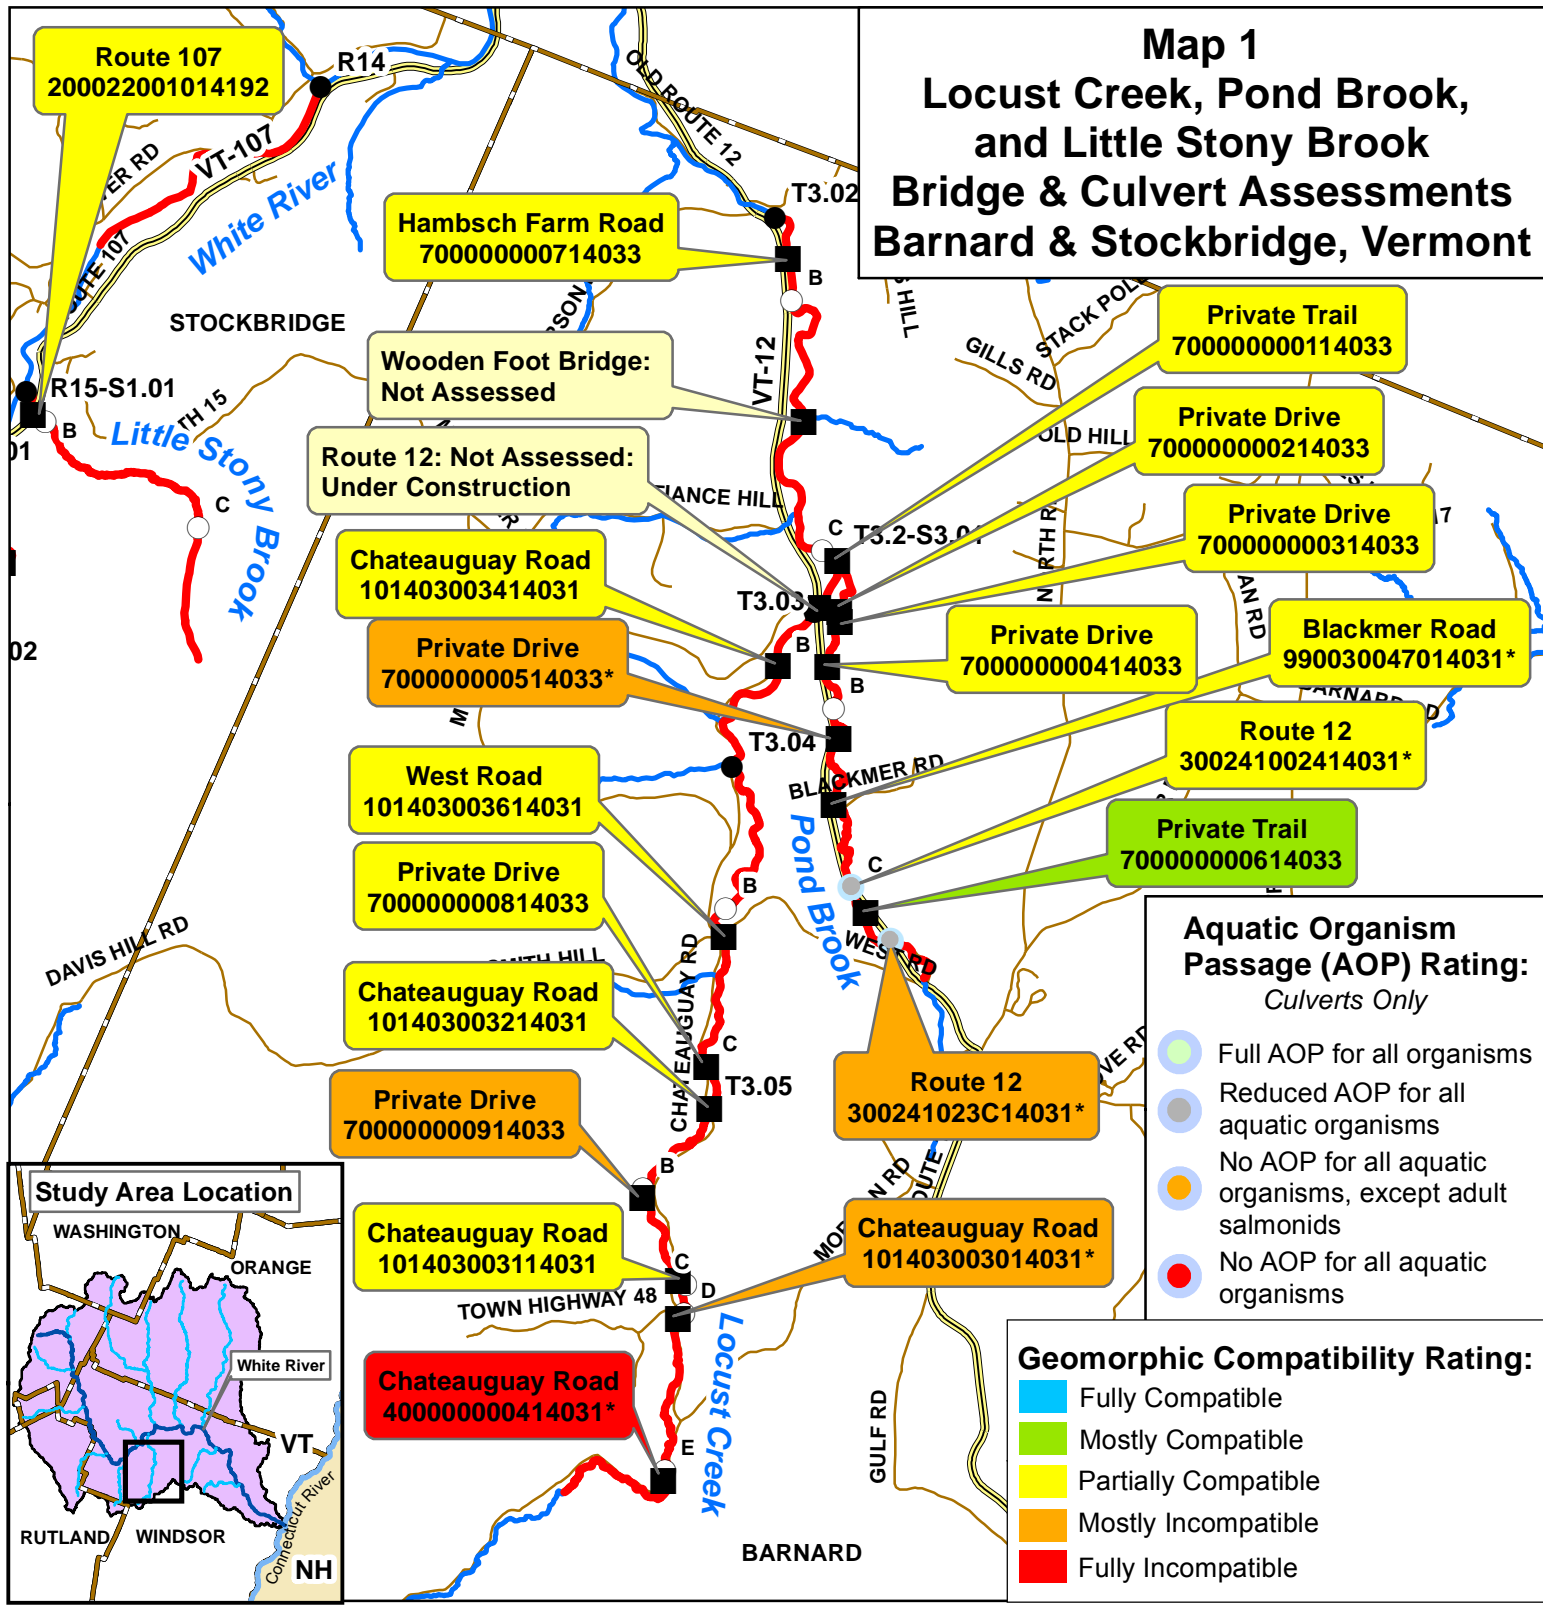
Map 1 Locust Creek, Pond Brook, and Little Stony Brook Bridge & Culvert Assessments Barnard & Stockbridge, Vermont

T3.2-S3.01-A (Map 1)	Barnard	Private Drive	70000000414033	23/29.9 = 77	Fair condition. Scour under right abutment. Failing riprap and rusting I-beams.	3	5	2 Channelized Straight	0	10	Partially Compatible	Moderate (Slightly undersized, fair condition and abutment scour)
T3.2-S3.01-B (Map 1)	Barnard	Private Drive	70000000514033	14.5/29.9 = 48	Poor condition. Scour around both abutments upstream. Channel windrowed/dredged downstream. Material was left piled on bank (no berm). Deposition above.	1	4	2 Channelized Straight	0	7	Mostly Incompatible	High (Significantly undersized, poor condition, scour around abutments)
T3.2-S3.01-B (Map 1)	Barnard	Blackmer Road	990030047014031	13.9/29.9 = 46	Very undersized. Alignment is not ideal but overall good condition.	1	5	3 Mild Bend	3	12	Partially Compatible	High (Significantly undersized, poor alignment)
T3.2-S3.01-C (Map 1)	Barnard	Private Trail	70000000614033	23.5/29.9 = 79	Bridge access to hayfield. New decking. Deposition below.	3	5	3 Mild Bend	3	14	Mostly Compatible	Low (Slightly undersized)

T3.02-A (Map 1)	Barnard	Hamsch Farm Road	70000000714033	36/50.8 = 71	Good condition. Scour on western bank abutment. Side bar inside and downstream of structure.	2	5	2 Channelized Straight	0	9	Partially Compatible	Low (Good condition, slightly undersized, abutment scour, deposition)
T3.03-A (Map 1)	Barnard	Chateauguay Road	101403003414031	29/38.4 = 76	Steep riffle and pool with sand and silt. West bank abutment and wing wall scour. Except for the scour, bridge in good condition. Mass failure on downstream western bank resulting in bare vegetation. Stormwater input from overland flow on all sides of structure. Poor alignment and deposition above and below.	3	1	5 Naturally Straight	0	9	Partially Compatible	Moderate (Slightly undersized, scour around abutments and wing wall, mass failure downstream)
T3.04-B (Map 1)	Barnard	West Road	101403003614031	26/34.4 = 76	Boulder weir just downstream of structure. Pool inside structure. Weir creates another pool downstream. Scour around upstream abutment.	3	5	3 Mild Bend	1	12	Partially Compatible	Moderate (Slightly undersized, abundant erosion and abutment scour upstream)

T3.04-C (Map 1)	Barnard	Private Drive	70000000814033	29/34.4 = 84	Bridge in adequate condition but cement blocks are being used for abutments. Structure may not hold out for long term. Deposition above.	3	4	2 Channelized Straight	3	12	Partially Compatible	Moderate (Good condition but needs stronger abutments, slightly undersized)

T3.05-B (Map 1)	Barnard	Chateauguay Road	101403003114031	17/29.4 = 58	Good condition. Large avulsion from TSI enters above bridge. Floodplain was bermed to put channel back to its original place. Deposition above and below. Scour below.	2	4	2 Channelized Straight	4	12	Partially Compatible	Moderate (Undersized but in good condition, geomorphically unstable upstream)
T3.05-D (Map 1)	Barnard	Chateauguay Road	101403003014031	20/29.4 = 68	Good condition overall but scour under western downstream abutment and wing wall. Riprap in bed within the structure. Headcut in structure. Poor alignment.	2	4	0 Sharp Bend	0	6	Mostly Incompatible	High (Good condition but undersized, poor alignment, head cut present)
T3.05-E (Map 1)	Barnard	Chateauguay Road	40000000414031	13/29.4 = 44	Significantly undersized. Bridge built on bedrock grade control. Scour on western abutment. Log landing adjacent to eastern side. I-beams rusting and in fair condition. Poor alignment and major aggradation above.	1	3	0 Sharp Bend	0	4	Fully Incompatible	High (Fair condition, significantly undersized, major aggradation)

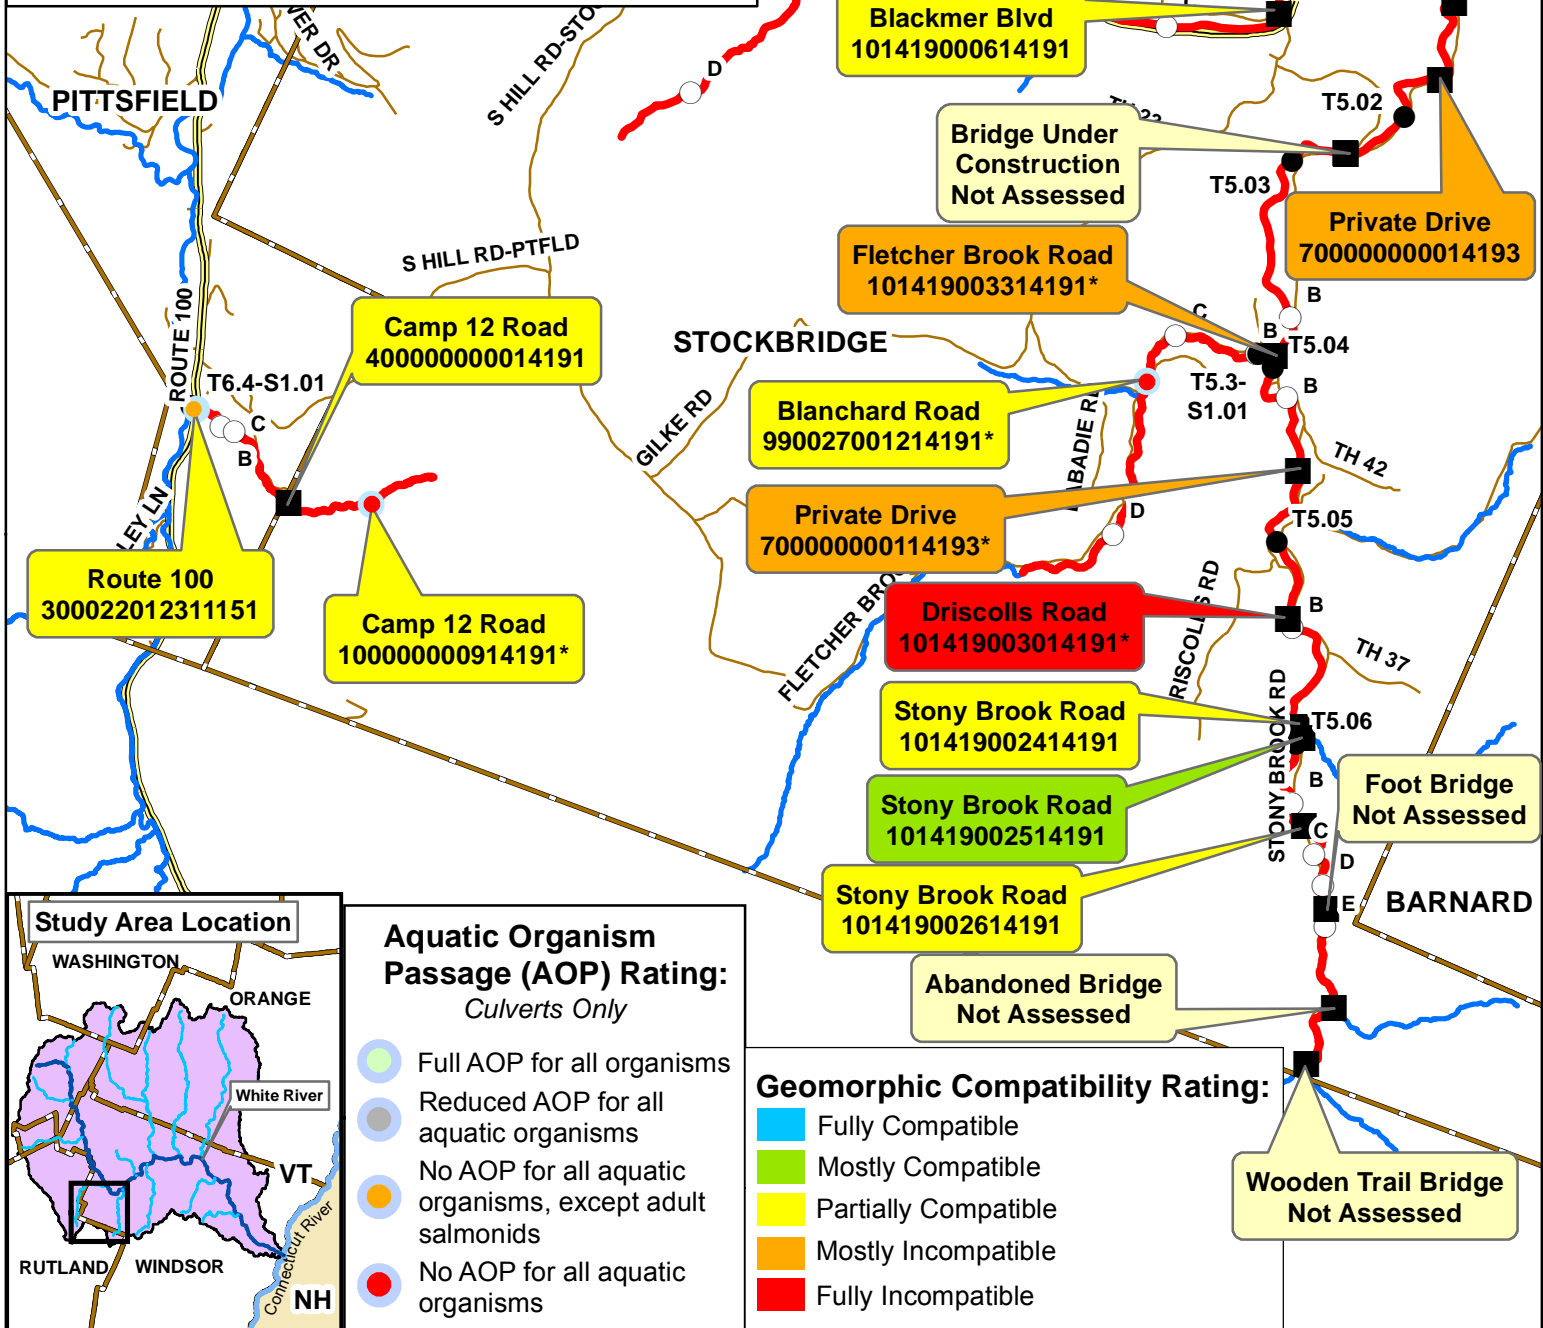
Map 2 White River, Stony Brook, Fletcher Brook, and Johnson Brook Bridge & Culvert Assessments Stockbridge, Vermont

T5.01-A (Map 2)	Stockbridge	Route 107	20002200914192	63/52.3 = 120	New structure built high on valley walls. Riprap creating constriction; bridge span is 135 feet, but riprap width is 63 feet causing constriction. Some stormwater inputs around structure.	5	3	2 Channelized Straight	1	11	Partially Compatible	Not recommended for replacement
T5.01-B (Map 2)	Stockbridge	Stony Brook Road	101419000514191	43.5/52.3 = 83	New bridge. Was washed out during TSI.	3	4	5 Naturally Straight	4	16	Mostly Compatible	Low (Slightly undersized, new construction)
T5.01-B (Map 2)	Stockbridge	Private Drive	700000000014193	37.5/52.3 = 72	New wooden decking. Most likely washed out during TSI. Bedrock on abutment on western bank. Constriction is 37.5 feet from bedrock on one side.	2	2	3 Mild Bend	0	7	Mostly Incompatible	Moderate (Decking most likely washed out during TSI, scour on abutment)
T5.03-B (Map 2)	Stockbridge	Fletcher Brook Road	101419003314191	33/50.7 = 65	Fair condition. Scour on eastern bank wing wall/abutment. Located just below confluence with Fletcher Brook. Large depositional features including delta bar from Fletcher Brook, which is not due to bridge. Western bank approach is in good condition but is severely constricting. Stony Brook overtopped the bridge during TSI and washed out Fletcher Brook Road to the west.	2	1	5 Naturally Straight	0	8	Mostly Incompatible	High (Undersized, fair condition, scour on abutment and wing wall, overtopped during TSI)

T5.05-B (Map 2)	Stockbridge	Stony Brook Road	101419002414191	35/36 = 97	Localized severe bank erosion on east side below bridge (riprap has failed). Minor deposition above.	3	4	5 Naturally Straight	0	12	Partially Compatible	Low (Slightly undersized, failed riprap)
T5.05-B (Map 2)	Stockbridge	Stony Brook Road	101419002514191	33/36 = 92	Riprap unstable below bridge (not intact). No other problems noted.	4	4	5 Naturally Straight	0	13	Mostly Compatible	Not recommended for replacement
T5.06-B (Map 2)	Stockbridge	Stony Brook Road	101419002614191	28/31.8 = 88	Bridge in good condition (fairly new). Very little riprap protecting wing walls. Large mass failure just upstream. Low clearance.	3	4	2 Channelized Straight	1	10	Partially Compatible	Low (Good condition, slightly undersized, low clearance)
T6.4-S1.01-C (Map 2)	Stockbridge	Camp 12 Road	400000000014191	12/24.1 = 50	Span is 21 feet but riprap in structure is constricting the channel to 12 feet. Good condition other than riprap failing.	2	5	3 Mild Bend	0	10	Partially Compatible	Moderate (Undersized but in good condition)

T6.4-S1.01-A (Map 2)	Pittsfield	Route 100	300022012311151	14.5/24.1 = 60	Deposition and scour below. Outlet perched 0.2 feet. Culvert in good condition.	2	2	5	3 Mild Bend	0	12	Partially Compatible	No AOP except adult salmonids	Moderate (Good condition but undersized and slightly perched)
T5.3-S1.01-C (Map 2)	Stockbridge	Blanchard Road	990027001214191	16/30.3 = 53	Significant outlet drop (1.8 feet) causing a barrier to aquatic organism passage. Slight alignment problem. Flow undermining wing wall on northern downstream side. Overall good condition. Deposition below.	2	4	2	3 Mild Bend	0	11	Partially Compatible	No AOP including adult salmonids	High (Good condition but significant outlet drop and undersized)
T6.4-S1.01-C (Map 2)	Stockbridge	Camp 12 Road	10000000914191	5/24.1 = 21	Structure problematic with aquatic organism passage due to 0.8 foot freefall. Significantly undersized. Deposition above and below.	0	3	5	2 Channelized Straight	0	10	Partially Compatible	No AOP including adult salmonids	High (Significantly undersized and no AOP)
