Upper & Middle White River Watershed Corridor Plan

Barnard, Hancock, Pittsfield, Rochester, and
Stockbridge, Vermont
July 15, 2015

Prepared by:
Bear Creek Environmental, LLC
149 State Street, Suite 3
Montpelier, Vermont 05602

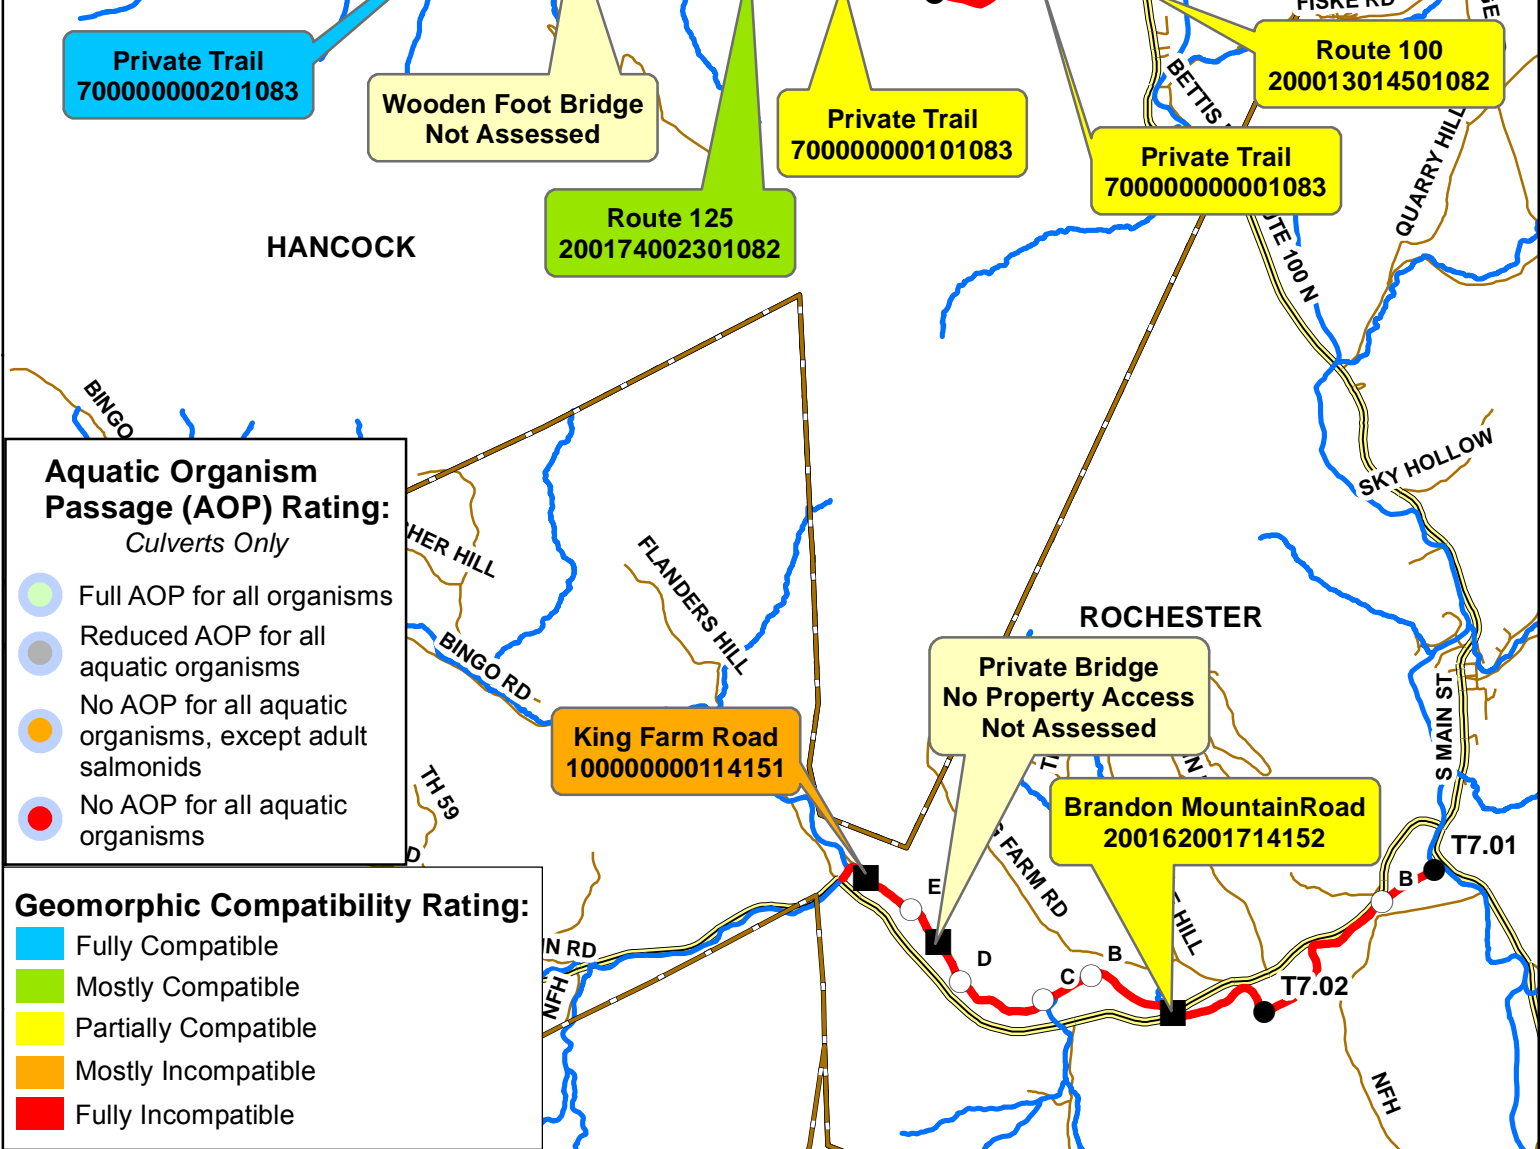
Map 3 Hancock Branch and West Branch White River Bridge & Culvert Assessments Hancock and Rochester, Vermont

T8.01-A (Map 3)	Hancock	Route 100	200013014501082	51/51.3 = 99	Very low clearance. Bermed and windrowed heavily upstream and downstream. If channel avulses around structure homes are vulnerable in residential area. Rusty I-beams but intact. Scour around the decking.	3	4	2 Channelized Straight	2	11	Partially Compatible	Moderate (Low clearance, homes in area are vulnerable)
T8.01-B (Map 3)	Hancock	Private Trail	70000000001083	70/51.3 = 136	Footbridge for Camp Killoleet. Remnants of old Killoleet Dam is 125 feet upstream of structure. Fairly new structure with extensive windrowing and riprap. Channel filled in with large side bar between center pier and northern abutment.	5	4	2 Channelized Straight	4	15	Mostly Compatible	Moderate (Good condition, adequate size, but major aggradation between pier and abutment)
T8.02-B (Map 3)	Hancock	Private Trail	700000000101083	56/50 = 112	Old rusty I-beams. Abutments unstable. New riprap. Stream ford below bridge. No major geomorphic problems noted.	4	5	2 Channelized Straight	0	11	Partially Compatible	Low (Rusty I-beams and unstable abutments but adequately sized)

T7.02-E (Map 3)	Rochester	King Farm Road	100000000114151	36/67.8 = 53	Northern bank abutment on bedrock. This concrete abutment is scoured. Steel structure is rusted but still intact. Structure rebuilt after TSI. Span is 57 feet but constriction width is 36 due to bedrock and riprap.	2	2	2 Channelized Straight	0	6	Mostly Incompatible	Moderate (Undersized and abutment scour but stable on bedrock)
R15-S1.01-A (Map 1)	Stockbridge	Route 107	200022001014192	27/18.7 = 144	Significant scour on western downstream abutment. Deterioration and cracking of eastern abutment. Fair condition. Bridge was likely plugged with sediment after Irene. Span is 27 feet at riprap and 34.8 feet at abutments. Deposition above and below and poor alignment.	5	2	3 Mild Bend	1	11	Partially Compatible	Low (Not undersized, fair condition)
R16-B (Map 2)	Stockbridge	Blackmer Blvd	101419000614191	120/134 = 90	Scour on northern pier. Bedrock on upstream northern bank protects abutment. Fairly new bridge with very deep pool underneath it due to bedrock. Sharp turn just upstream of structure. Road embankment on upstream northern bank eroded severely during TSI and has since been armored. Bridge span is 180 feet but constriction width is 120 feet due to piers.	5	4	0 Sharp Bend	1	10	Partially Compatible	Low (Slightly undersized, poor alignment)

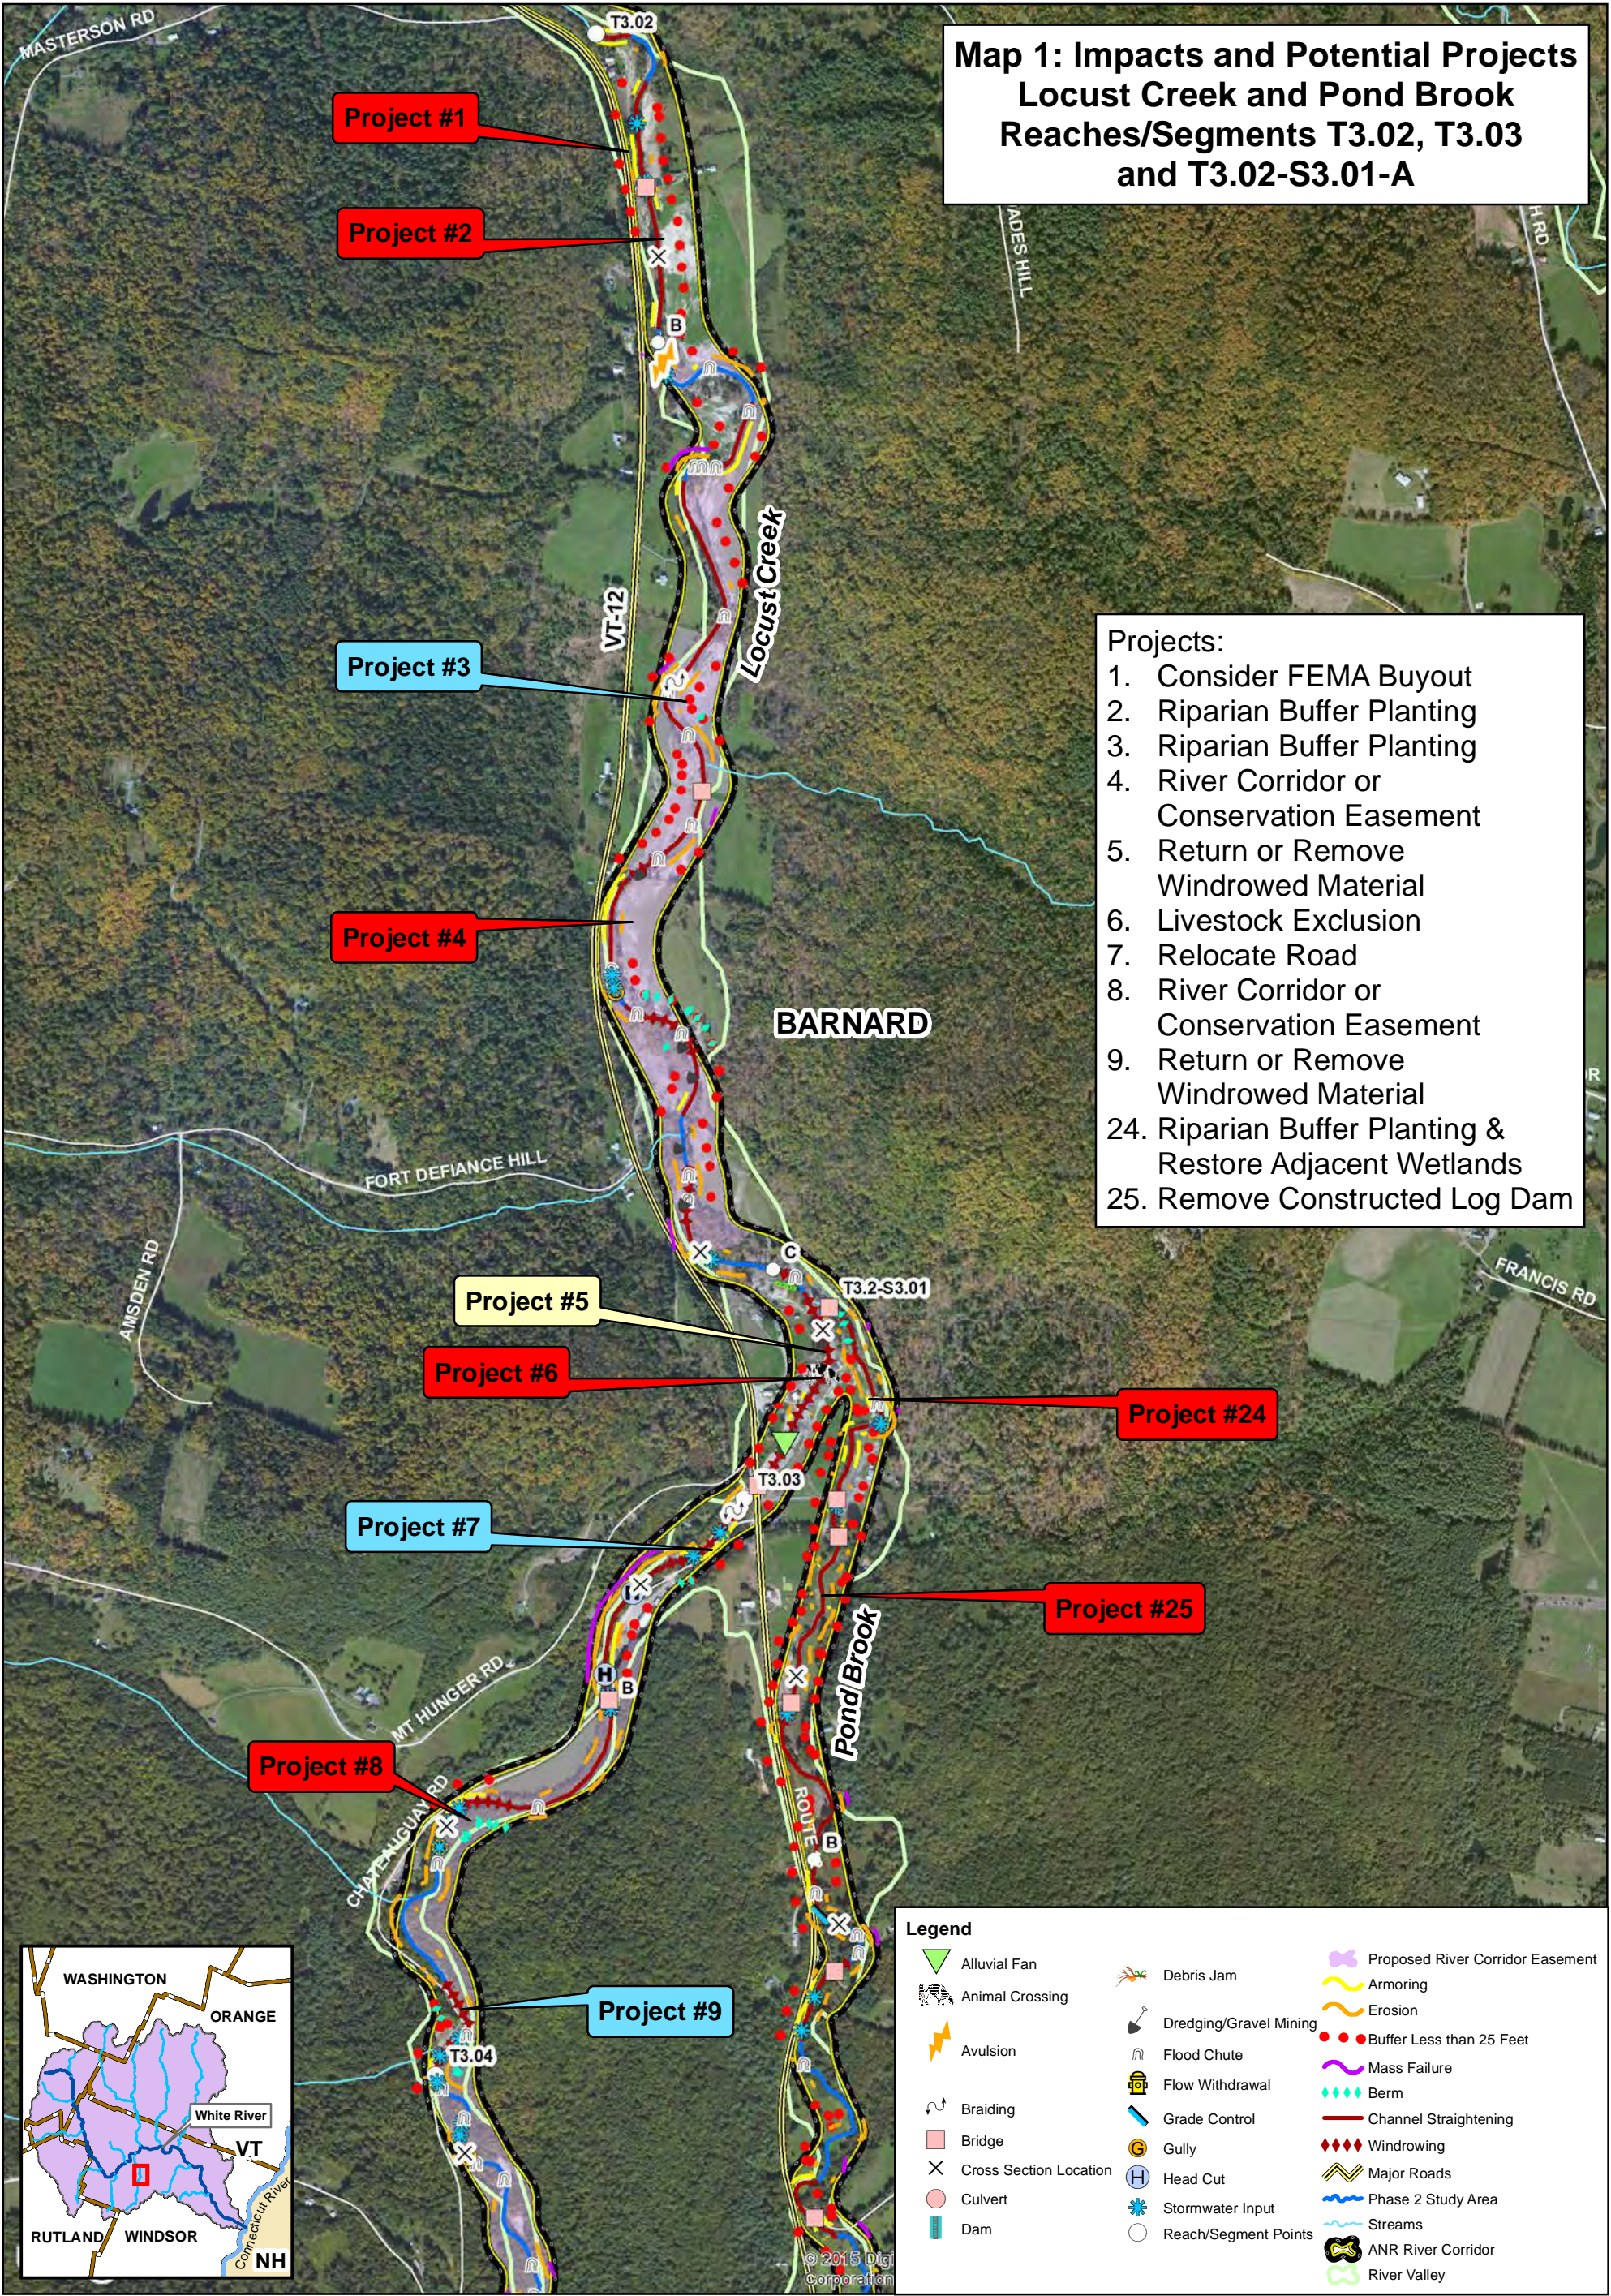
**Map 1: Impacts and Potential Projects
Locust Creek and Pond Brook
Reaches/Segments T3.02, T3.03
and T3.02-S3.01-A**

Single family dwelling is located on the western bank of Locust Creek between the stream and Route 12. The creek is widening in this location and the house is at risk of damage/destruction due to fluvial erosion.
Project #2 T3.02-A (Refer to Map 1)	Floodplain Improvement and Conservation	Riparian Buffer Planting	Locust Creek	Barnard	Along eastern bank throughout segment	High

All of this section of the creek was windrowed post-Irene, excavating the channel and creating gravel berms. This section is an alluvial fan, which is important for floodwater and sediment attenuation. Restoring floodplain access here would increase flood storage. Several buildings exist on the western bank of the creek in this section, which could be damaged if material is returned to the channel.

Lower Chateauguay Road is a significant channel encroachment to Locust Creek. Its presence has caused a loss of floodplain access and geomorphic instability. Investigate road relocation - could be relocated to run along southern valley wall, which would remove encroachment and open up a large potential floodplain.

- Projects:**
1. Consider FEMA Buyout
 2. Riparian Buffer Planting
 3. Riparian Buffer Planting
 4. River Corridor or Conservation Easement
 5. Return or Remove Windrowed Material
 6. Livestock Exclusion
 7. Relocate Road
 8. River Corridor or Conservation Easement
 9. Return or Remove Windrowed Material
 24. Riparian Buffer Planting & Restore Adjacent Wetlands
 25. Remove Constructed Log Dam

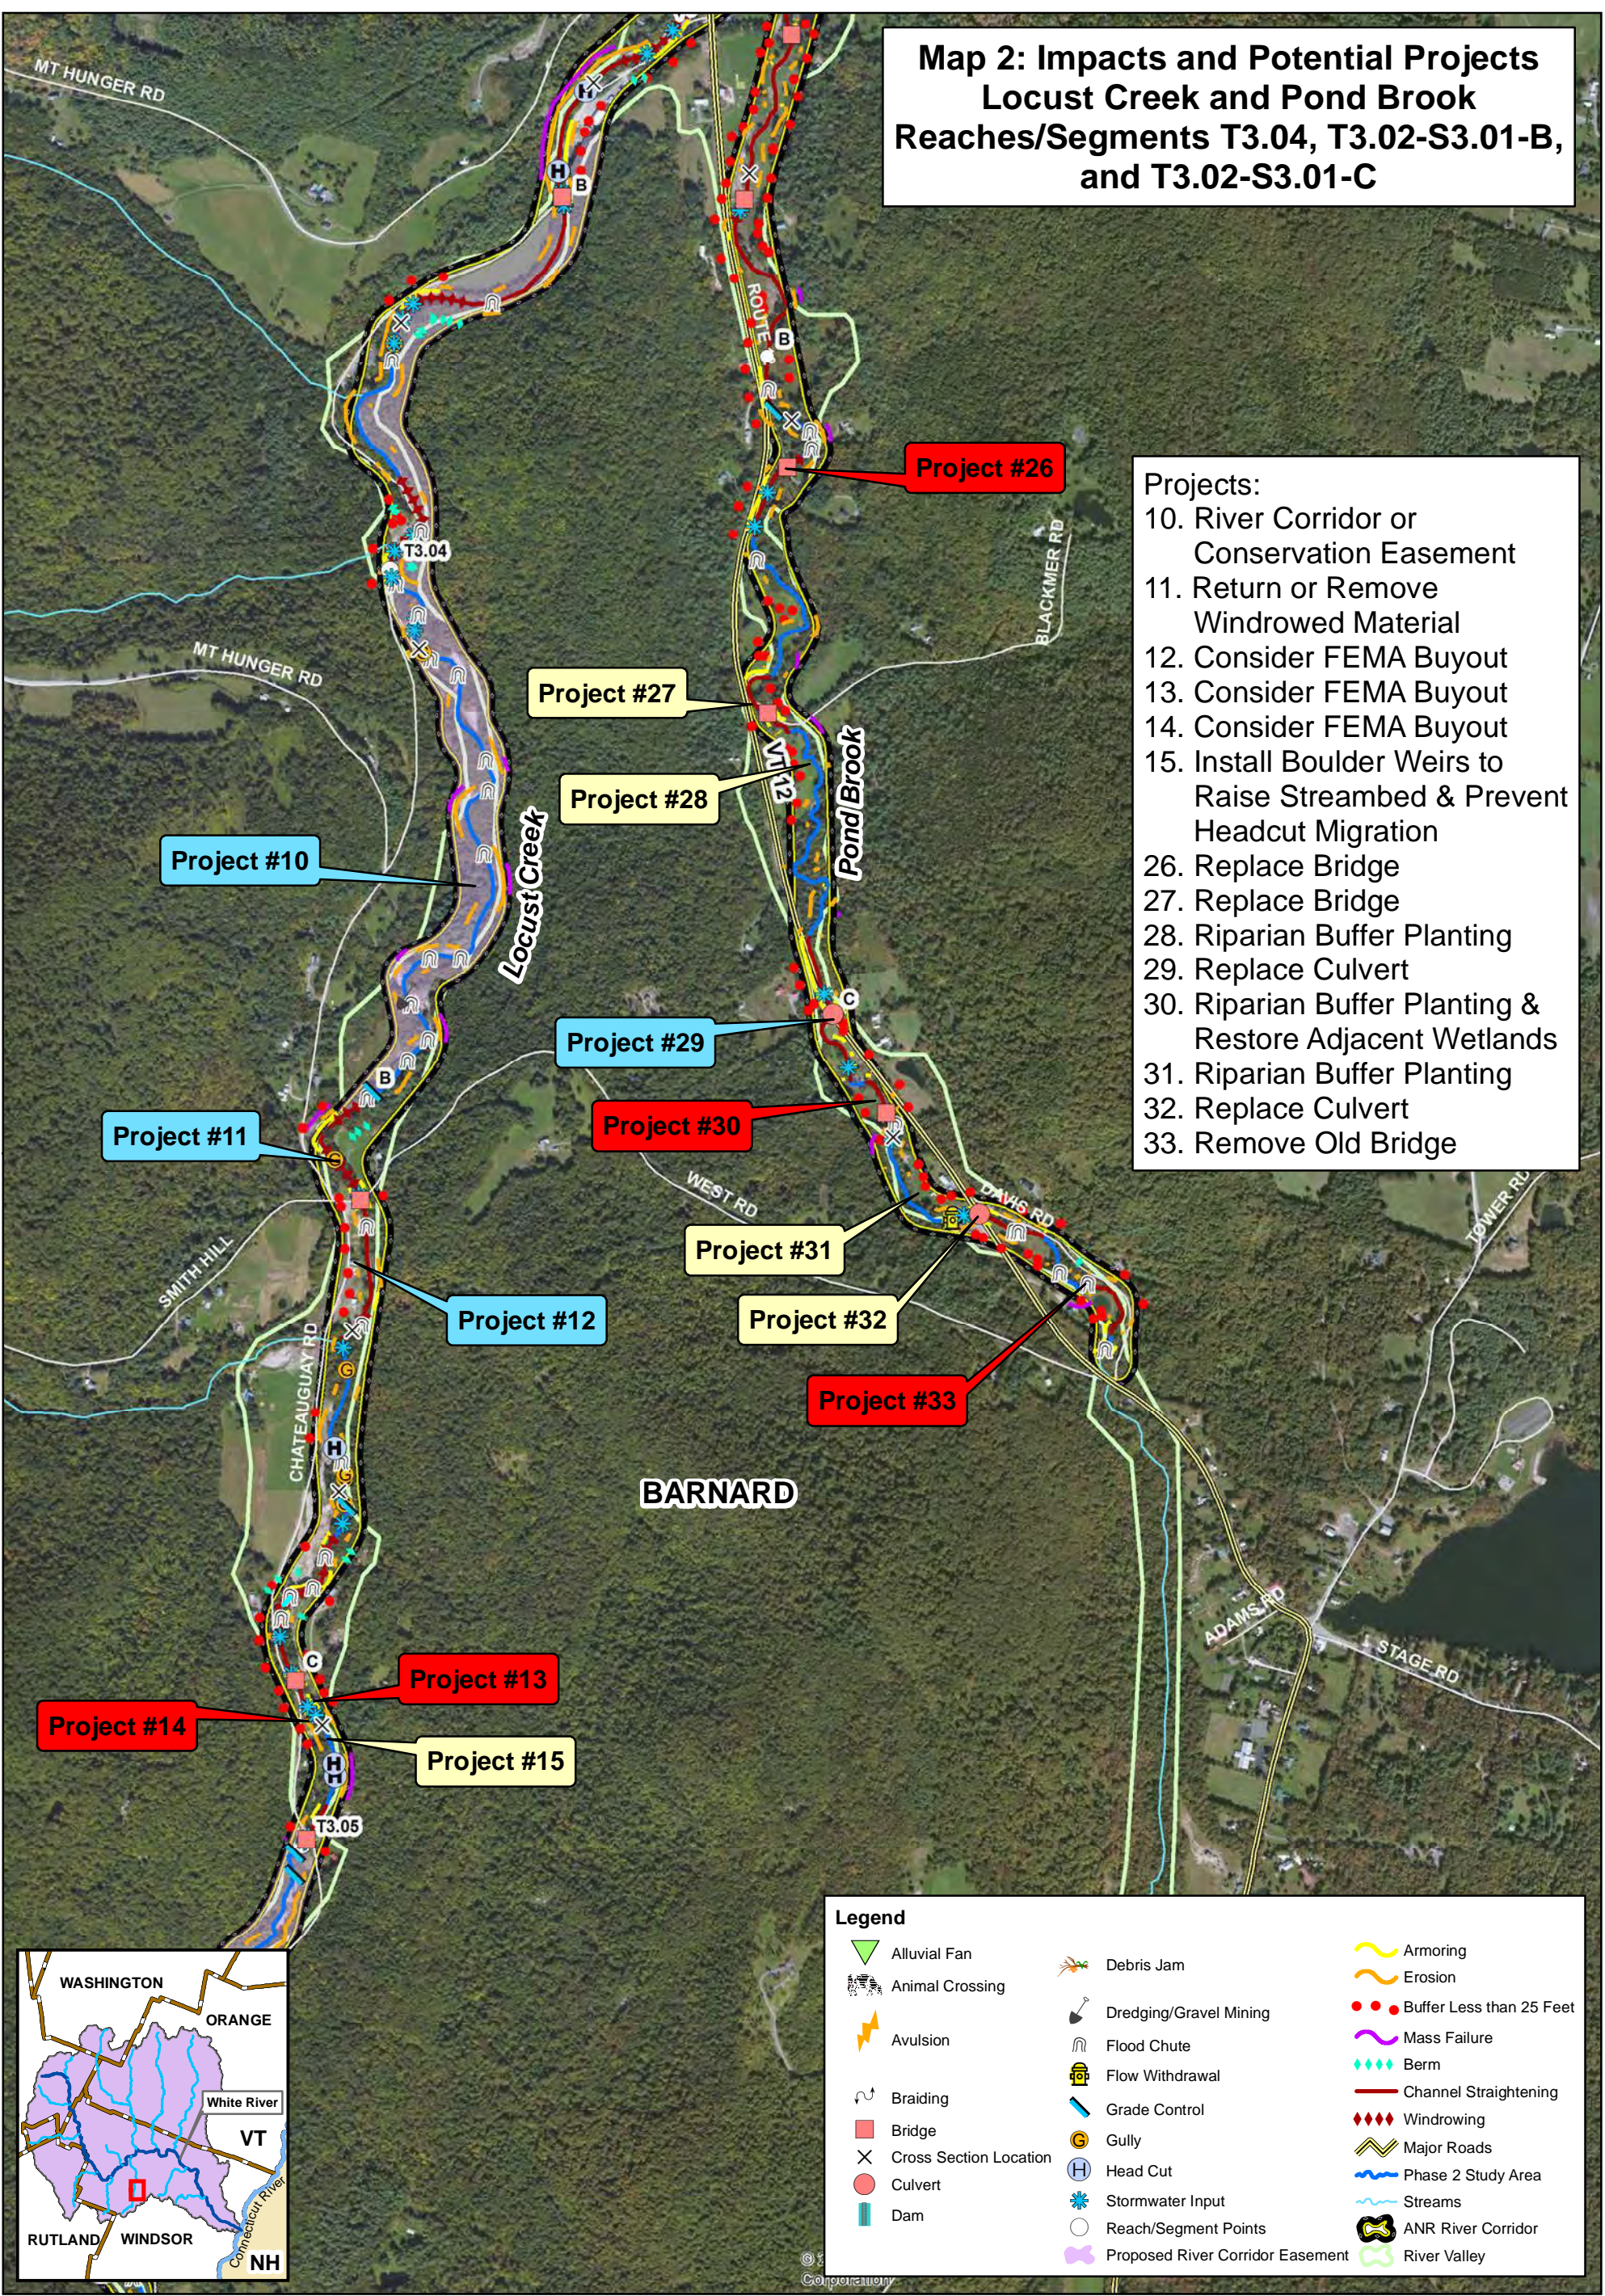
**Map 2: Impacts and Potential Projects
Locust Creek and Pond Brook
Reaches/Segments T3.04, T3.02-S3.01-B,
and T3.02-S3.01-C**

Project #26 T3.2-S3.01-B (Refer to Map 2)	Structure Replacement/ Removal	Replace Bridge	Pond Brook	Barnard	Private Drive to 7854 & 7856 VT Route 12	High	○	○	●	●	The bridge is a major channel constriction and is in poor condition. Aggradation was windrowed in vicinity of bridge post-Irene.
Project #27 T3.2-S3.01-B (Refer to Map 2)	Structure Replacement/ Removal	Replace Bridge	Pond Brook	Barnard	On Blackmer Road near intersection with Route 12	Low	○	○	●	●	Bridge is very undersized and has poor channel alignment. Bridge is in good condition.

Project #33 T3.2-S3.01-C (Refer to Map 2)	Structure Replacement/ Removal	Remove Old Bridge	Pond Brook	Barnard	Near 6714 Route 12	High	◐	○	●	◐	An abandoned bridge across the brook exists and is creating a channel constriction.
Project #34 R14 (Refer to Map 4)	Floodplain Improvement and Conservation	Riparian Buffer Planting and River Corridor Easement	White River	Stockbridge	At 1340 River Road	Moderate	◐	◐	●	◐	Large parcel of land is located on the inside of a meander bend. Good floodplain access; large amounts of sediment deposited in field during Irene. There is an open-air roofed shelter on property within river corridor.
Project #35 R14 (Refer to Map 4)	Public Safety Improvement	Consider FEMA Buyout	White River	Stockbridge	5321-5361 Route 107	Moderate	◐	◐	●	●	A single family dwelling at 5361 Route 107 was destroyed during Irene. The single family dwelling next door at 5321 Route 107 appears to be at high risk of damage/destruction during flooding.

- Projects:**
- 10. River Corridor or Conservation Easement
 - 11. Return or Remove Windrowed Material
 - 12. Consider FEMA Buyout
 - 13. Consider FEMA Buyout
 - 14. Consider FEMA Buyout
 - 15. Install Boulder Weirs to Raise Streambed & Prevent Headcut Migration
 - 26. Replace Bridge
 - 27. Replace Bridge
 - 28. Riparian Buffer Planting
 - 29. Replace Culvert
 - 30. Riparian Buffer Planting & Restore Adjacent Wetlands
 - 31. Riparian Buffer Planting
 - 32. Replace Culvert
 - 33. Remove Old Bridge

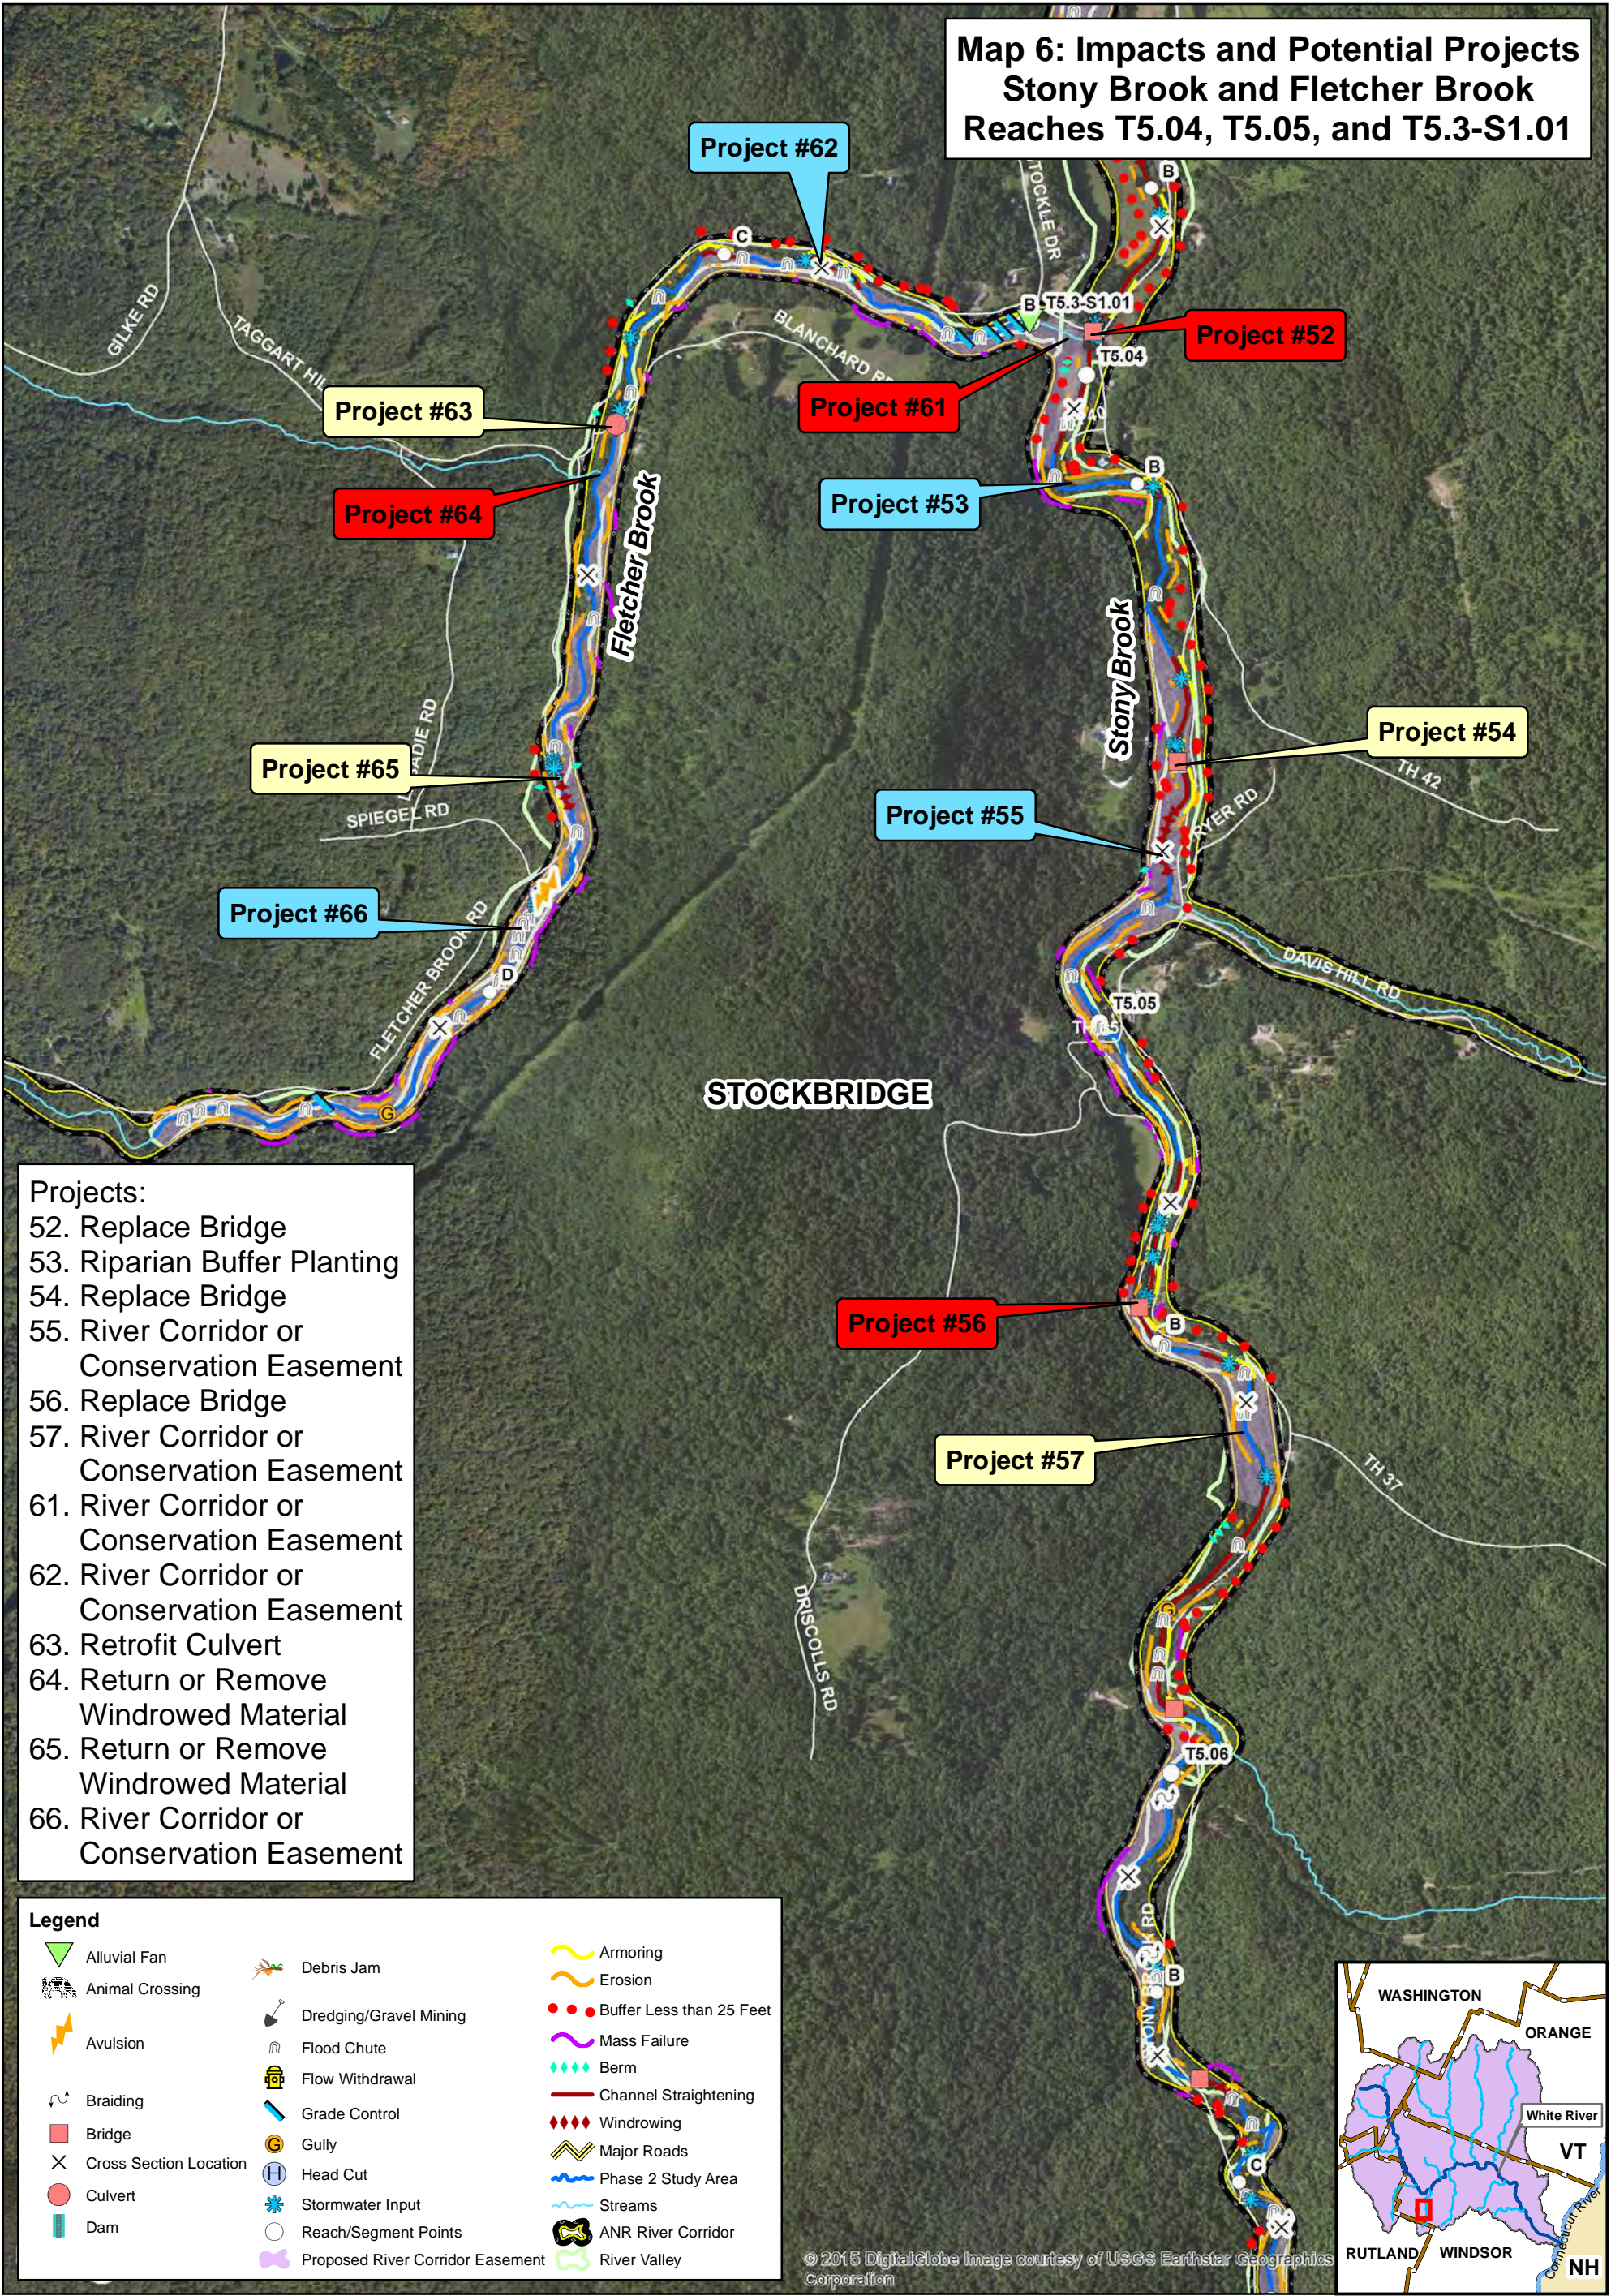
**Map 6: Impacts and Potential Projects
Stony Brook and Fletcher Brook
Reaches T5.04, T5.05, and T5.3-S1.01**

Windrowed sections have gravel berms restricting floodplain access. Landowner is interested in potential projects.
Project #52 T5.03-B (Refer to Map 6)	Structure Replacement/ Removal	Replace Bridge	Stony Brook	Stockbridge	On Fletcher Brook road just west of intersection with Stony Brook Road	High

Riparian buffer is lacking on eastern bank. Landowner indicated interest in potential projects.
Project #54 T5.04-B (Refer to Map 6)	Structure Replacement/ Removal	Replace Bridge	Stony Brook	Stockbridge	Private drive to 3222 Stony Brook Road	Low

Project #56 T5.05-A (Refer to Map 6)	Structure Replacement/ Removal	Replace Bridge	Stony Brook	Stockbridge	Driscolls Road bridge just west of intersection with Stony Brook Road	High

- Projects:**
- 52. Replace Bridge
 - 53. Riparian Buffer Planting
 - 54. Replace Bridge
 - 55. River Corridor or Conservation Easement
 - 56. Replace Bridge
 - 57. River Corridor or Conservation Easement
 - 61. River Corridor or Conservation Easement
 - 62. River Corridor or Conservation Easement
 - 63. Retrofit Culvert
 - 64. Return or Remove Windrowed Material
 - 65. Return or Remove Windrowed Material
 - 66. River Corridor or Conservation Easement

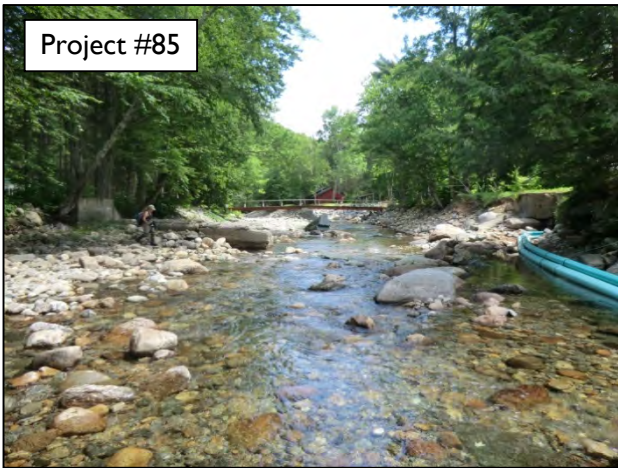
This section of the river is extremely incised and lacks strong bedform and habitat features. Building it up and installing woody debris could increase floodplain access and create more diverse channel features.
Project #85 T8.01-B (Refer to Map 11)	Structure Replacement/Removal	Remove Destroyed Dam	Hancock Branch White River	Hancock	At Camp Killololet	High
