SECOND BRANCH WHITE RIVER WATERSHED

STREAM GEOMORPHIC ASSESSMENT and RIVER CORRIDOR PLAN

March 19, 2021

Prepared by:
Daniel Ruddell, Christian Pelletier,
Greg Russ and Mary Russ,
White River Partnership

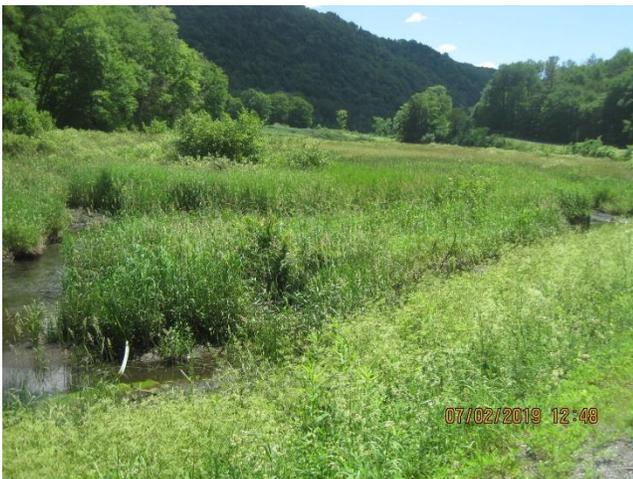
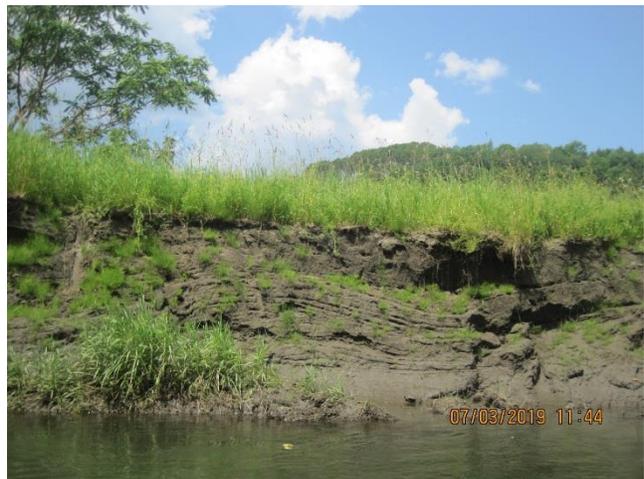
Figure 12. Small, anabranching channels and extensive vegetated wetlands like those in currently beaver-occupied portions of reaches M16 and M17 (left) are likely closer to pre-European settlement conditions along much of the Second Branch than the incised single-thread channel in M03 (right), upstream of the now-removed Stoughton Mills/Royalton-5 dam in North Royalton.

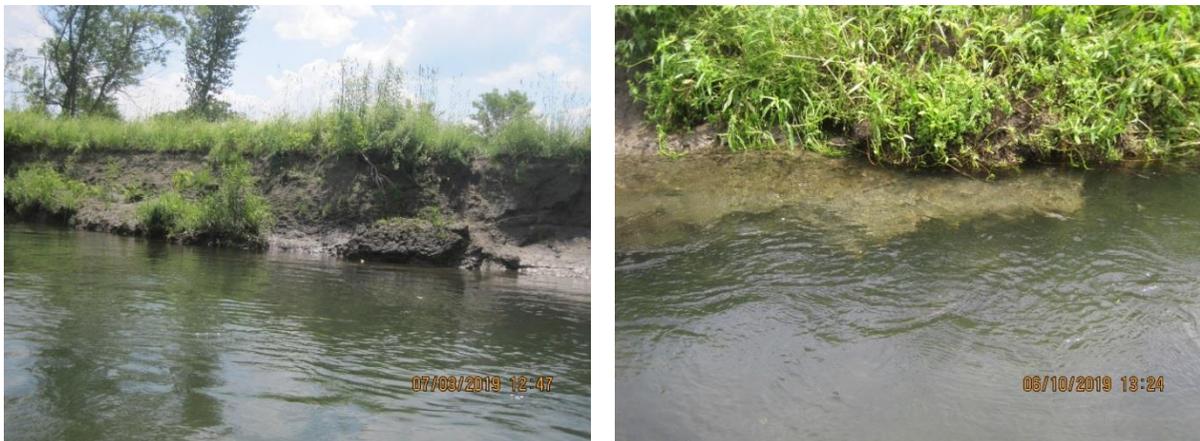
Along the Second Branch mainstem the sediment regime is closely tied to the preponderance of fine sediments left behind by glacial Lake Hitchcock. Even with areas influenced by gravel from kame terraces (reaches M01, M02, M08, M11) and valley train gravels (M14), every representative cross-section measured in Phase 2 assessment showed a cumulative particle distribution (D50) of sediments equivalent to fine gravel or smaller. With few grade controls present, the historically straightened, single thread channel has cut down into these fine sediments and exposed glacial lacustrine soils (especially downstream from reach M11 in North Randolph to the mouth in North Royalton) or buried former wetland soils in numerous areas, prominently in upstream reaches where beavers are active currently and were likely extensive pre-European settlement (Fig. 15).

Figure 15. Left: Cohesive silty clays indicating lake bottom (glaciolacustrine) soils underlie coarser alluvial sediments backed up behind the former Stoughton Mills/Royalton-5 dam in reach M03. Right: Cohesive, mottled organic soils in reach M14 likely indicate former wetlands similarly overlain by alluvium but not impounded by a dam.

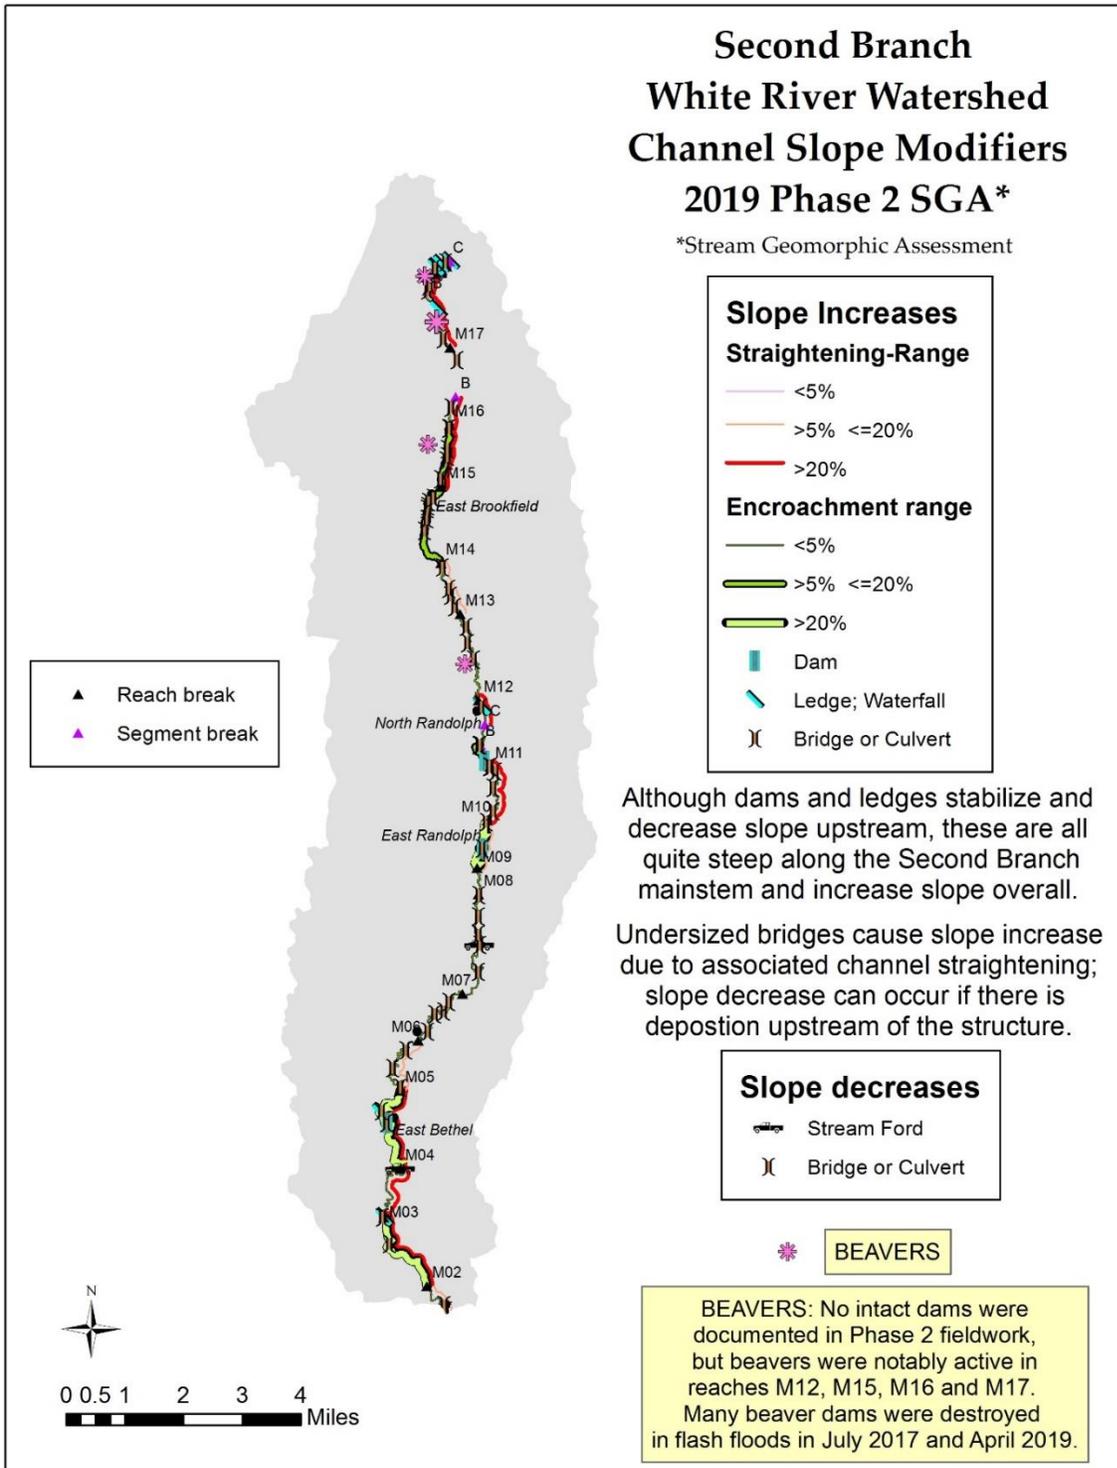
Analysis of channel slope modifiers along the Second Branch mainstem indicates that channel straightening is the predominant stressor, with indications of straightening observed in at least some portion of every reach except M08 (Fig. 20).

Figure 20. Channel Slope Modifiers map for the Second Branch mainstem.

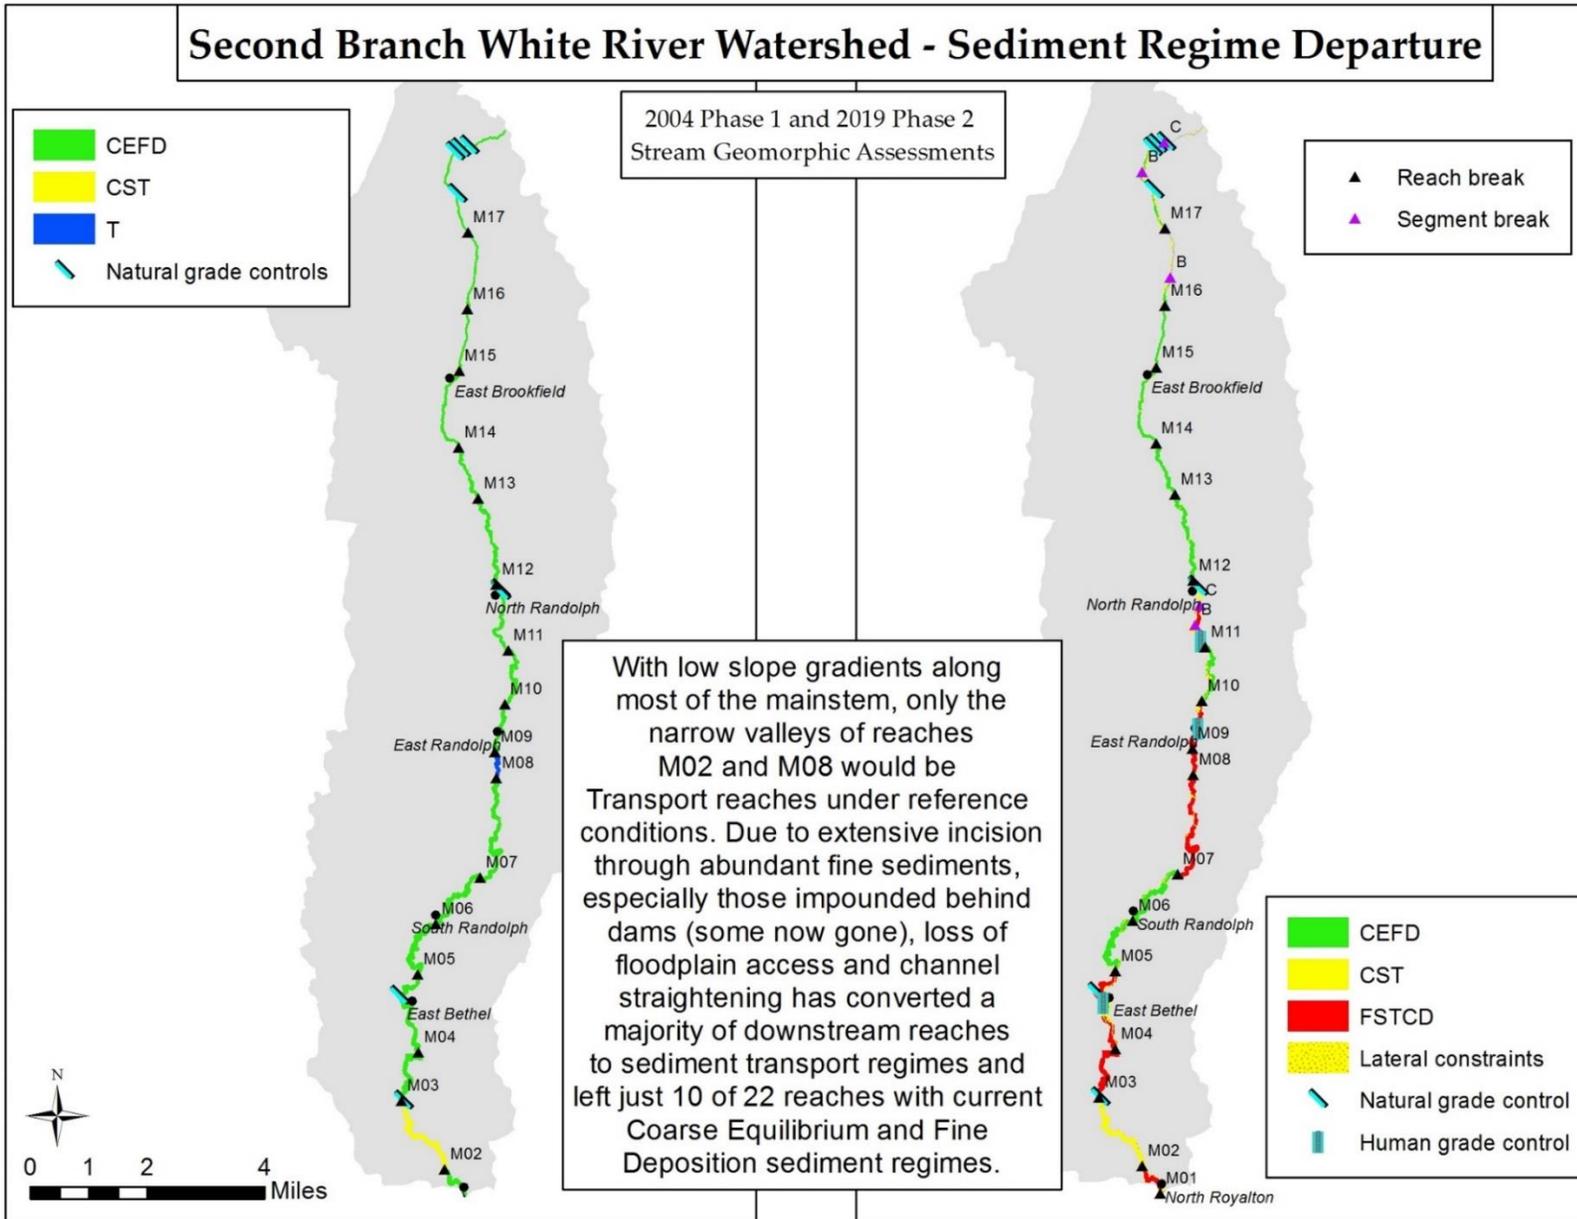
Due to incision through abundant fine sediments, especially in downstream reaches, Phase 2 assessment indicated that loss of floodplain access and channel straightening has converted roughly half of assessed reaches and segments to sediment transport regimes, leaving 10 of 22 reaches or segments with current Coarse Equilibrium and Fine Deposition sediment regimes (Fig. 27). Of these ten (M05, M06, M10 and upstream reaches from M12 through M17), many have significant lateral constraints to further channel evolution on at least one side of the channel, increasing the importance of protecting corridors from further encroachment or bank armoring on the opposite bank. Efforts to lock the channel into place on both sides will increase risks for further channel incision and subsequent widening, given a dearth of bed grade controls in all but reach M17 (Fig. 27).

Figure 27. Sediment Regime Departure Map for the Second Branch mainstem. See accompanying text for description of abbreviated sediment transport regimes.

Fine Source and Transport and Coarse Deposition regimes (coded red in Fig. 27) now exist in 10 (of 22) stream reaches or segments that lack extensive bank armoring and are characterized by channel widening, elevated levels of erosion and concentrated deposition at meander bends, channel constrictions (including upstream of undersized bridges and culverts as well as current and breached dams), tributary mouths, and overwidened sections of the stream. These are concentrated in portions of the mainstem from reach M14 (East Brookfield) downstream to reach M03 in North Royalton. It should be emphasized again, however, that “coarse deposition” is a

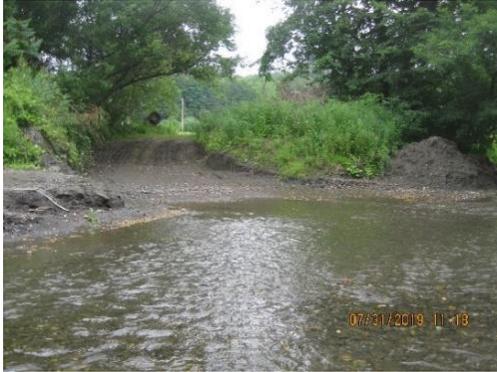
relative term along the Second Branch and these sediments are largely gravel or small cobbles on the larger end (Fig. 29).

Figure 29. Dredging at a stream ford in reach M04 exposes the relatively small “coarse deposition” in “Fine Source and Transport and Coarse Deposition (FSTCD) sediment regime reaches along the Second Branch.

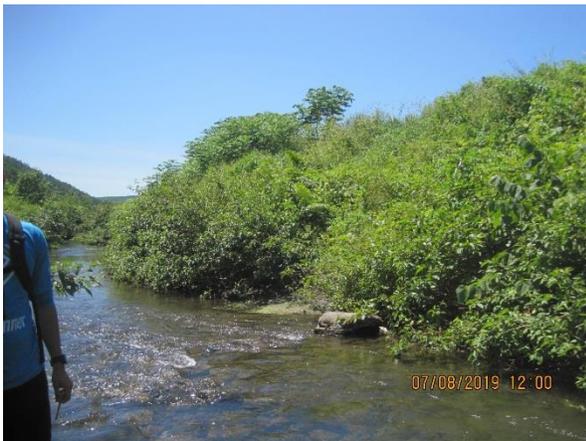
Figure 30. Larger coarse sediments in M15 (cobble and some boulder size) were present at several current and likely former (as here) stream crossings that have now released sediments contributing to bed aggradation and better floodplain access for the time being, but most are fine and subject to being scoured out again.

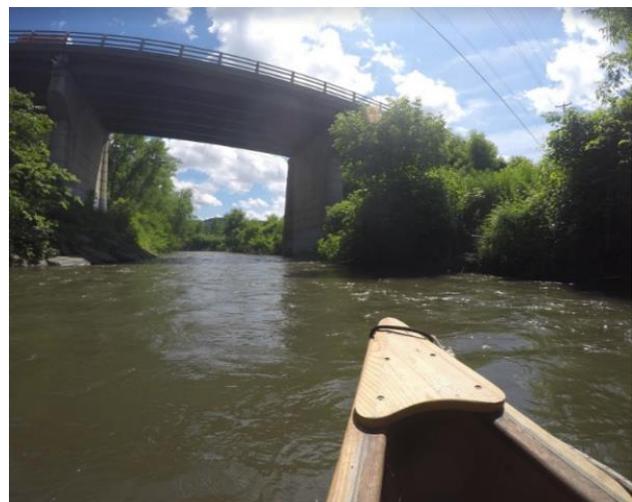
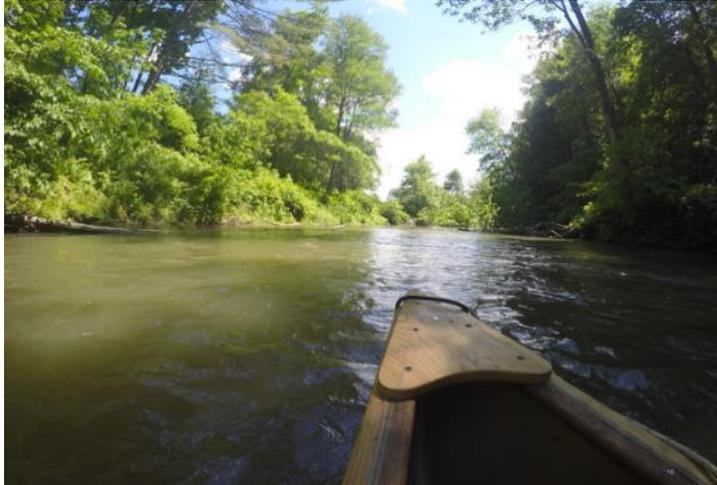
Figure 35. Upper section of M01, buffers on both sides of river, road embankment limits floodplain access

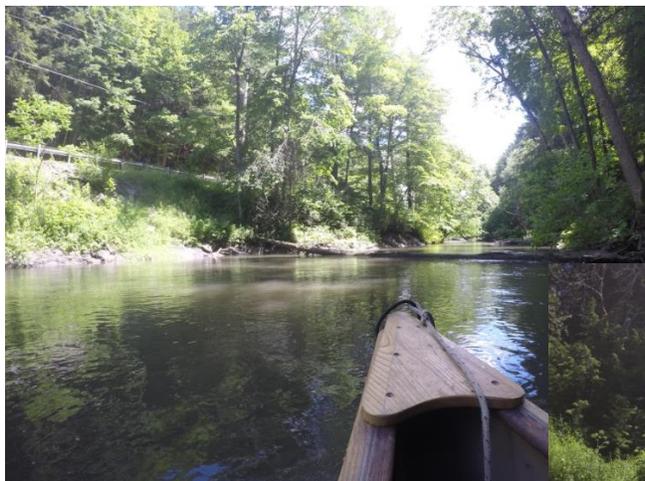
Figure 37. Road embankment on river left, debris jam, and steep valley wall on river right – a typical stretch in M02

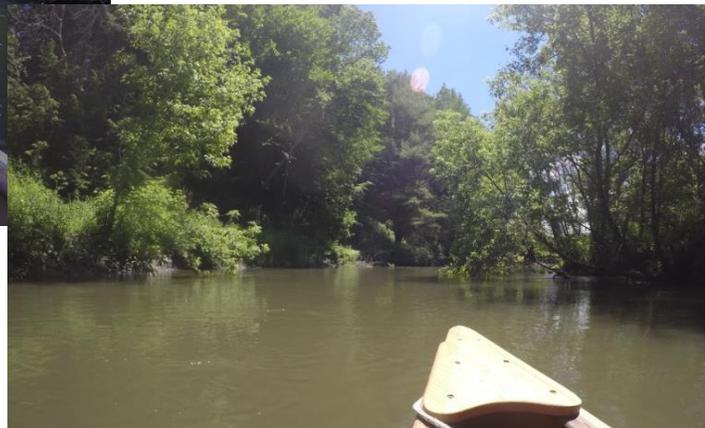
Figure 38. Widened section in upper portion of M02, limited floodplain access on river left

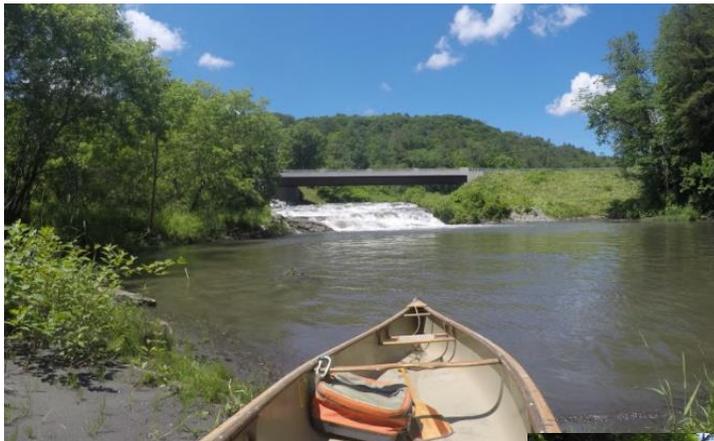
Figure 40. Site of former Stoughton Mills/Royalton-5 Dam – now a waterfall with a large scour pool

crossing at the start of this reach where the VT-14 bridge sits atop the location of the former dam. The removed dam exposes waterfalls with a large scour pool beneath. The angle of the bridge and VT-14 here is almost perpendicular to the flow of the river, cutting off left floodplain access and reducing the effective width of the bridge though not

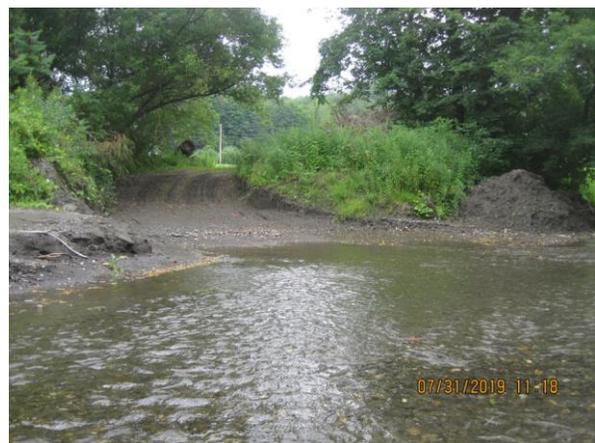
Figure 42. Erosion on right bank and heavy deposition of fine sediments on river left in M03; banks shown here on river right have no buffer

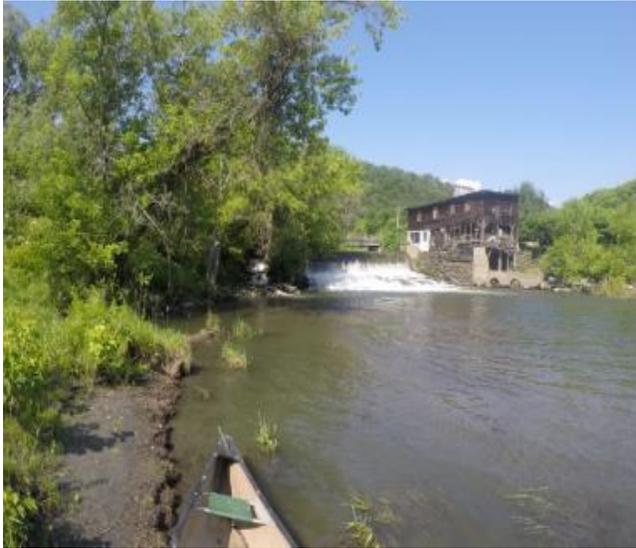
Figure 46. View of Hyde Dam (downstream looking upstream), with portions of the old mill complex visible at right of photo.

The Hyde Dam is located approximately 100 feet downstream from the Store Hill Rd bridge in East Bethel. The Hyde Dam is approximately 45 feet in length and 14 feet in height and historically provided water power to the village. Starting around 1860 the Hyde Dam was crucial in powering a gristmill, creamery, and woolen mill. The dam has long been out of use and in recent years the dam, adjoining property, and water rights were purchased by Vermont River Conservancy

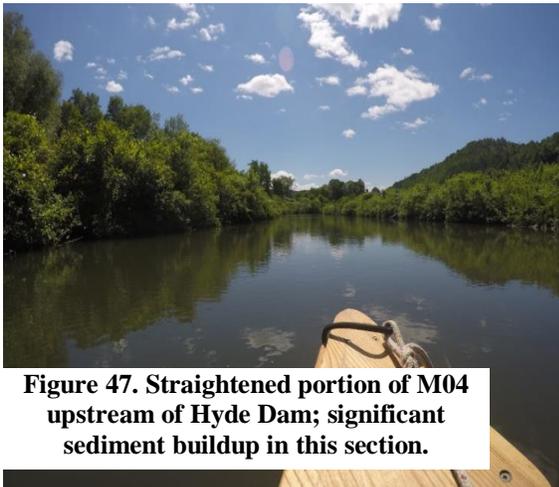
Figure 47. Straightened portion of M04 upstream of Hyde Dam; significant sediment buildup in this section.

turns east and crosses under the second bridge of the reach. This reach sees a stream type departure from planform E to C due to reduced sinuosity and widening related to straightening (apparently long-standing), exacerbated by sediments that are highly erodible. Cyclical rapid, localized incision seems to be offset by aggradation and widening. Down cutting along the reach is limited by grade controls (intact dam but also likely channel-spanning ledge upstream), and planform adjustments are limited by road encroachment and placement of vegetated berms pinning the stream to the valley wall. Progressive fining is exacerbated by the dam impoundment and lack of sediment transport continuity.

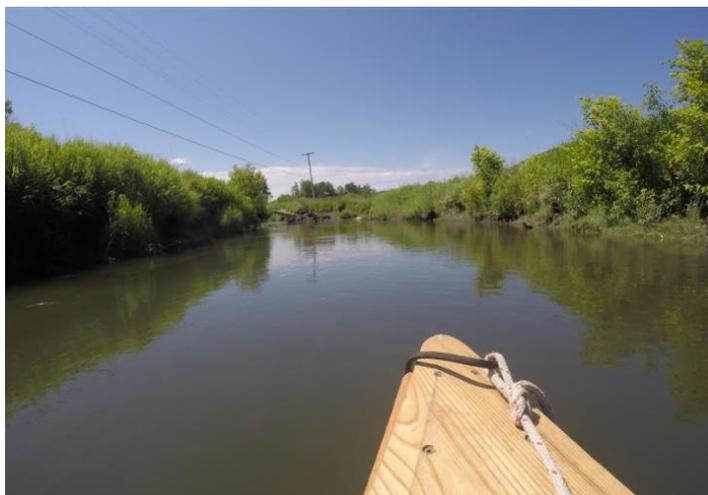
- River corridor encroachment in lower reach due to VT-14
- Loss of sinuosity, evidence of recent and impending neck cutoffs
- Three bridges acting as constriction points and contributing to widening and aggradation present along reach

Figure 49. Power lines on river left indicate presence of VT-14 as a river corridor encroachment along M05

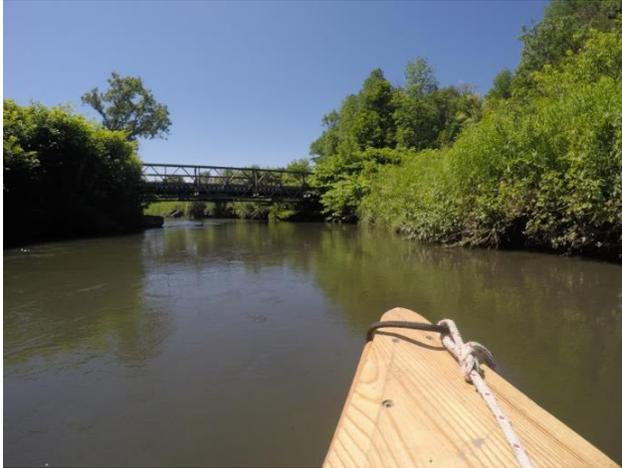
Figure 50. One of three bridges in M05 with abutments that act as significant constriction points

three neck cutoffs have greatly reduced the overall length and sinuosity of this reach leading to widening and aggradation. The reduced sinuosity and the strong predominance of very fine sediments create a very dynamic system bordering on an E to C stream type departure. Overall the reach has a large amount of erosion, both the left and right banks see over 1,000 feet of erosion at an average height of 3.5 feet. Though not well documented, it appears that a brickyard once operated in this reach (“Brickyard Farm” is located near the VT-14 bridge in the upstream portion of the reach) and the channel may have been dredged for clay (Ries and Merrill 1895).

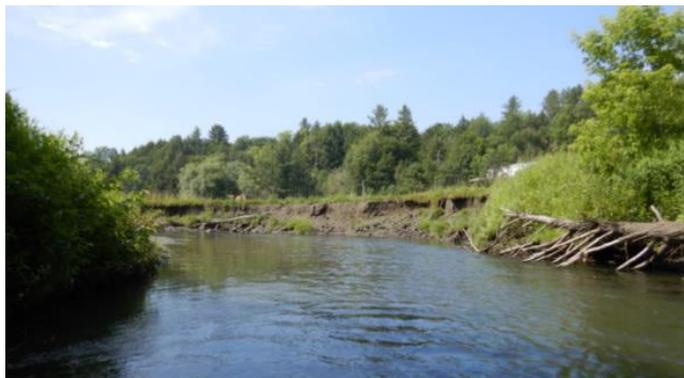
Figure 55. Active erosion along un-buffered agricultural fields has not taken the banks behind a downed tree (large woody debris)

While the corridor land use on river left is predominately forest, the river right corridor is dominated by agriculture (Fig. 55) with multiple historical farms lining this stretch of river starting north of Dugout Road and continuing past Hyde Road and up into the top portions of the reach. Large woody debris was common in M07, with 247 pieces of woody debris counted in the reach and 9 debris jams making the reach difficult to paddle but greatly benefitting habitat, diffusing high flows, and protecting banks in some areas (Fig. 55).

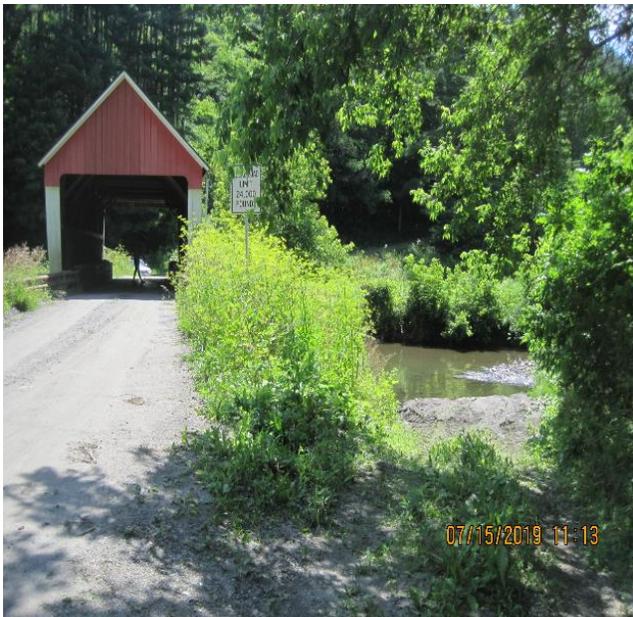
Since most farm machinery can't fit, there is a stream ford directly downstream of the Gifford Covered Bridge (Fig. 57).

Figure 57. Stream ford downstream of the Gifford Covered Bridge

The area around the Gifford Covered Bridge and ford has been identified for river corridor protection, ford remediation, and buffer planting. Just upstream of the Gifford Covered Bridge, Penny Brook enters along the right bank. At the Penny Brook and Second Branch confluence, there appeared to be indications of dredging, possibly related to plugging at the bridge, or use for ford maintenance.

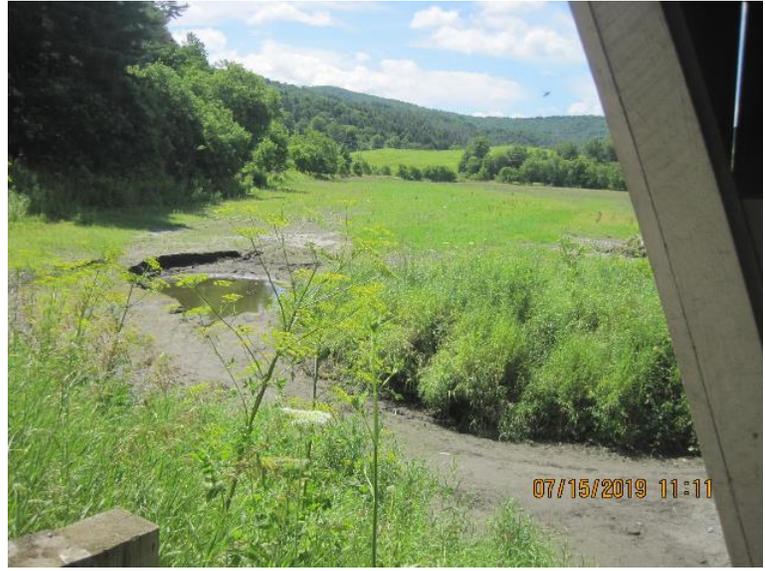
Recent channel avulsions initiated at the ford have captured portions of the adjacent left bank agricultural fields (Fig. 58).

Figure 58. Field capture from ford at Gifford Covered Bridge; river can access this field in higher flows

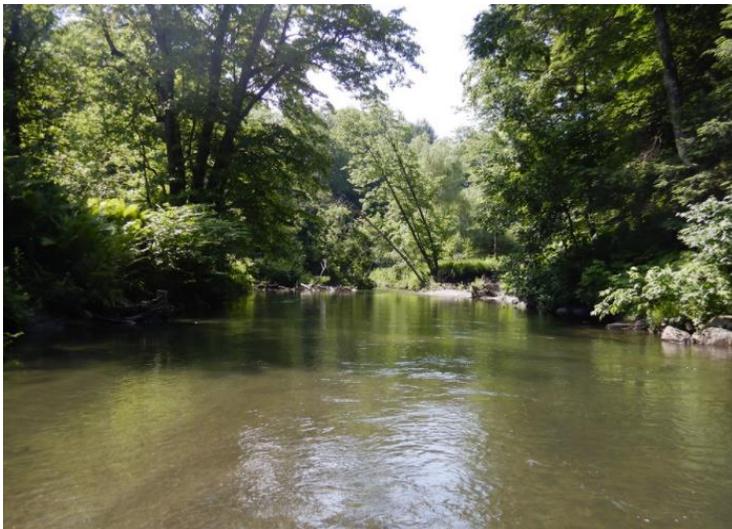
Figure 60. VT-14 does not enter the river corridor (or even the river valley) in reach M08, a rarity in the Second Branch. The result is a stretch of stream that is a relatively well buffered, with minimal erosion

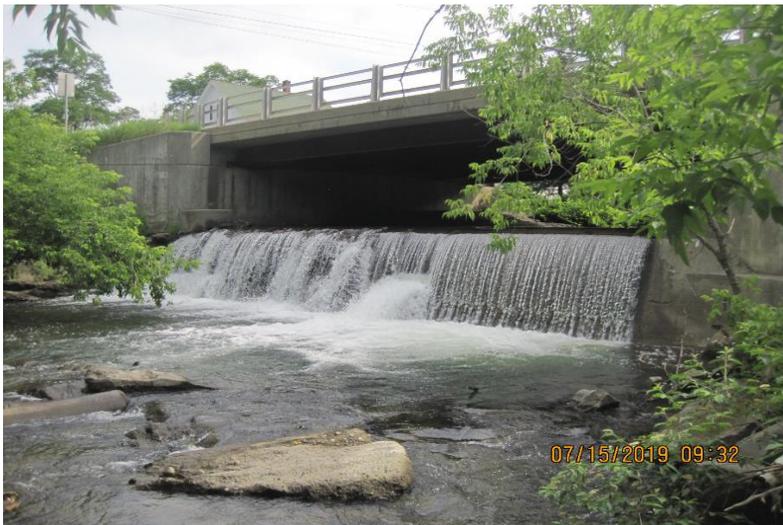
Figure 63. Looking upstream at Gulf Road Dam and the VT-14 bridge that sits above it

At the junction of VT-66 and VT-14 is the Gulf Road Dam (Fig. 63). The dam spans under the VT-14 bridge that sits next to the Middle Branch Market and Deli. The 0.11-acre property downstream of the dam, as well as the dam rights, are owned by the Town of Randolph, and there

is a dry hydrant at the upstream end of the dam that is maintained and utilized by the East Randolph Fire Department (Fig. 64). Gulf Road Dam is a low-hazard concrete structure that is 55 feet long and 8 feet in height. With projected removal of Hyde Dam in East Bethel in summer of 2021, the Gulf Road Dam would be the only remaining intact dam on the Second Branch of the White River.

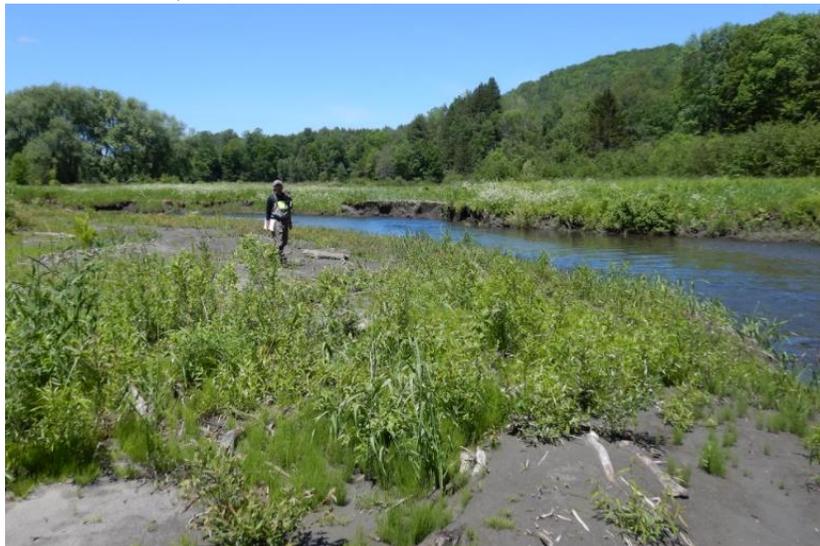
- VT-14 restricts access to historic floodplains
- Severe erosion and in response extensive revetments to protect VT-14
- Tire dump (eroded after use as revetments) and lack of established buffer through agricultural fields along reach

Figure 67. M10 is characterized by a lack of buffers - the wide open reach offers little in bank stability and habitat due to the lack of buffers.

property. In addition to the cleanup, buffer plantings and river corridor easements are recommended. The heavy erosion in this project area, with several stretches of revetments and bank armoring, have severely impacted the reach and lead to almost 2,500 feet of historic straightening resulting in reduced sinuosity. M10 also has 4 small, undersized private bridges amplify the straightening and erosion issues in the reach. The reach can be summarized as undergoing major widening and planform adjustments following primarily historic incision. Apparent successive floodplain abandonment (a likely older, higher abandoned floodplain was noted on the right bank in the area where the reach cross-section was taken) was probably offset by aggradation in recent flash flood events. Widening now appears as a more evident adjustment, with coarser sediment inputs (“sediment slugs”; Fig. 69) from tributaries increasing localized bed resistance relative to a lack of stability and increased erosion in adjacent banks. This dynamic lends to frequent cycling of widening and aggradation offsetting localized incision.

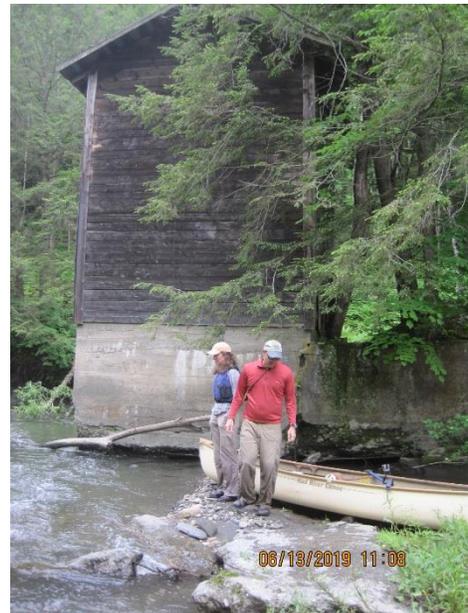
Based on fieldwork for this report, it is suspected that a log crib dam was replaced by concrete after 1921 (based on VWRC 1921 and presence of Ransome bar remnants on-site), then destroyed in the 1927 flood and not rebuilt. The stream is very entrenched here and fine sediments cyclically deposit/wash out, while decent buffers actually limit the rate of channel evolution; floodplain access is likely to remain very limited. Significant large woody debris and debris jams were present in this segment, and buffers over 50 feet in width are dominant on both banks. It was not clear if ledge underlies the concrete apron remains at the old dam site (but seems likely).

Figure 72. Not clear if channel-spanning ledge underlies the remains of a concrete apron at the former dam site behind the Creamery in North Randolph, in segment M11-A

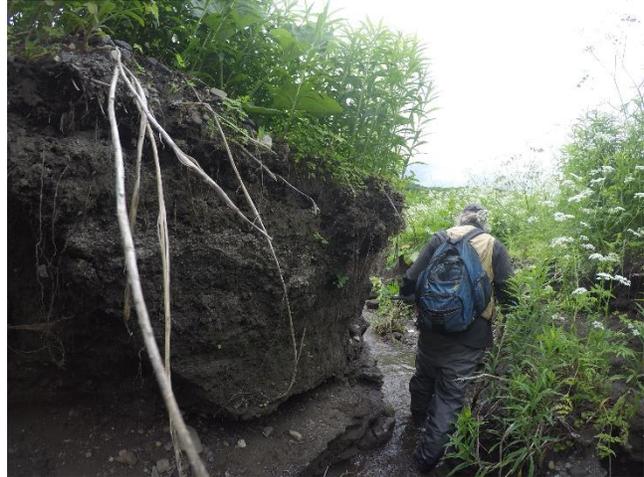
sidewall. Significantly coarser sediment inputs at the mouth of Snows Brook off the right bank contribute to higher sinuosity and elevated planform adjustments. The Second Branch likely shared floodplain with an alluvial fan, possibly historically but certainly during the presence of glacial Lake Hitchcock, at the base of Halfway Brook off left bank toward the downstream end of this segment. The Second Branch has been historically routed under VT-14, toward the right valley wall, cut off from this former floodplain by Ferris Road. A large headcut present in deep, fine deposits along the left valley wall upstream of here may be due to a small tributary and/or stormwater inputs from further up Ferris Rd, but the source was not discovered.

Figure 73. Severe head cut in M11-B, with areas of eroded banks over 6 feet in height

Corridor Protection	River Corridor Easement - Design	M-11B	43.967691	-72.553796	Attenuate dump outs from headcuts due to trib along Ferris Rd, (should drain to Halfway Brook?) (possible culvert replacements off mainstem)

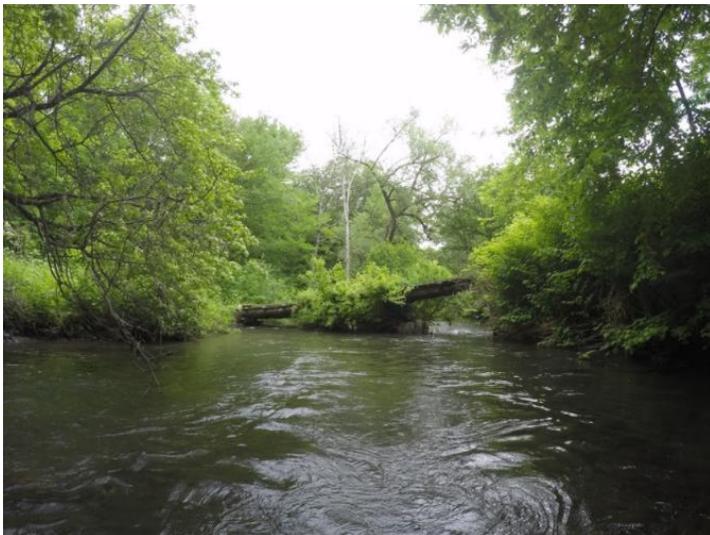
Figure 74. Log bridge and mid-channel abutment in M11-C sit atop old dam remains that appear to rest on a channel-spanning ledge grade control.

“At North Randolph village a head of about 9 feet is obtained and a 40 horsepower water wheel is used for operating a saw mill, shingle mill, and grist mill.” (VWRC 1921). The upstream portion of M11-C is the tail end of the old mill pond, and most of the segment is dominated by very fine silts. Infrastructure from mill buildings and a raceway are still present downstream off

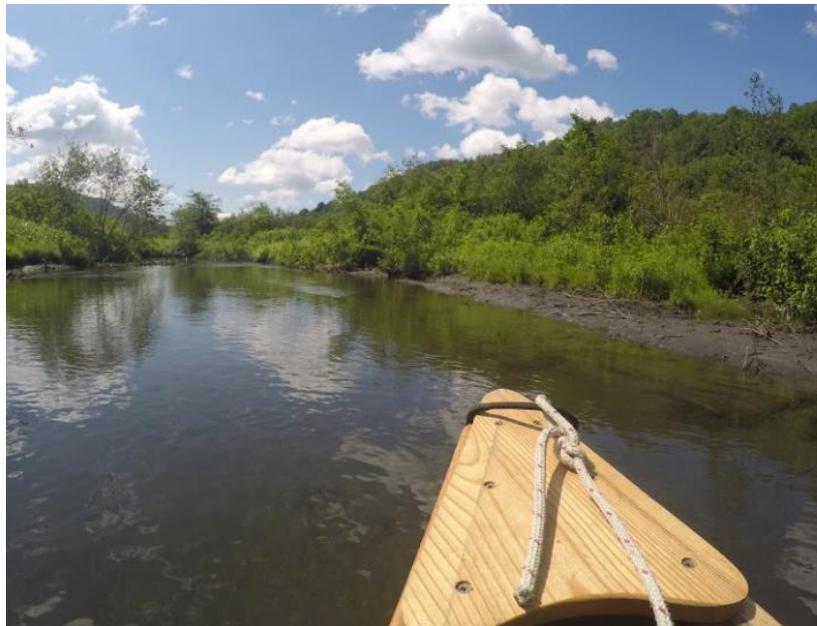
M12 shows similar characteristics to many of the heavily farmed reaches in the upper portion of the Second Branch, including over 1,000 feet of erosion on each bank and diminished or absent woody vegetated buffers. This reach has an E to C stream type departure due to major reduction in sinuosity and minor aggradation, widening, and planform change driven in part by coarser sediment recruitment from steeper valley sidewall tributaries as a result of flash floods in upstream reaches. The typical soils within the reach are very fine silty loams (Fig. 78).

Figure 78. Typical M12 segment: widenend, reduced sinuosity, and fine-grained sediments

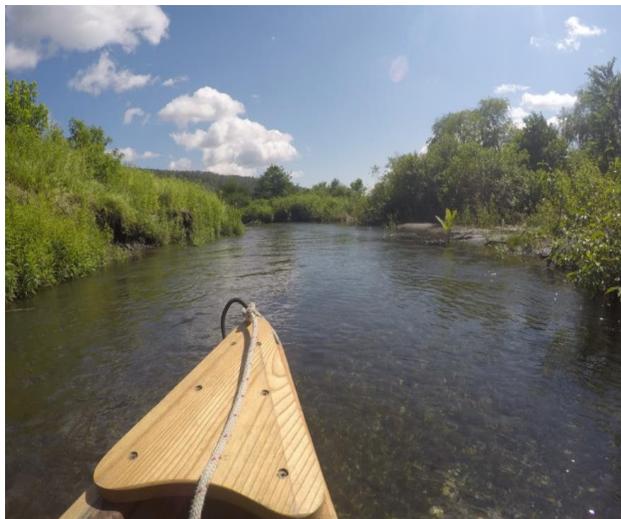
Figure 80. Typical stretch of M13 and many upstream portions of the Second Branch as a whole: diminished buffers with eroded or recently healed banks bordering agricultural fields

across the reach suffer from pronounced erosion and three neck cutoffs have contributed to the reduced sinuosity of the reach. While erosion can be severe at times, only 800 feet of active erosion was measured on each of the left and right banks. Many of the banks across the reach that were

once more actively eroding showed signs of healing with vegetation stabilizing the banks, but a lack of woody buffers can leave the banks more exposed during the winter when herbaceous vegetation dies back, and steeper portions of banks can be prone to heavy erosion during freeze-thaw cycles (Walter and Merritts et al 2018). This reach has almost no established woody buffers, with over 6,000 feet on both rivers left and right identified as having buffers less than 25 feet in width. The reach has 4 small bridges that it crosses under, restricting localized access to the floodplain and contributing to reduced sinuosity (which can amplify erosion much like routing a trail straight down a slope). M13 would likely be an E-type stream under reference conditions, but long-term straightening via the presence of multiple bridges, as well as ditching of valley sidewall tributaries and seeps, contributes to a widened stream with reduced sinuosity in a primarily agricultural setting along the floodplain areas. Both the downstream and upstream section of the reach feature mapped Class 2 wetlands (VSWI 2010), and possible wetland restoration projects were identified as part of this report for M13.

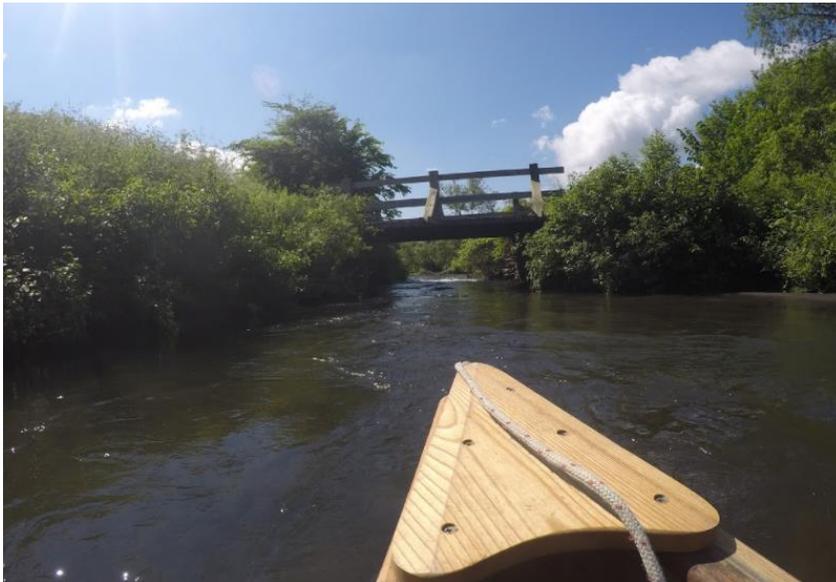
Figure 81. As seen in lower reaches as well, multiple farm, road and private bridges constrict reach M13 in places and contribute to straightening; herbaceous vegetation dominates buffers, few trees or shrubs

Replacement or removal of old/out of use bridges	Floodplain-Stream Restoration - Preliminary Design	M-13	44.004839	-72.5658229	Multiple undersized structures, severe ditching, limited floodplain access across entire reach. Wetland restoration possible in multiple areas.

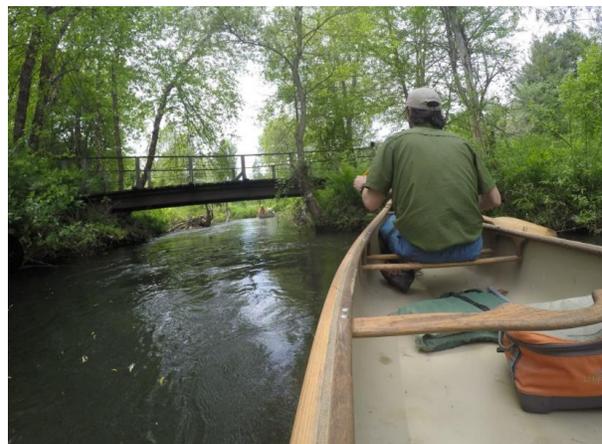
This reach has six small bridges used to cross the stream to private residences or used as farm bridges, and these bridges create localized areas of constriction and limit access to floodplain in what otherwise functions as a Very Broad valley with moderate floodplain access (Fig. 84). Straightened planform (amplified and maintained by the six bridges in the reach, Fig. 85) lends to cyclic scour/deposition in response to flash flood events, which occur with some frequency due to a combination of orographic effects (particularly pronounced along the steep valley walls in upstream reaches approaching the Brookfield-Williamstown Gulf) and intermittent encroachments, both here and

Figure 85. Private bridge in upper portion of M14 has a small section of woody buffers on both banks, but presents localized constriction and diminished floodplain access that contribute to the straightened planform of the reach

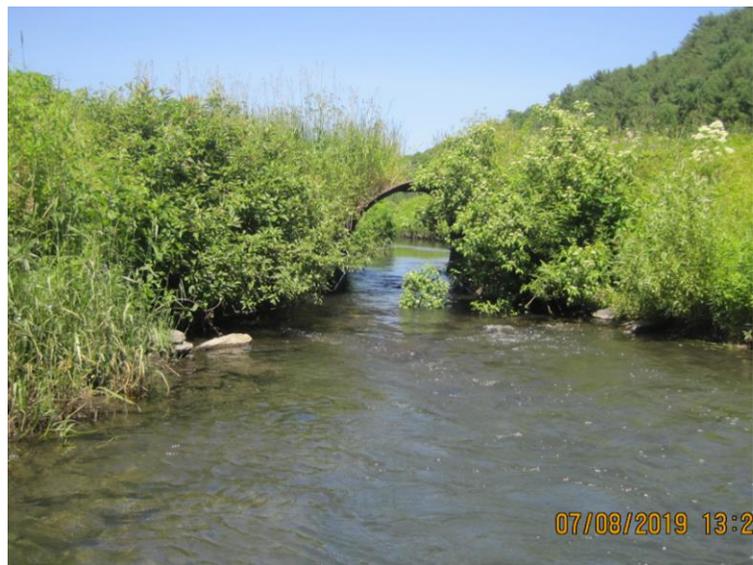
Figure 87. An out of use farm culvert, no road runs atop this structure. The culvert constricts the reach and further straightens the "ditch" like stream

Multiple old farm bridges and culverts (likely not in use) along farm to be removed or replaced	Floodplain-Stream Restoration - Preliminary Design	M-15	44.031346	-72.568471

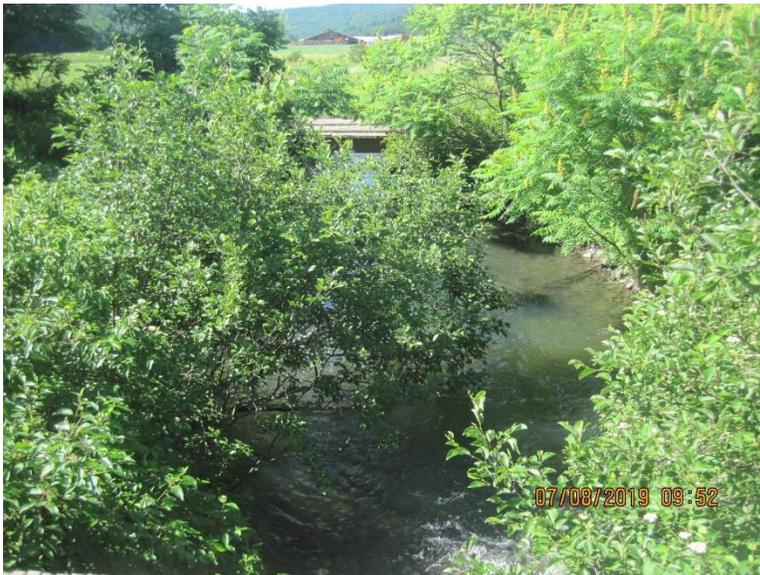
Figure 88. Downstream of the active bridge shown here, surrounded by some of the very limited woody vegetation along M15, a series of farm bridges and culverts in varying states of use further constrict and straighten the reach.

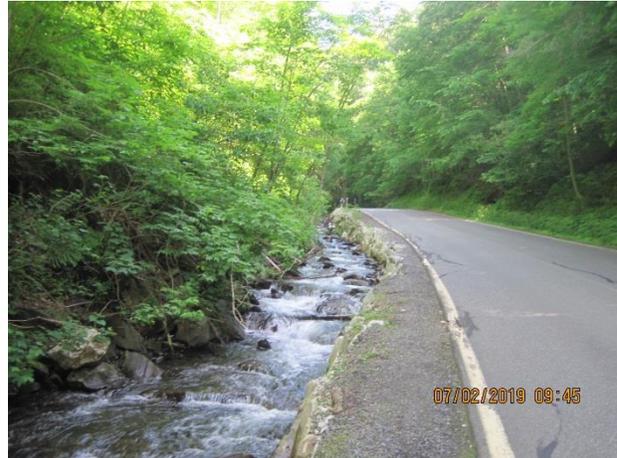
between VT-14 (cut out of the left valley wall) and a bedrock right valley wall continuous with the opposite bank, that comprises most of the elevation change (Fig. 93).

Figure 93. Long ledge drop at this valley pinch-point mid-reach in M17-A comprises almost all the elevation change, with relatively level beaver meadows both upstream and downstream

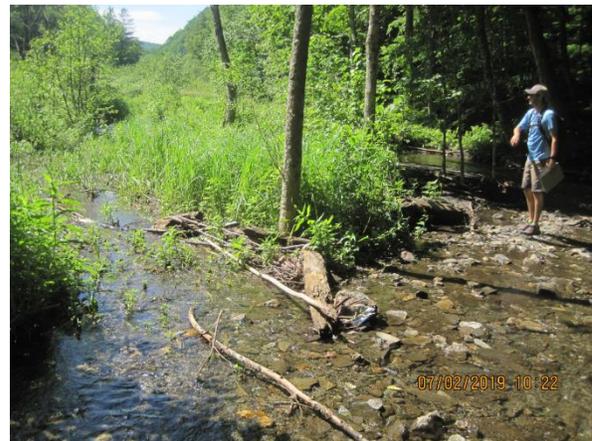
The presence of VT-14, accompanying bridges, and strategic post-flood windrowing at the base of the mid-reach ledge drop in M17-A encourage a single-thread channel in what would more likely be a series of connected beaver impoundments and multi-thread channels under reference conditions. The “berm” at the base of the ledge drop (likely created from “windrowed” materials dredged from the channel after a flood) was identified for potential removal as part of this assessment (Figs. 94. 95). This berm sits approximately 1.2 miles south of Staples Pond, very close to the Brookfield/Williamstown town line. The section of steep flow preceding the berm features a section of extensive rip-rap protecting VT-14. At the base of the steep section, the river outlets to a much gentler slope in a multi-channel beaver inhabited area. The berm extends for 200 feet and is approximately 2 feet high, constructed out of rocks, sediment, and recruited debris. The project would remove the berm and allow the flow coming from the steep rip-rapped section to disperse into the multi-channel wetland area that is found in much of the lower section of M-17A.

Figure 94. This figure shows the channel that runs to the left of the berm, even at moderate flows the berm is being outflanked

The project would remove the berm and allow the flow coming from the steep rip-rapped section to disperse into the multi-channel wetland area that is found in much of the lower section of M-17A.

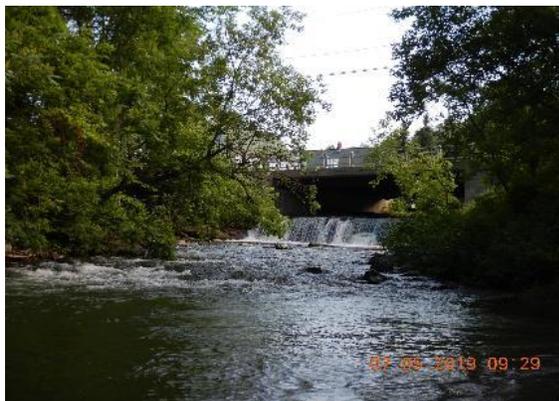
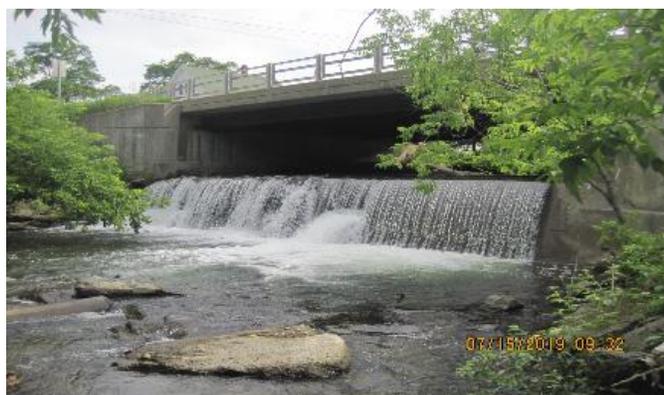
Figure 97. Gulf Road Dam - 2 views

The dam is located along M09 of the Second Branch of the White River in Randolph, VT. The dam is situated along the downstream end of the Rt-14 bridge that sits across from Middle Branch Market and Deli (Intersection of VT-14 and Route 66). The 0.11-acre property downstream of the dam as well as the dam rights are owned by the Town of Randolph and there is a dry hydrant just upstream of the dam that is maintained and utilized by the East Randolph Fire District. The Gulf Road Dam is a low-hazard concrete structure that is 55 feet long and 8 feet high. After the anticipated removal of Hyde Dam in summer of 2021, the Gulf Road Dam would be the only remaining dam on the Second Branch of the White River.

The plan to remove the Gulf Road Dam represents a larger initiative to improve water quality and sediment continuity in the White River watershed. Water quality sampling locations downstream of the Gulf Road Dam have historically had the highest *E. coli* bacteria readings in the watershed. The increased sediment continuity resulting from a dam removal may help address naturalized *E. coli* populations found in the fine sediments of the Second Branch. Additional co-benefits include aquatic organism passage.

Follow up with the East Randolph Fire District and the Town of Randolph Selectboard. An engineer with dam removal experience should also be engaged to determine a scope of work.

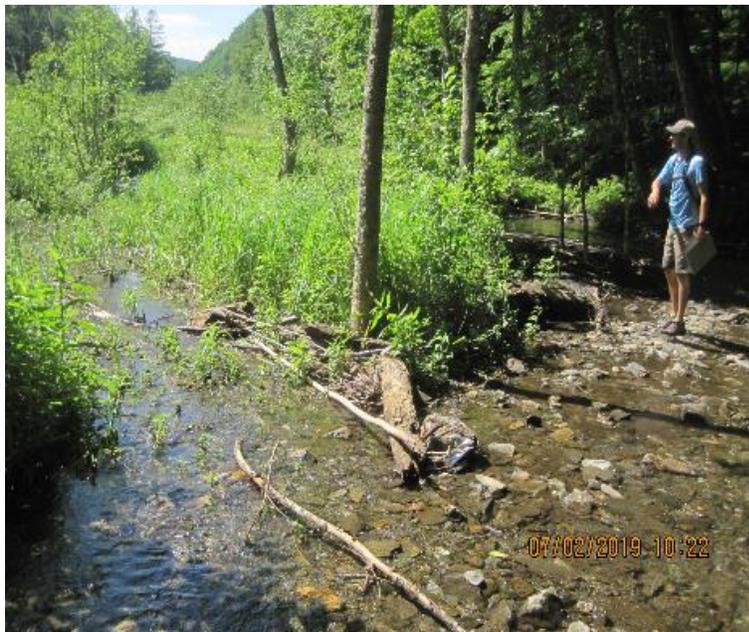
Figure 100. M17 Berm Removal Project Overview

The berm is located at the Brookfield Town line and has possible multiple landowners, including VT Dept. Forest, Parks, & Recreation (Ainsworth State Park). The berm currently directs the flow of water away from VT-14 and towards the valley wall. Removal of the berm would allow flows into the multi-channel area that runs parallel to VT-14. To ensure that the removal of the berm does not cause any adverse effects to VT-14, VTrans should be contacted.

Follow-up with landowners and VTrans.
