River Corridor Plan for the White River and Tributaries in Sharon, Vermont

March 15, 2010

Fitzgerald Environmental Associates, LLC.
316 River Road
Colchester, VT 05446

Two Rivers-Ottawquechee Regional Commission
3117 Rose Hill, The King Farm
Woodstock, VT 05091

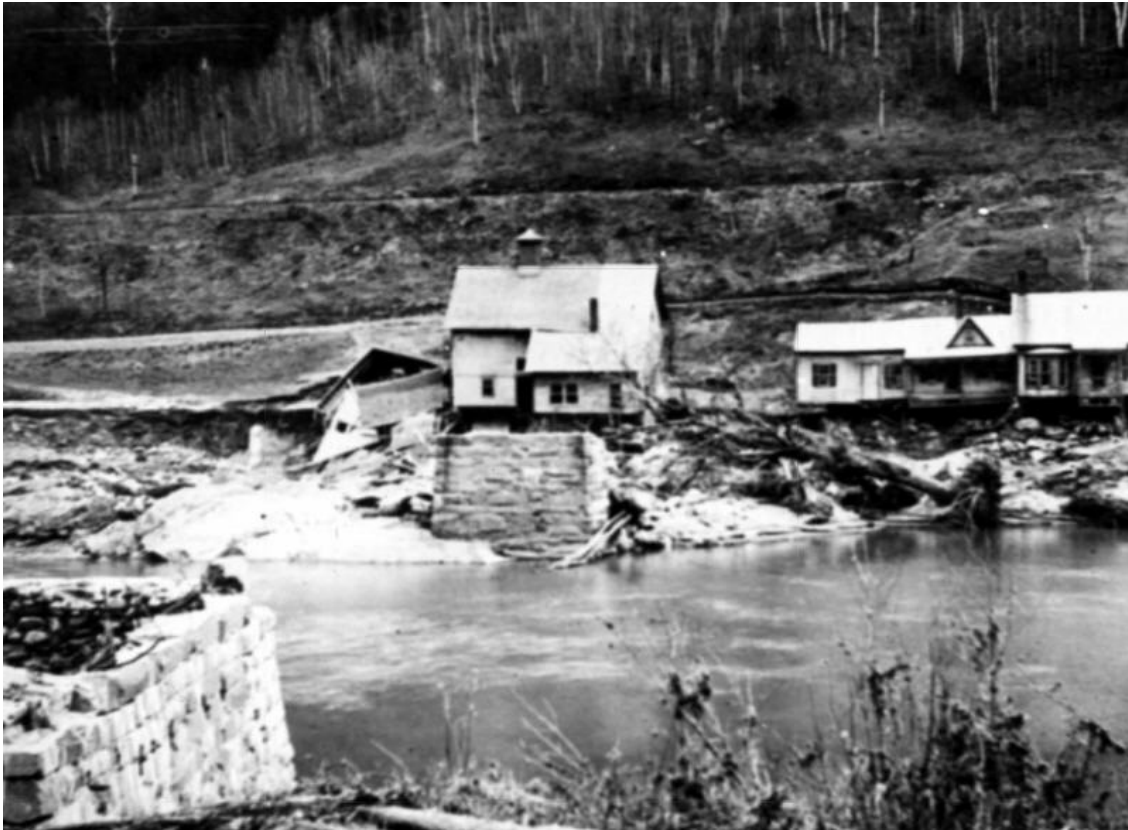
Figure 2.10 The abutments of the washed-out bridge in Sharon; the house was moved downstream (UVM Landscape, 2010)

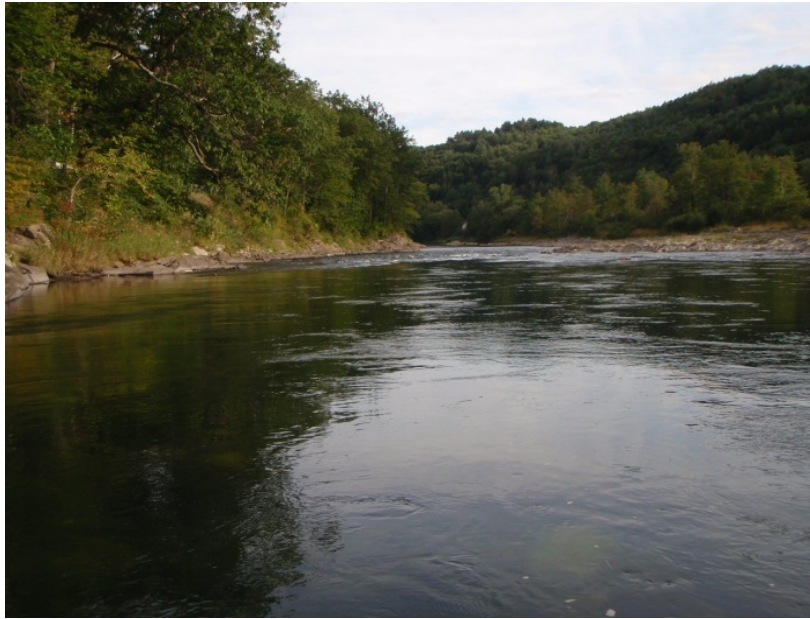
Figure 4.2 Looking downstream at the cross section location

The dominant adjustment processes observed were widening (possible legacy adjustment from 1927 flood impacts). Due to the natural grade controls and the reformed floodplain, stage III of the D channel evolution model (CEM) was selected to characterize current channel morphology in the context of historical adjustments. Overall, the channel was largely stable despite the high width-to-depth ratio (RGA score = “Good”). Habitat in this segment is naturally limited due to the confined setting (e.g., limited meanders and pool formation) and inability of the channel to attenuate wood (RHA score = “Fair”). Woody debris and pool densities per mile were 24 and 8, respectively.

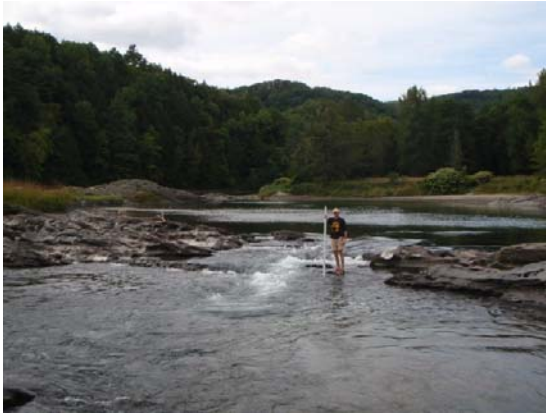
Figure 4.3 One of several bedrock grade controls in the reach

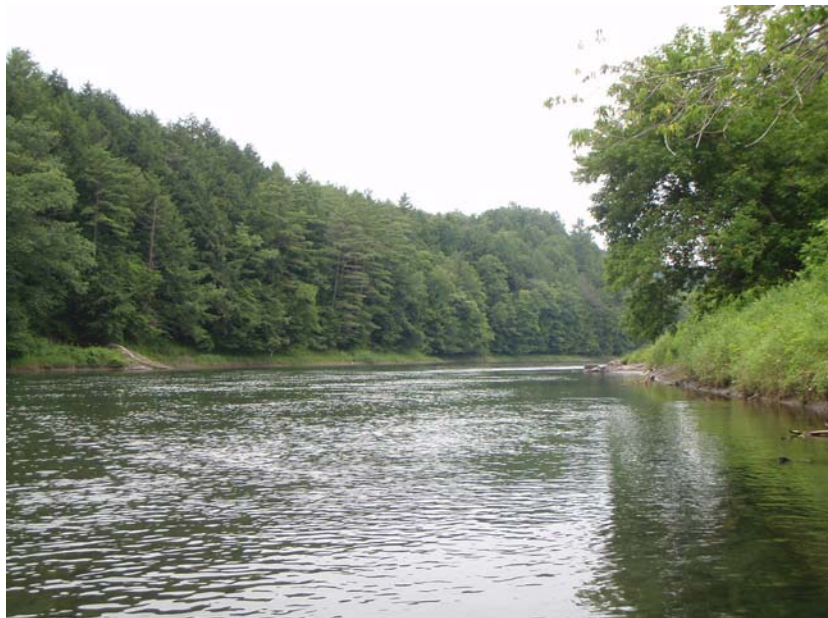
The channel has F-type morphology due to a lower than expected entrenchment ratio. The reach likely had Bc type channel morphology and plane bedform by reference. The cross-section was taken mid-reach (Figure 4.5). There, the width-to-depth and entrenchment ratios of the channel are 31.7 and 1.2, respectively. An incision ratio of 2.0 is reported for this reach; however we do not think it is realistic that the channel bed has incised 10 feet from the floodplain as the incision ratio would indicate. Rather, there has likely been a lesser degree of bed incision that has reduced what limited access there was to the floodplain under natural conditions. The substrate was predominately cobble (48%); however an elevated level of sand in the bed (22%) was noted.

Figure 4.5 Looking upstream at the cross section location

The dominant adjustment processes observed were degradation and widening (RGA score = "Fair"); however ongoing bed incision is limited by natural grade controls. Bar formation within the reach has increased since the large flood events of the 1920's and 1970's, and the bars have grown in size considerably since the 1990's. Further channel widening is predicted in this reach according to the CEM. Adjustments in planform are also likely to occur along

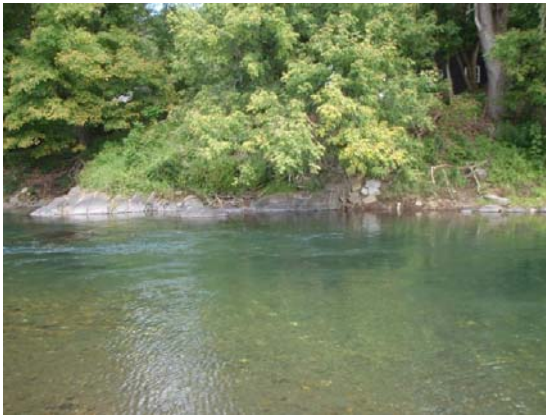
Figure 4.6 Deep pool along the left bank in the upper reach

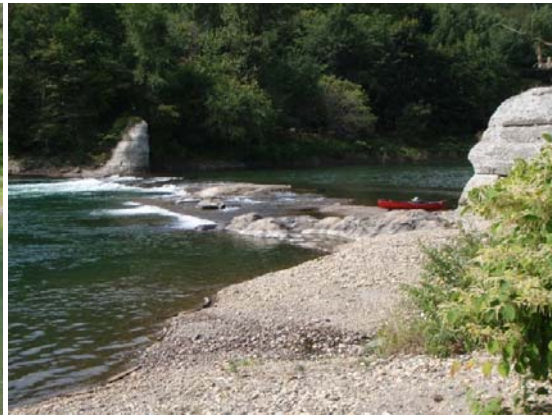
Figure 4.7 Remnants of the Sharon Dam

This reach has some notable erosion features on both banks and two very prominent mid-channel bars. The current geomorphic state is still adjusting to historic incision following the 1927 flood and the failure of the Sharon Dam. Any sediment that aggraded behind the dam, prior to its failure, was transported out of the system and downstream. Now, the channel is re-aggrading sediment and some moderate bank erosion and widening is occurring. Bar enlargement and bank erosion is most severe in the lower reach near the railroad trestle (Figure 4.8). The substrate was predominately cobble (58%), with a median substrate size of 210 mm.

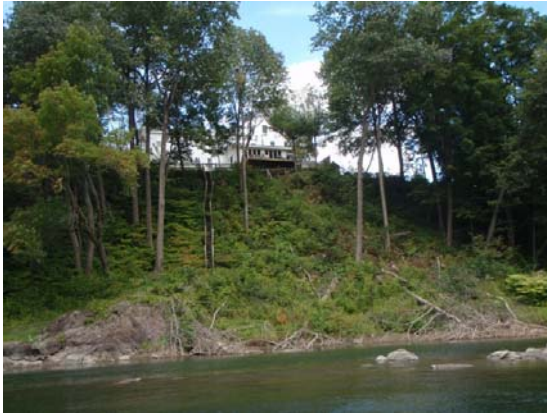
Figure 4.9 Felled mature trees on the north bank in Sharon

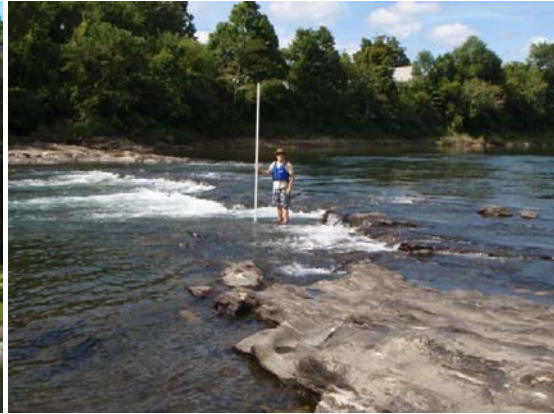
Figure 4.10 Bedrock grade control in upper reach

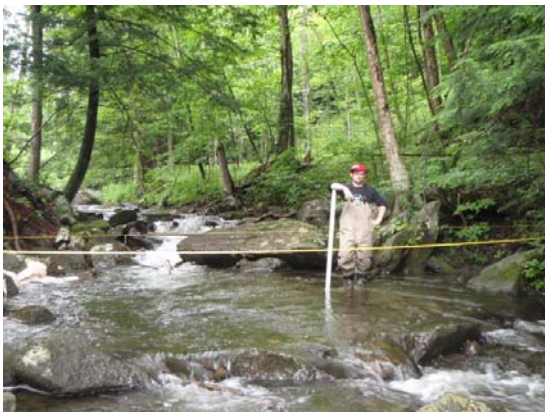
Reach R6.S3.01 begins at the confluence with the main stem of the White River and it extends upstream 1.5 miles at an average slope of 6.7%. This reach is a B-type by reference with a subclass slope designation a. The valley is semi-confined with human-caused change in the valley width. The width-to-depth ratio and entrenchment ratio are both indicative of the stream type (WDR = 11.7; ER = 1.9). No incision was observed on this reach (IR = 1.0; Figure 4.12). Slope changes are common within this reach because of bedrock grade controls. This makes it possible for several different types of bedforms to be present: cascade, step-pool, and plane bed features were all observed, but step-pool features were dominant. The substrate was predominately cobble (37%) and boulder (38%) in R6.S3.01, with a median substrate size of 210 mm (cobble). The frequency of grade controls is higher in the lower reach, and the channel is vertically stable. Much of the reach is heavily encroached upon by Route 132, which limits the buffer width on the right side and impacts the valley width (Figure 4.13). In the upper reach the armoring and encroachment of the channel has caused some large mass failures to form. These features are contributing significant sediment to the upper reach and if slope failures persists problems with the roadway and channel flooding could result.

Figure 4.12 Cross-section location w/ no incision observed

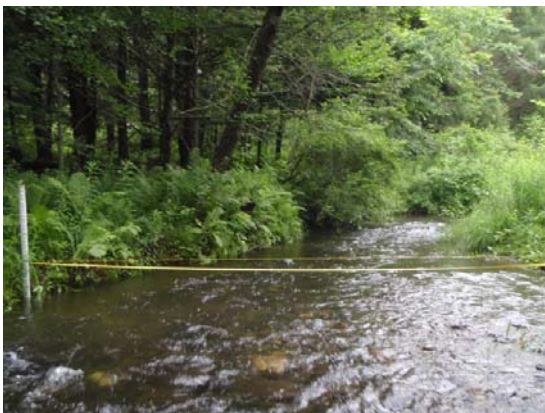
Figure 4.14 Cross-section location C-type geometry

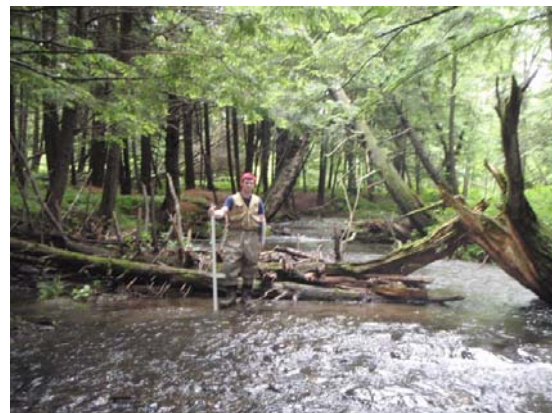
Figure 4.15. Riffle-pool formation aided by debris jams

Minor scour and deposition features negatively impacted the habitat condition of the segment. Woody debris (LWD/Mile = 118) density was 'reference' and pools were common (Pools/Mile = 24). The stable banks and wide riparian areas in this segment positively influenced the habitat condition (RHA score = "Good"). The frequent debris jams and high woody debris density observed also made the segment geomorphically stable. No major

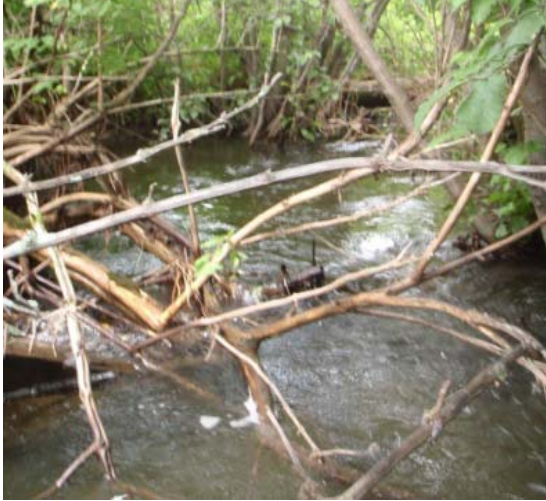
Figure 4.18 Dune-ripple feature in area covered by dense WADs

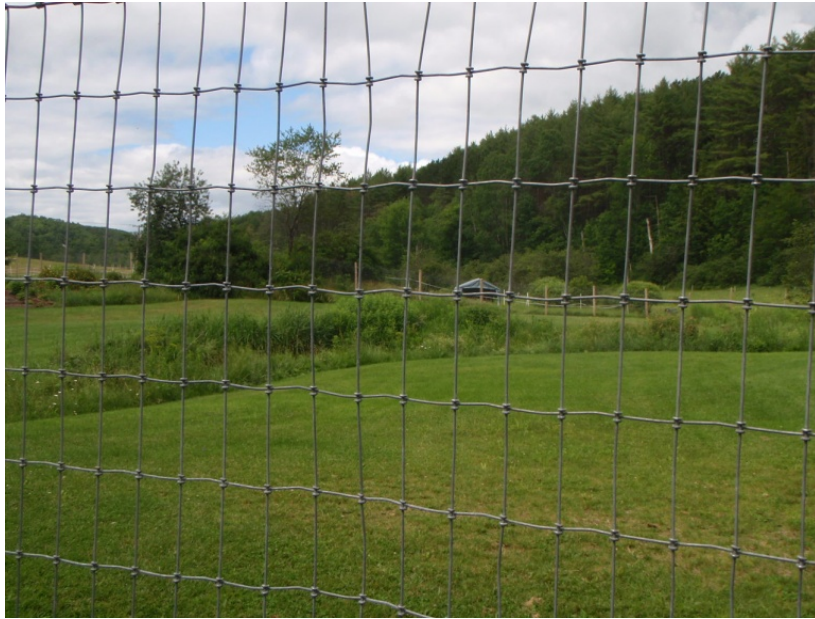
R6.S3.03 was segmented because of lack of property access at the Sunnybrook Trout farm, which is surrounded by a large fence to prevent predator species from feeding on the fish (Figure 4.20). The segment is 0.2 miles in length and has a low slope of approximately 0.9%. R6.S3.03-A begins at the reach break at the Trout Farm and ends just downstream of the Route 132 crossing upstream. The valley is very broad with no human-caused change in the valley width. Administrative judgment was used to determine stream type: E-type, dune-bedform, and sand substrate.

Figure 4.20 The channel upstream of segment R6.S3.02-C within Sunnybrook Trout Farm

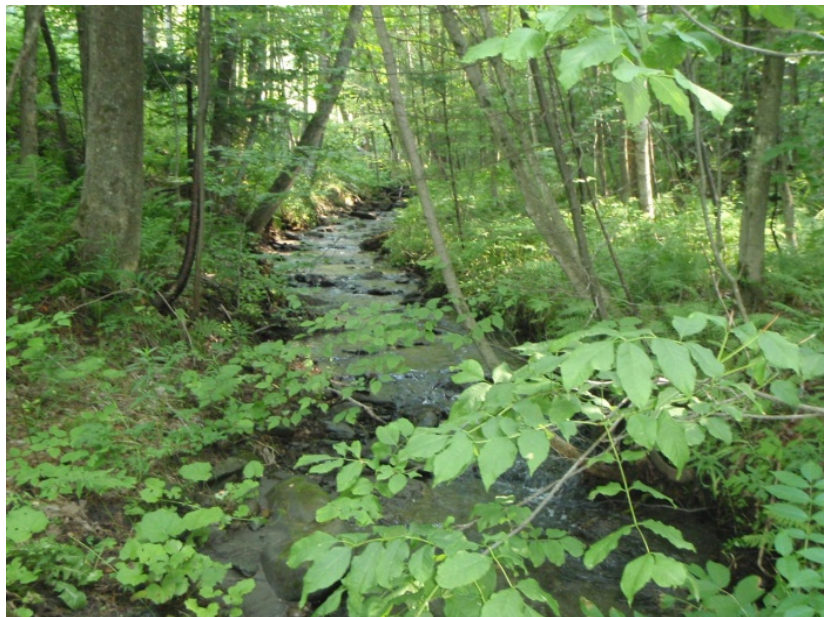
Figure 4.23 Plane bed section of channel in upper segment

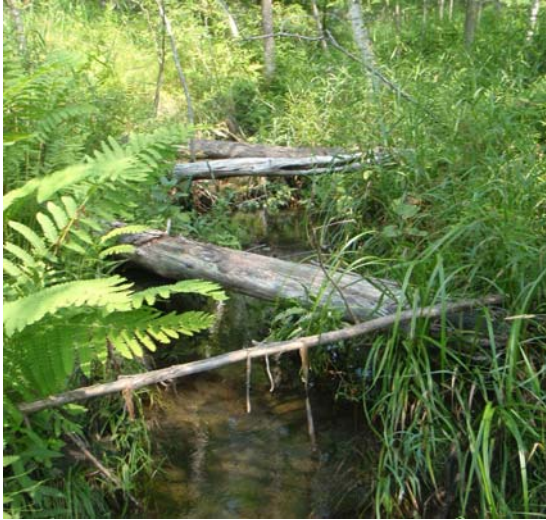
Figure 4.25 E-type channel with nice woody debris cover

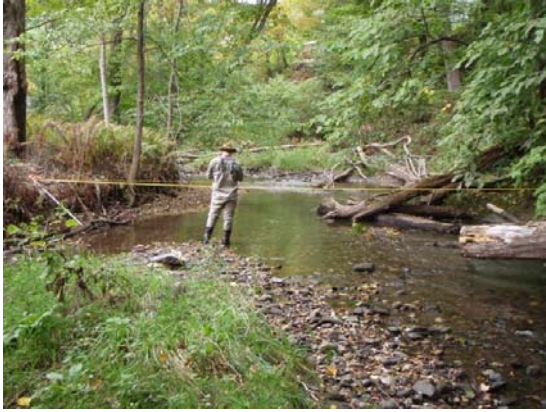
Figure 4.27 Cross-section location looking upstream

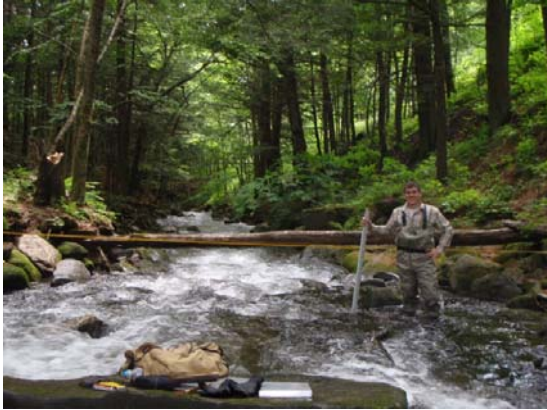
Figure 4.29 Cross-section location looking downstream

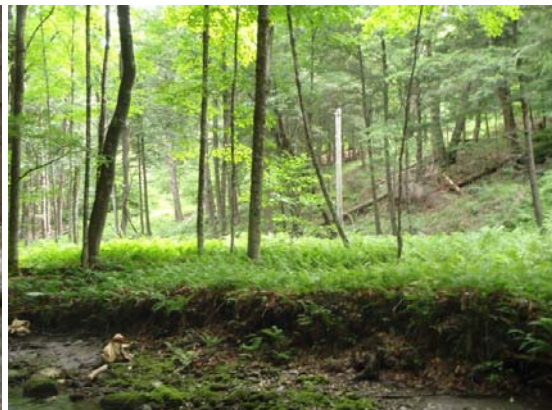
Figure 4.32 Accessible floodplain at the cross-section location

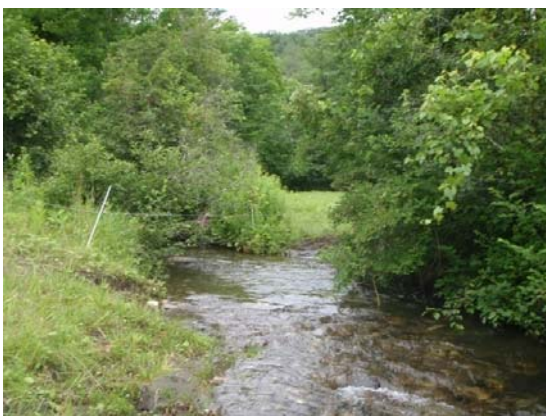
Figure 4.33 Stream animal crossing (rip-rap upstream)

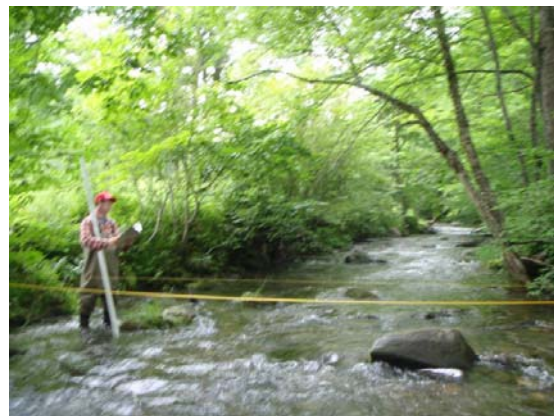
Segment R7.S1.02-B was segmented out because channel and valley dimensions differed from the downstream segment. The valley confinement is broad with no human-caused changes to the valley width. Segment R7.S1.02-B begins at the break near the horse pasture to the east and extends upstream 0.8 miles until the slope changes dramatically about 500 feet downstream of the Fay Brook Road Crossing. Segment R7.S1.02-B exhibits C-type channel morphology, with a subclass channel slope of b (2.3%). Width-to-depth and entrenchment ratios are 13.3 and 2.6, respectively. This segment has recently degraded and the floodplain is elevated slightly above the bed (IR = 1.3). Riffle-pool bed features have eroded with degradation and now plane bedform is dominant. Bed substrate is predominately gravel (27%) and cobble (34%) with a median particle size of 67.5 mm (Cobble). Where the segment begins at the horse pasture to the east, much of the buffer width is less than 25 feet on both sides of the channel. Two animal crossings were noted that provide access to the pasture area. Rip-rap was added at these locations to stabilize the banks up and downstream of the crossings (Figure 4.33). West of the channel upstream of the horse pasture area the corridor is used for hay production. This channel was likely straightened here to provide a more contiguous field area. The channel incision is most notable in the pasture and field area, yet the banks appear to be stable (Figure 4.34).

Figure 4.34 Cross-section location in straightened area

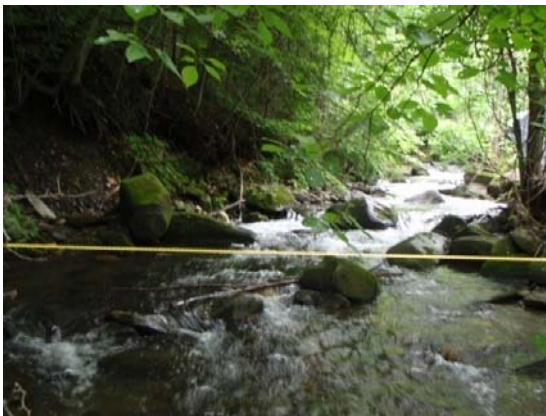
Figure 4.35 Cross-section location looking upstream

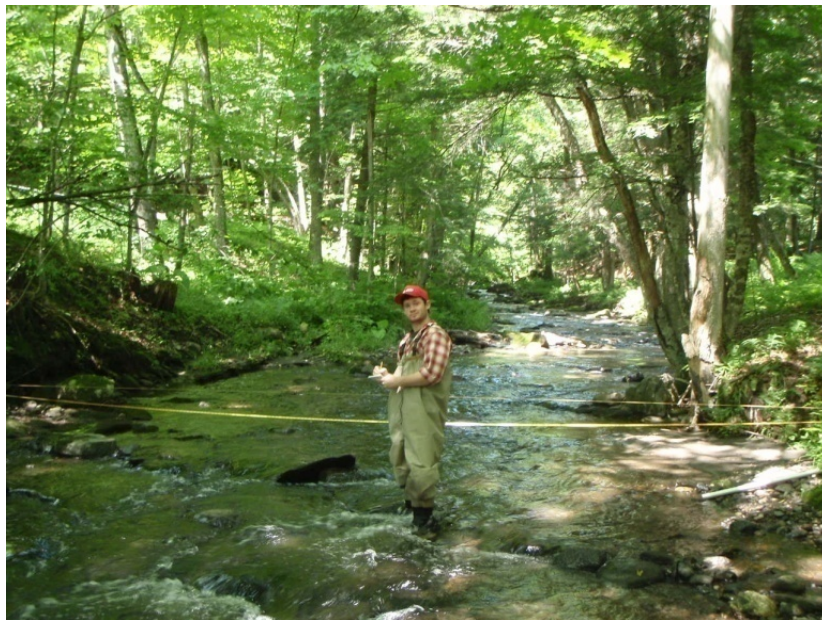
Figure 4.37 Segment R7.S1.03-A cross-section location looking upstream

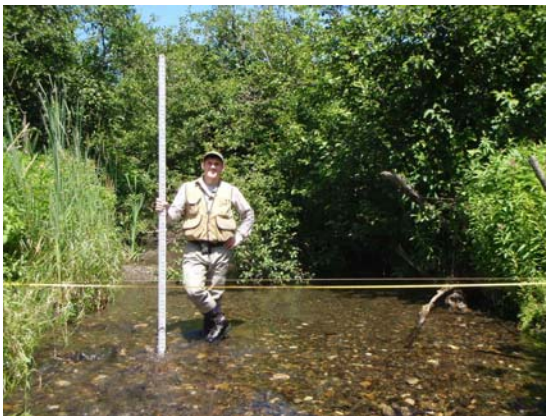
Figure 4.39 Cross-section location looking upstream

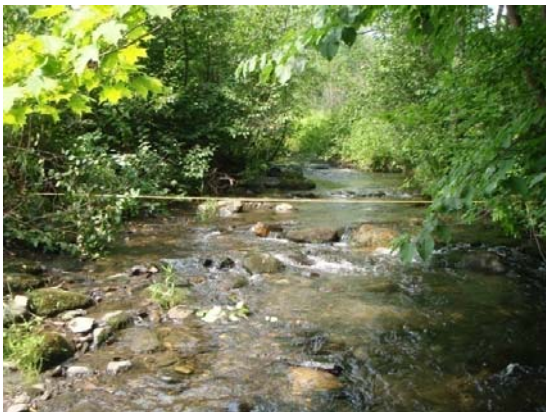
Figure 4.41 Cross-section location looking upstream

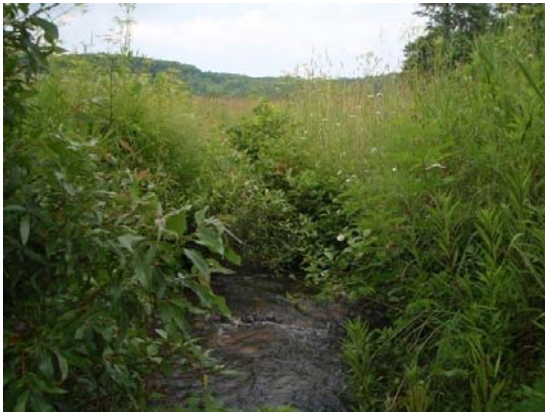
Channel geometry is consistent with the stream type designation; the width-to-depth entrenchment ratios are 4.9 and 26.5, respectfully. The low bankfull width (and WDR) is common with E-type channels, especially when the near banks are dense with WAD and herbaceous cover (Figure 4.45). The dense WAD cover also helped stabilize the banks and no incision was observed in this segment (IR = 1.0). The upper end of this segment had a temporary grazing area for a large bull (Figure 4.46). Fencing livestock away from this section of the channel would improve long-term stability and overall health of this reach.

Figure 4.45 E-type channel with WAD and herbaceous cover

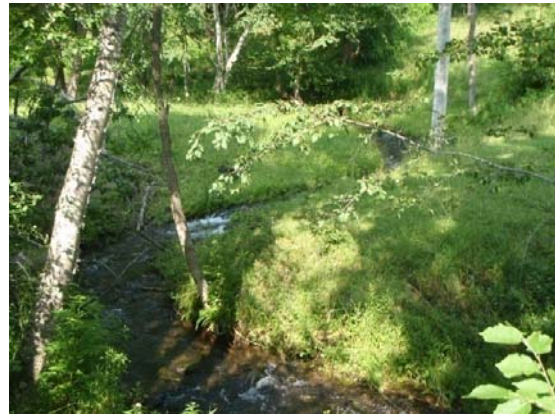
Figure 4.48 Well-formed C-type channel with riffle-pool bedform

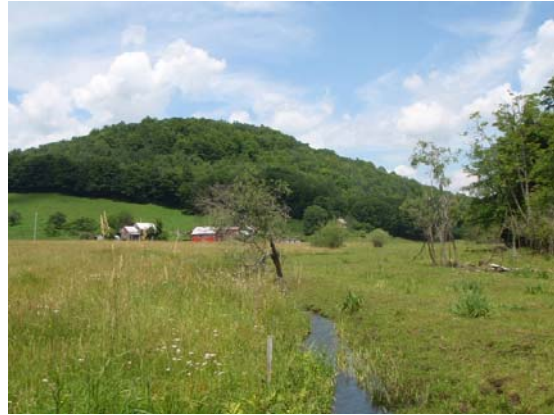
Administrative judgment was used to determine stream type: E-type, dune-bedform, and sand substrate (Figure 4.50).

Figure 4.50 E-type channel upstream of segment R7.S1.04-D

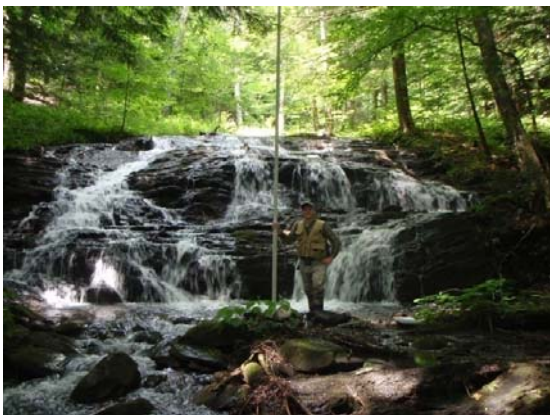
Figure 4.51 Waterfall: total height =18ft; height above water =17ft

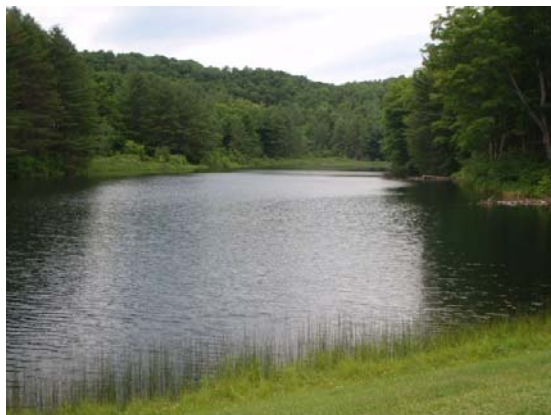
The final segment of Fay Brook begins at the segment break and extends 0.6 miles upstream, ending at the Kratky Dam. The segment has an average slope of approximately 3.8% with most slope change occurring at grade controls. The valley is narrow with human-caused change in valley width in the lower segment where the channel parallels Robinson Road for about 600 feet. The channel exhibits C-type morphology with a subclass slope of b. The width-to-depth ($WDR = 13.1$) and entrenchment ($ER = 2.7$) ratios are both consistent with the stream type designation. Incision was not observed on this segment ($IR = 1.0$). Bedform was predominately riffle-pool, but in areas with many grade controls and elevation change step-pool bedform was also observed. Substrate was mostly cobble (27%) and gravel (42%) with a median substrate size of 10 mm (Gravel). The segment had two large waterfalls that were responsible for about 30 feet of elevation change (Figure 4.51). The Kratky Dam, which marks the end of reach R7.S1.04, was not included in the grade control listing of the reach, but the head of water above the outlet is approximately 20 feet (Figure 4.52). The dam was built for recreational purposes and acts as a large run-of-the river flow regulation.

Figure 4.52 Reservoir upstream of the Kratky Dam

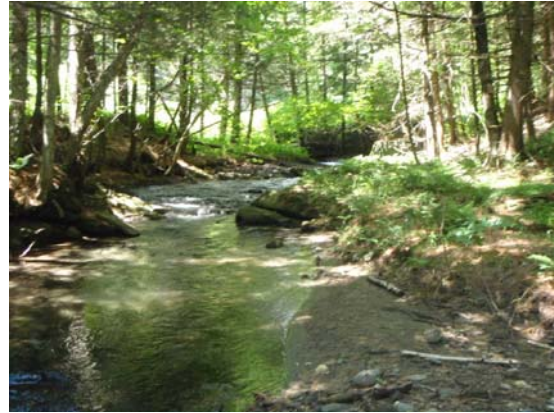
This segment presents numerous restoration opportunities that have been summarized in Section 5 of this report. The culvert crossing of Route 14 is perched and replacing it or modifying it would greatly improve fish passage from the main stem up into the tributary (Figure 4.53). Also, the habitat downstream of the Sharon Meadows Road crossing is excellent and this area would be ideal for conservation (Figure 4.54).

Figure 4.54 Potential conservation area

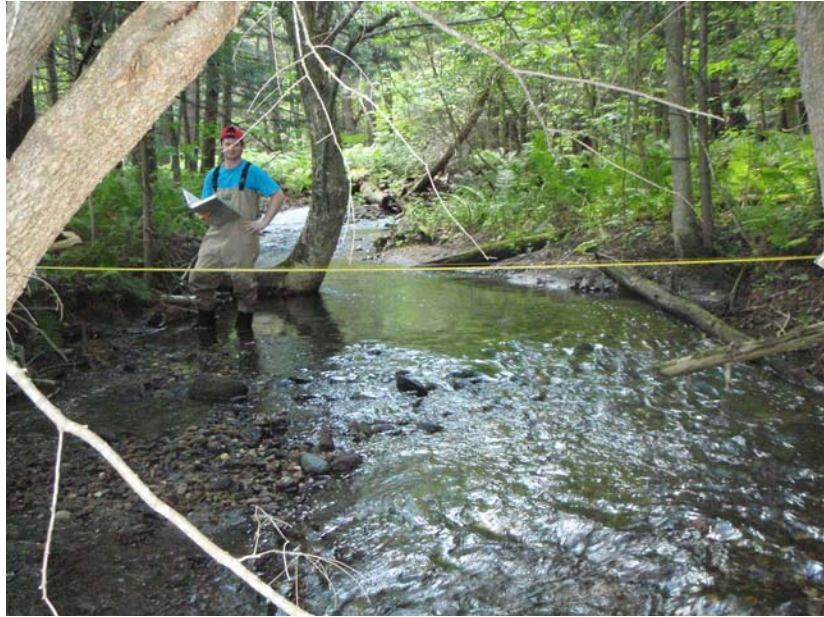
R7.S2.01-B is a highly sinuous segment that begins at the change in confinement at a farm crossing downstream of the auto salvage yard and ends at the reach break with R7.S2.02 downstream of the Moore Road culvert crossing. The segment is 0.5 miles in length and has an average slope of approximately 1.9%. The valley setting is broad with no human caused change to the valley width. The channel exhibits C-type morphology with riffle-pool bedform and high sinuosity (Figure 4.55). Channel geometry is consistent with the stream type designation and no incision was observed (WDR = 10.8; ER = 3.7; IR = 1.0). The width-depth ratio is on the cusp between E and C-type channels; however the cross-section was taken at a point where the channel was slightly narrower than the average width throughout. The substrate in R7.S2.01-B is mostly comprised of gravel-sized (47%) and cobble-sized (35%) particles and the median substrate size is 50.0 mm (Gravel).

Figure 4.55 Cross-section looking upstream; C-type morphology and riffle-pool bedform

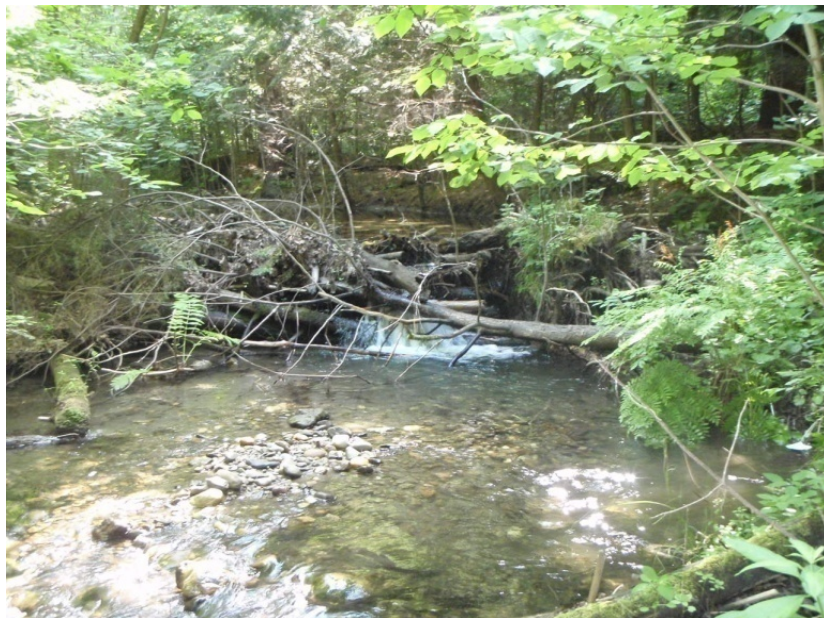
This segment has excellent bank condition and, with the exception of one crossing by the auto salvage yard, has excellent riparian buffer condition as well. Well-formed riffle-pool sequences, the abundance of woody debris and pools (LWD/Mile = 172; Pools/Mile = 49) makes for excellent habitat throughout (RHA score = "Reference"). Several debris jams provided great habitat in the pools that formed below them (Figure 4.56). The geomorphic condition is stable (RGA score = "Good"). However, evidence of past terraces suggests that this reach has recently reestablished dynamic equilibrium following disturbance. Stage V of the channel evolution model best describes the state of this segment.

Figure 4.56 Debris jam with covered pool habitat feature downstream

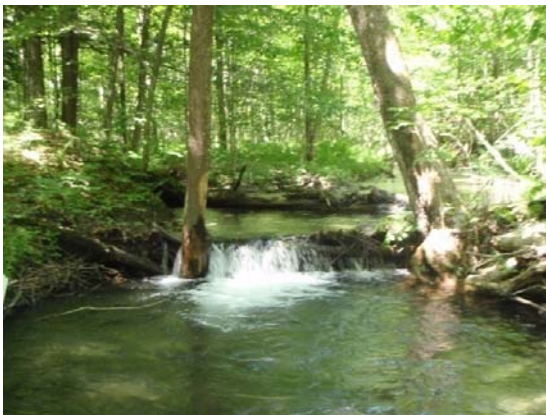
The banks and buffers on the right side of the channel were usually well vegetated and wide, but the left buffer area had some areas that were less than 25 feet wide where the corridor was used for hay fields. The density of woody debris was 'reference' (LWD/Mile = 118) and the pool density was at the upper end of 'good' (Pools/Mile = 48). Debris jams and other snags that have fallen down into the channel made for good habitat throughout the reach (RHA score = "Good;" Figure 4.57). In the upper reach some dredging was noted (Figure 4.58). There, the channel was manipulated to create a series of swimming holes for the nearby landowners. Large piles of sediment about 3 feet high were observed on the banks on either sides of the channel downstream of the pools. The presence of dredging, straightening, and incision in this reach reduced the overall geomorphic condition (RGA score = "Fair"). Currently, the reach is in stage II of the CEM because limited widening has occurred.

Figure 4.57 Debris jam, with pool feature downstream

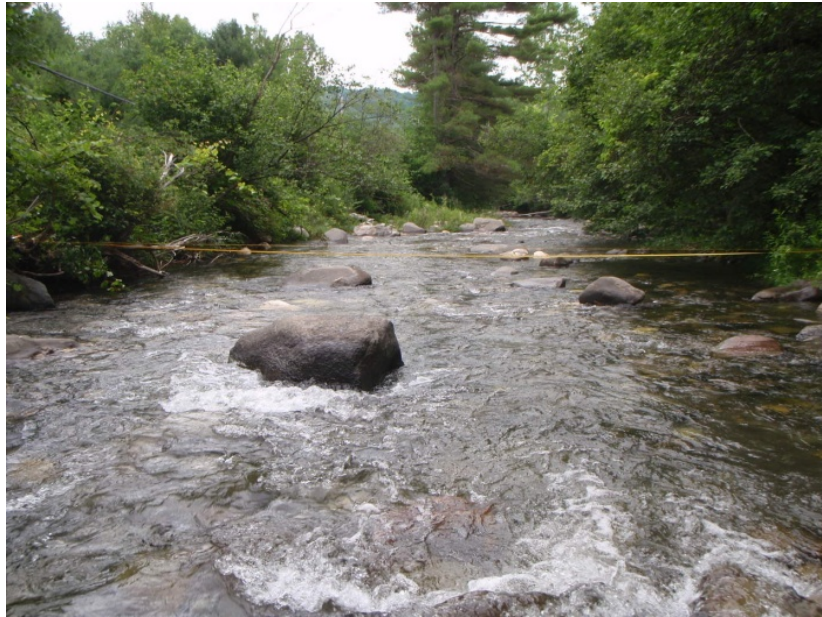
broad, with human caused changes to the valley width. The segment is 0.8 mile long and has an average channel slope of approximately 0.8%. T2.01-A exhibits C-type channel morphology with plane bedform (Figure 4.59). The current bedform represents a departure from reference bedform, which would be riffle-pool. Channel geometry is consistent with the stream typing ($WDR = 15.9$; $ER = 2.5$). Upstream of the Interstate-89 crossing the reach has been straightened and pushed up against the valley wall. There, a moderate degree of incision was observed ($IR = 1.6$). Substrate is dominated by cobble-sized particles (69%) with a median size of 130 mm (Cobble).

Figure 4.59 Cross-section location looking downstream

This segment has been largely impacted by the two culvert crossings, as well as historic channel straightening. The departure from a riffle-pool bedform setting to a plane bed has reduced the total density of pools (Pools/Mile = 14). Also, the poor riparian buffer condition on the right bank and the transport nature of the plane bed system reduced the channels potential to attenuate large woody debris (LWD/Mile = 45). The overall habitat condition was also impacted negatively by the channel morphology and geomorphic condition (RHA score = "Fair"). Geomorphically, this reach had several adjustment processes present. In the lower segment, between River Road and Interstate-89, the alignment of the culvert has caused the channel downstream to change its planform significantly (Figure 4.60). Since the culvert has a higher slope than the channel and the stream power is concentrated a large plunge pool has formed downstream that exceeds 8 feet of depth (Figure 4.61). The alignment of the culvert is toward the intersection of Broad Brook Road and River Road instead of toward the River Road Culvert. Over time it has slowly eroded the north side slope of the valley, and may pose a serious threat to the first house on Broad Brook Road in the future. This major migration feature and the bars associated with it are indicative of stage III of the CEM. The incision upstream also lowered the overall geomorphic score and makes this segment unstable (RGA score = "Fair").

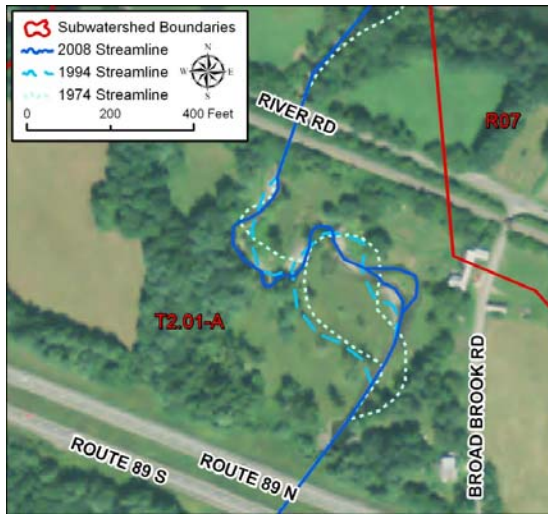
Figure 4.60. Channel migration observed over the last 34 years
